## SERVICE BULLETIN 13-3-21 REV 1

**Subject:** Ethanol in gasoline

**Affected Models:** All flying RV-12 and RV-12iS aircraft

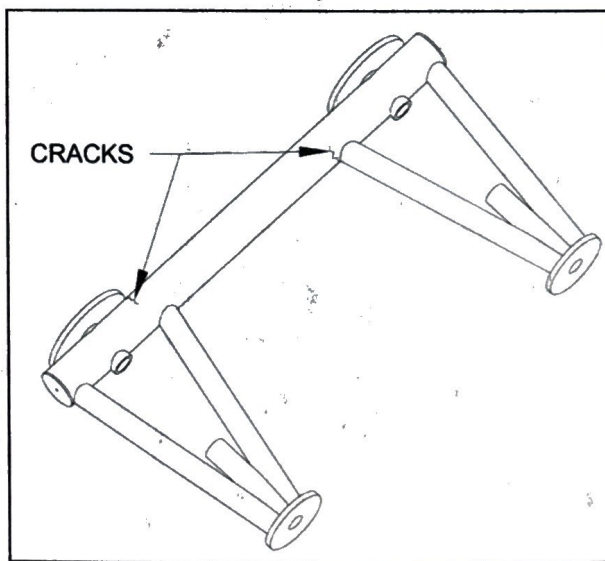
**FIGURE 1:** WD-1221 CRACK LOCATIONS

Remove the top cowl. Inspect the WD-1221 Engine Mount Standoff for cracks in the main cross tube (refer to Figure 1 for specific location).

If cracks are discovered in the standoff, notify Van's Aircraft support at [support@vansaircraft.com](mailto:support@vansaircraft.com) and replace it with a WD-01221-1 Engine Mount Standoff as described in this document. If no cracks are discovered, 100-hour inspections are required until the standoff is replaced.
