This sheet transmits Revision 01 to Service Bulletin 500-27-A026.

## FLIGHT CONTROLS - AILERON TRIM TAB, RUDDER TRIM TAB AND ELEVATOR TRIM TAB INSPECTION AND TORQUE

## **SERVICE BULLETIN**

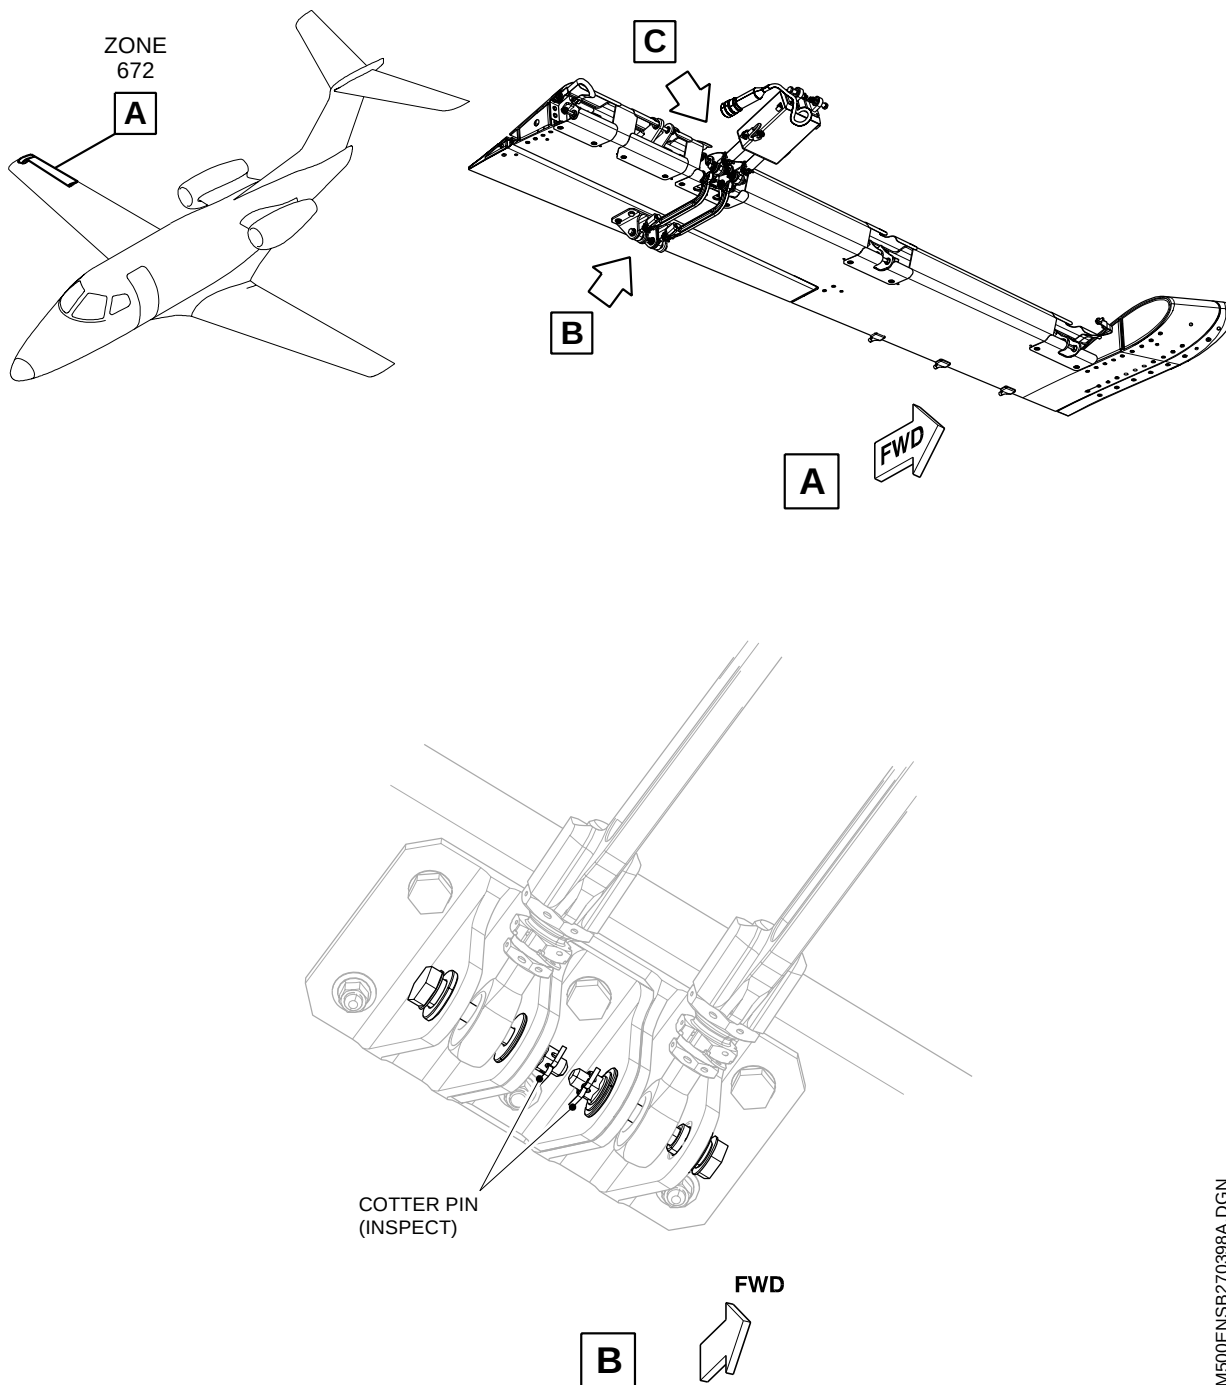
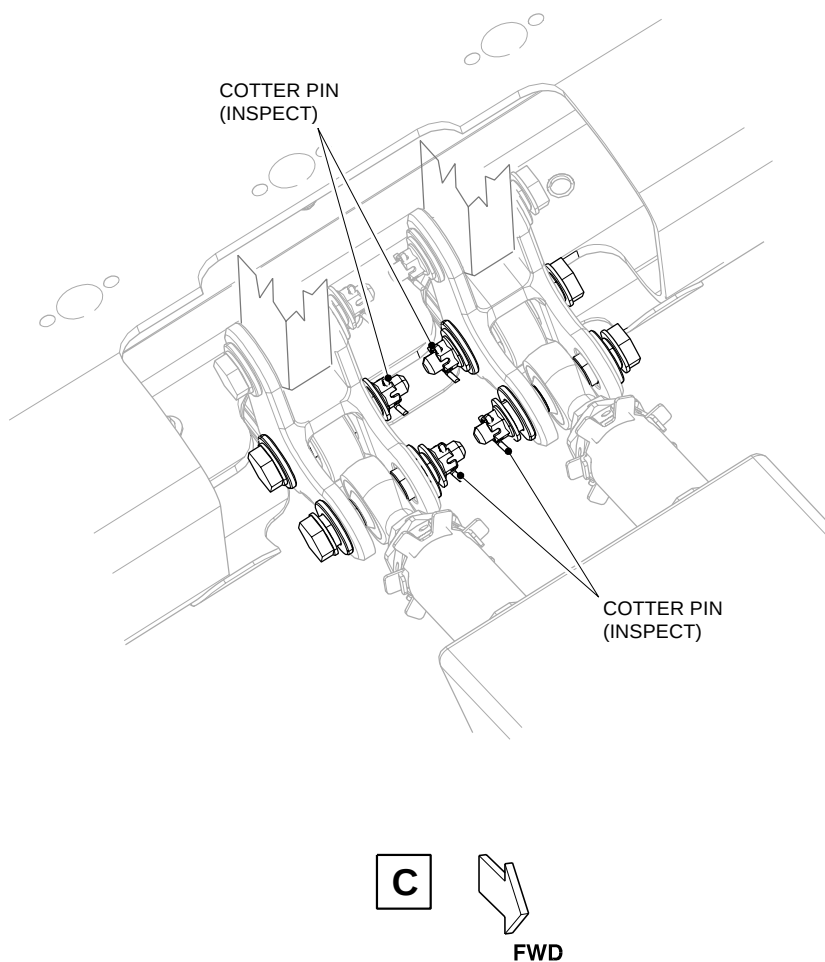
FIGURE 1 - AILERON TRIM TAB INSPECTION  
(SHEET 01 OF 02)

- (1) Inspect the aileron trim tab, rudder trim tab and elevator trim tab attachment points to make sure the cotter pin is installed. Refer to [Figure 1](#), [Figure 2](#) and [Figure 3](#).

- (2) If the cotter pin is installed, no action is required.

- (3) If the cotter pin is not installed, perform PART II of this service bulletin.
