**WINGS - STRUCTURAL REPAIR ALLOWABLE DAMAGE INSPECTION**

Embraer has identified a quality escape in Structural Repair Manual (SRM) 3858, associated with discrepancies in some allowable damage instructions. Structural Repair Manual (SRM) 3858 revision 13th has already been released to address the necessary corrections.

To inspect the aircraft log book associated with allowable damage instructions for the regions affected by the quality escape and take necessary actions if applicable.

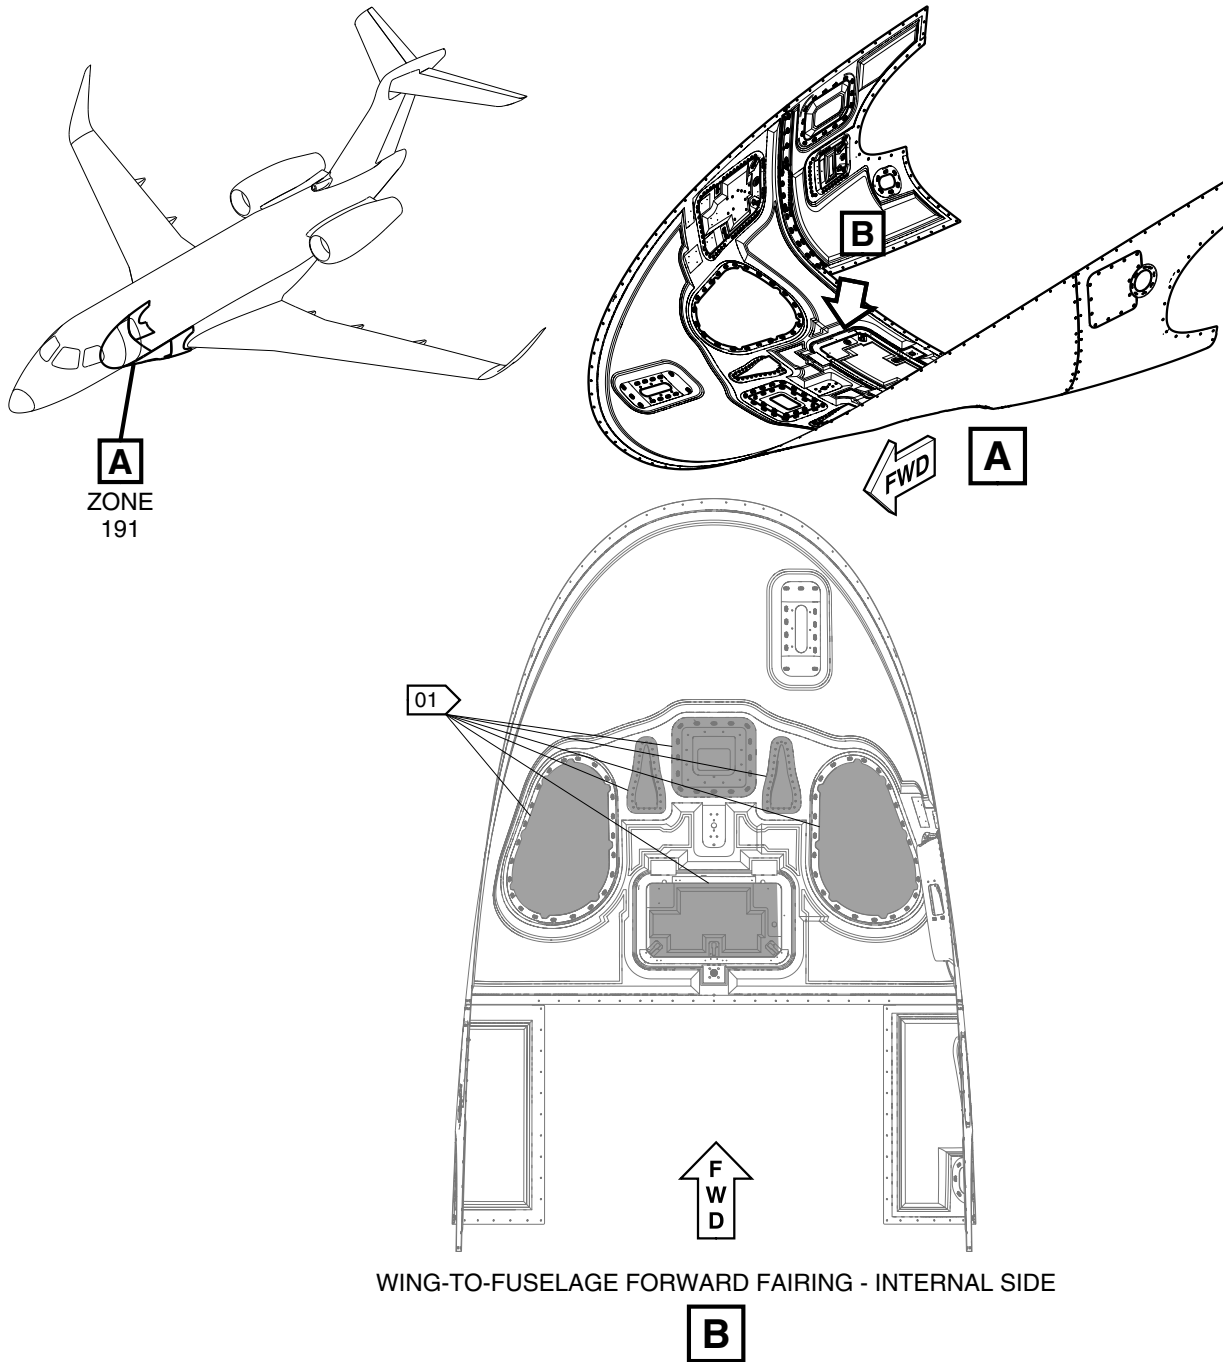
FIGURE 1 - WING-TO-FUSELAGE FORWARD FAIRING INTERNAL SIDE INSPECTION -  
GROUP 1  
(Sheet 1 of 1)

**01** VERIFY IN THE AIRCRAFT LOG-BOOK WHETHER IT HAS USED ALLOWABLE DAMAGE INSTRUCTION **FOR HOLES AND PUNCTURES** IN THE SHADED AREA.

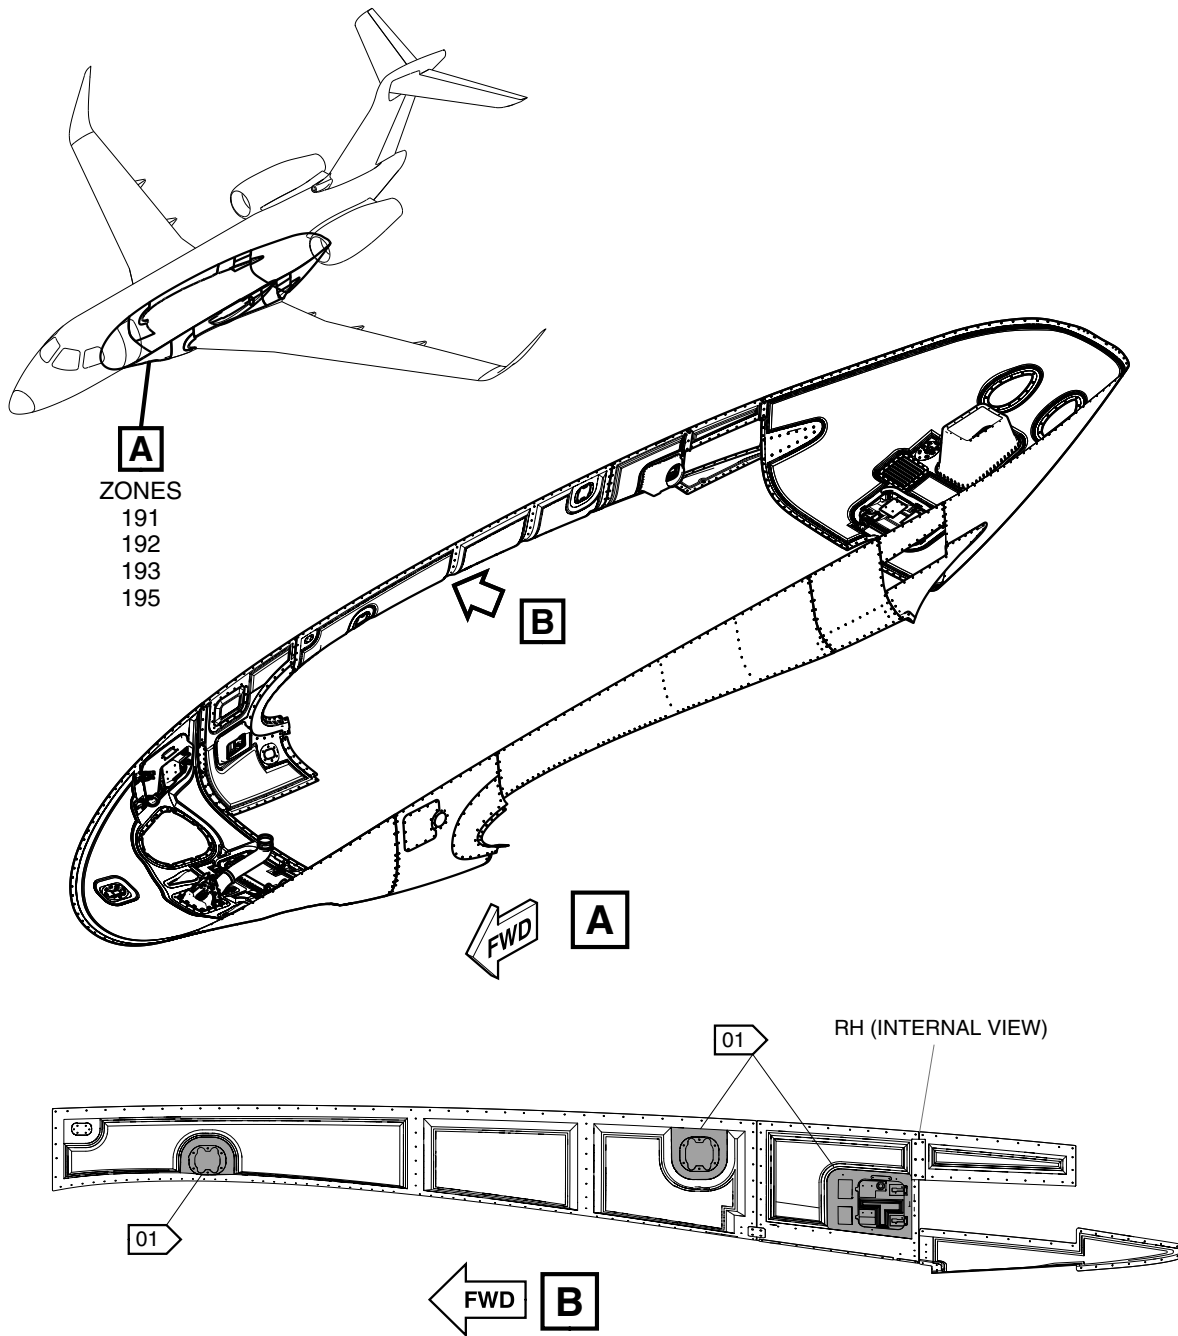
**FIGURE 3 - WING-TO-FUSELAGE LATERAL FAIRING INSPECTION - GROUP 1**  
(Sheet 1 of 1)

**01** VERIFY IN THE AIRCRAFT LOG-BOOK WHETHER IT HAS USED ALLOWABLE DAMAGE INSTRUCTION **FOR HOLES AND PUNCTURES** IN THE SHADED AREA.

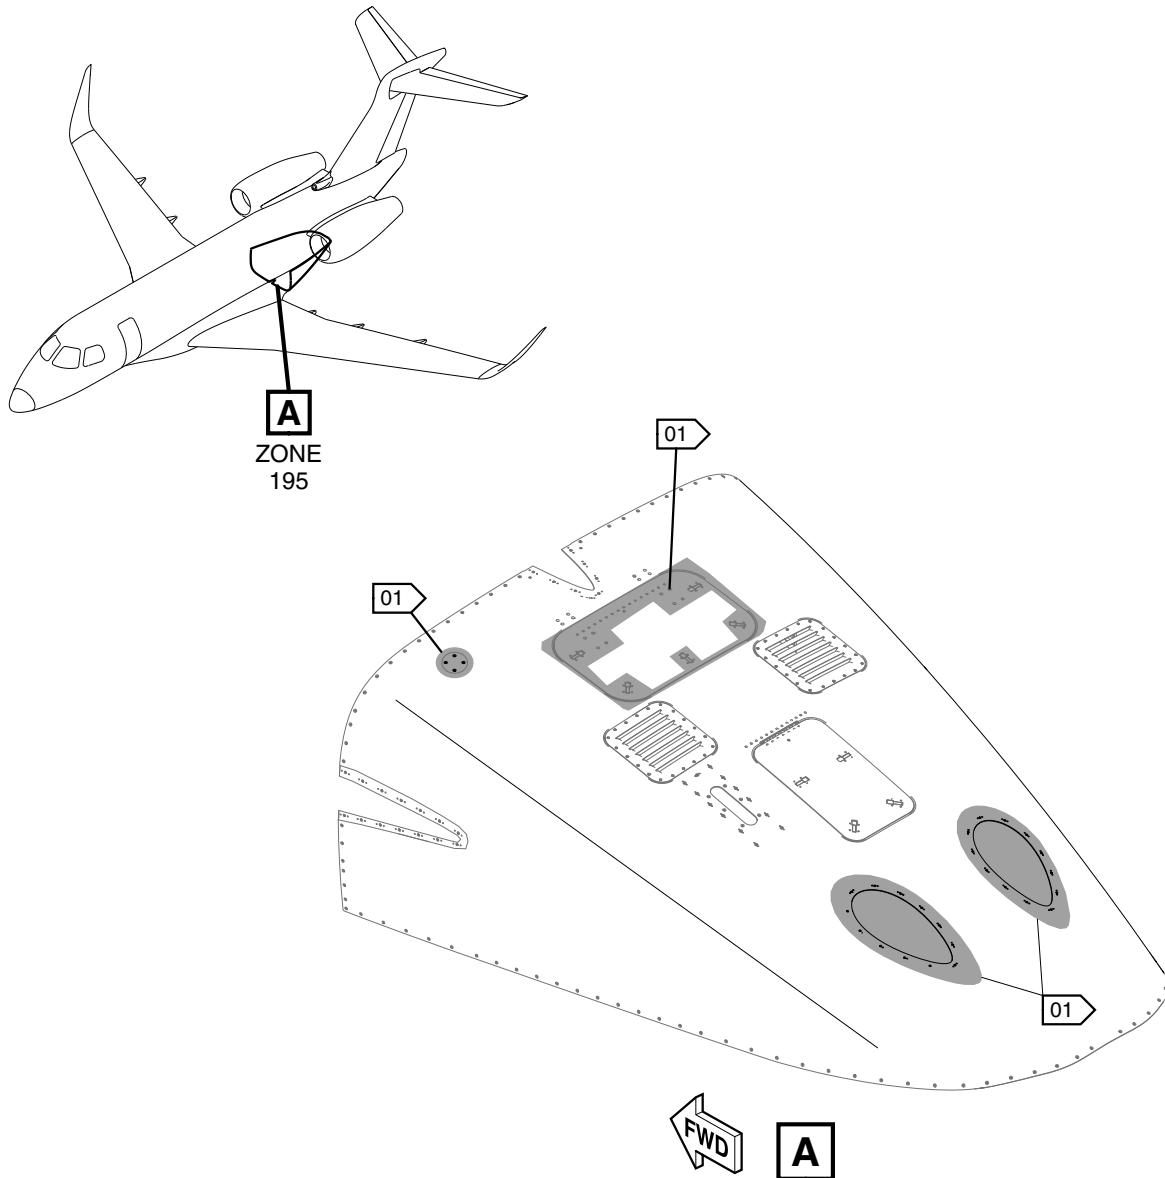
FIGURE 4 - WING-TO-FUSELAGE REAR FAIRING INSPECTION - GROUP 1  
(Sheet 1 of 1)

**01** VERIFY IN THE AIRCRAFT LOG-BOOK WHETHER IT HAS USED ALLOWABLE DAMAGE INSTRUCTION **FOR HOLES AND PUNCTURES** IN THE SHADED AREA.

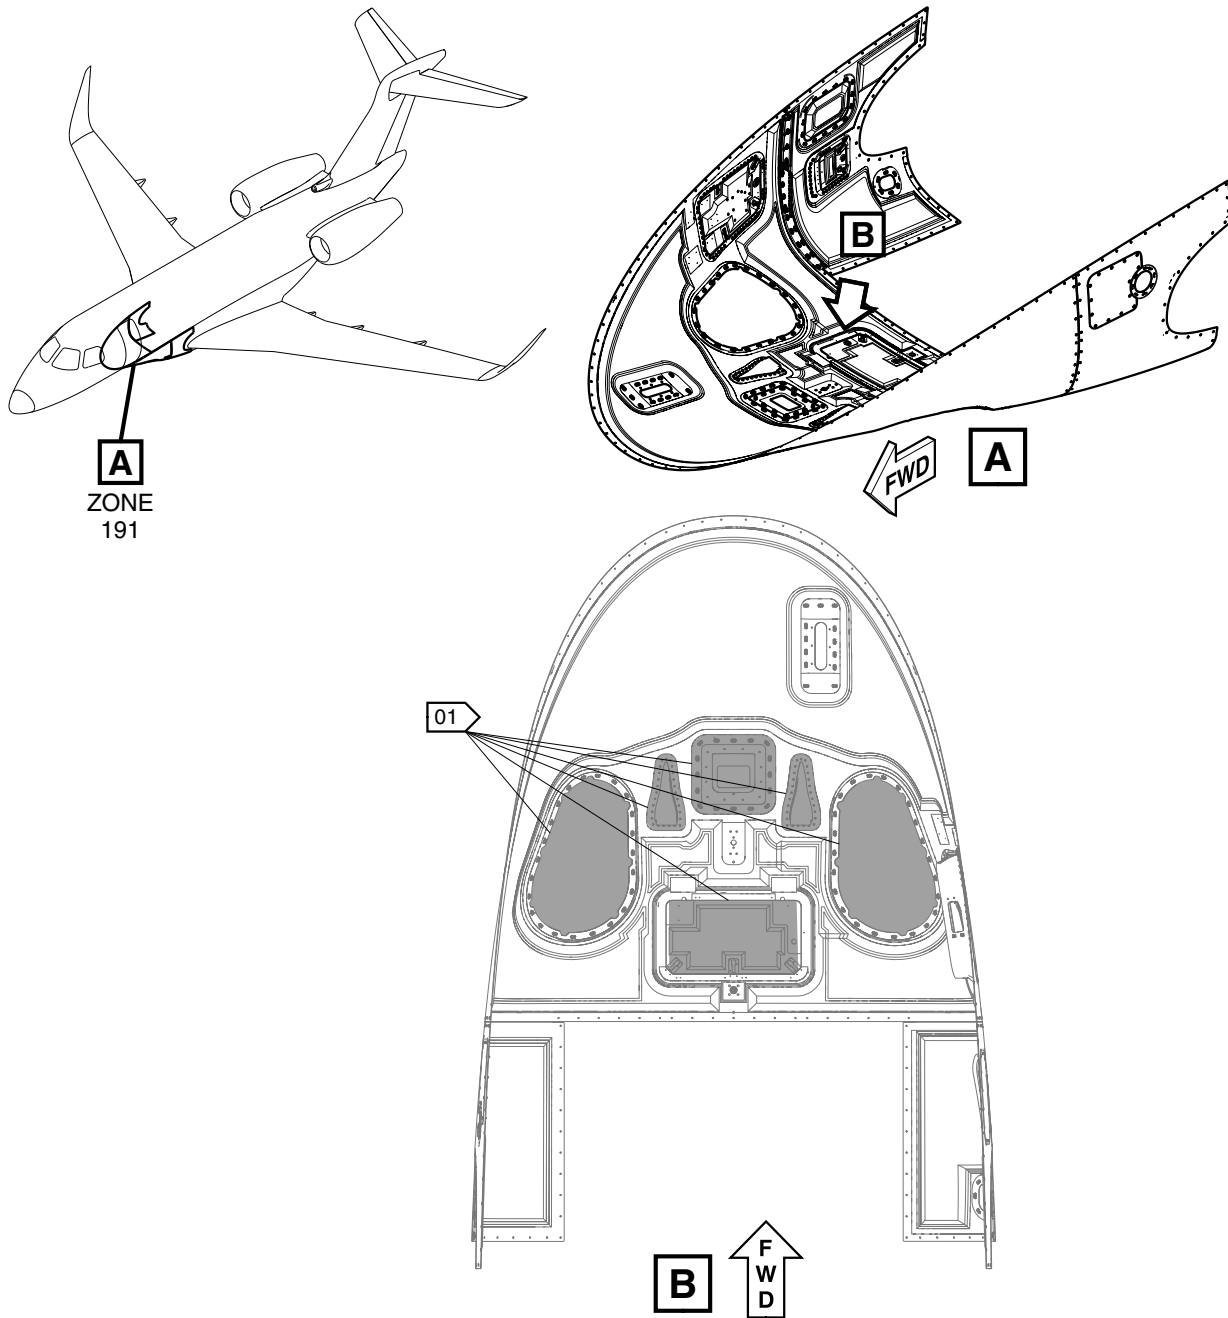
FIGURE 5 - WING-TO-FUSELAGE FORWARD FAIRING INSPECTION - GROUP 1  
(Sheet 1 of 1)

**01** VERIFY IN THE AIRCRAFT LOG-BOOK WHETHER IT HAS USED ALLOWABLE DAMAGE INSTRUCTION **FOR THICKNESS REDUCTION** IN THE SHADED AREA.

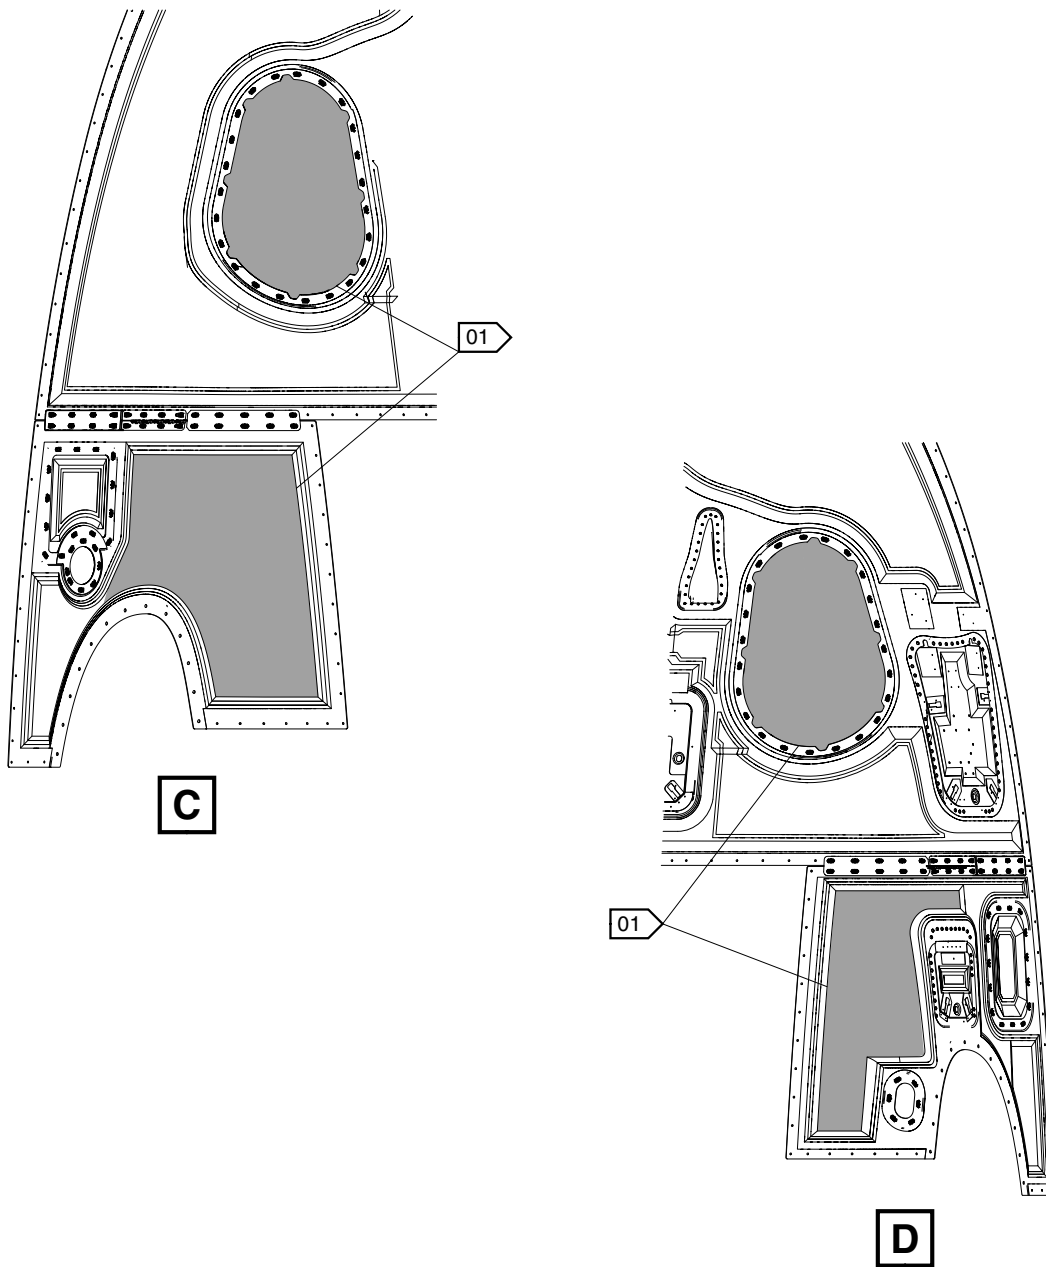
FIGURE 6 - WING-TO-FUSELAGE FORWARD FAIRING INSPECTION - GROUP 1  
(Sheet 2 of 2)

**01** VERIFY IN THE AIRCRAFT LOG-BOOK WHETHER IT HAS USED ALLOWABLE DAMAGE INSTRUCTION **FOR THICKNESS REDUCTION** IN THE SHADED AREA.

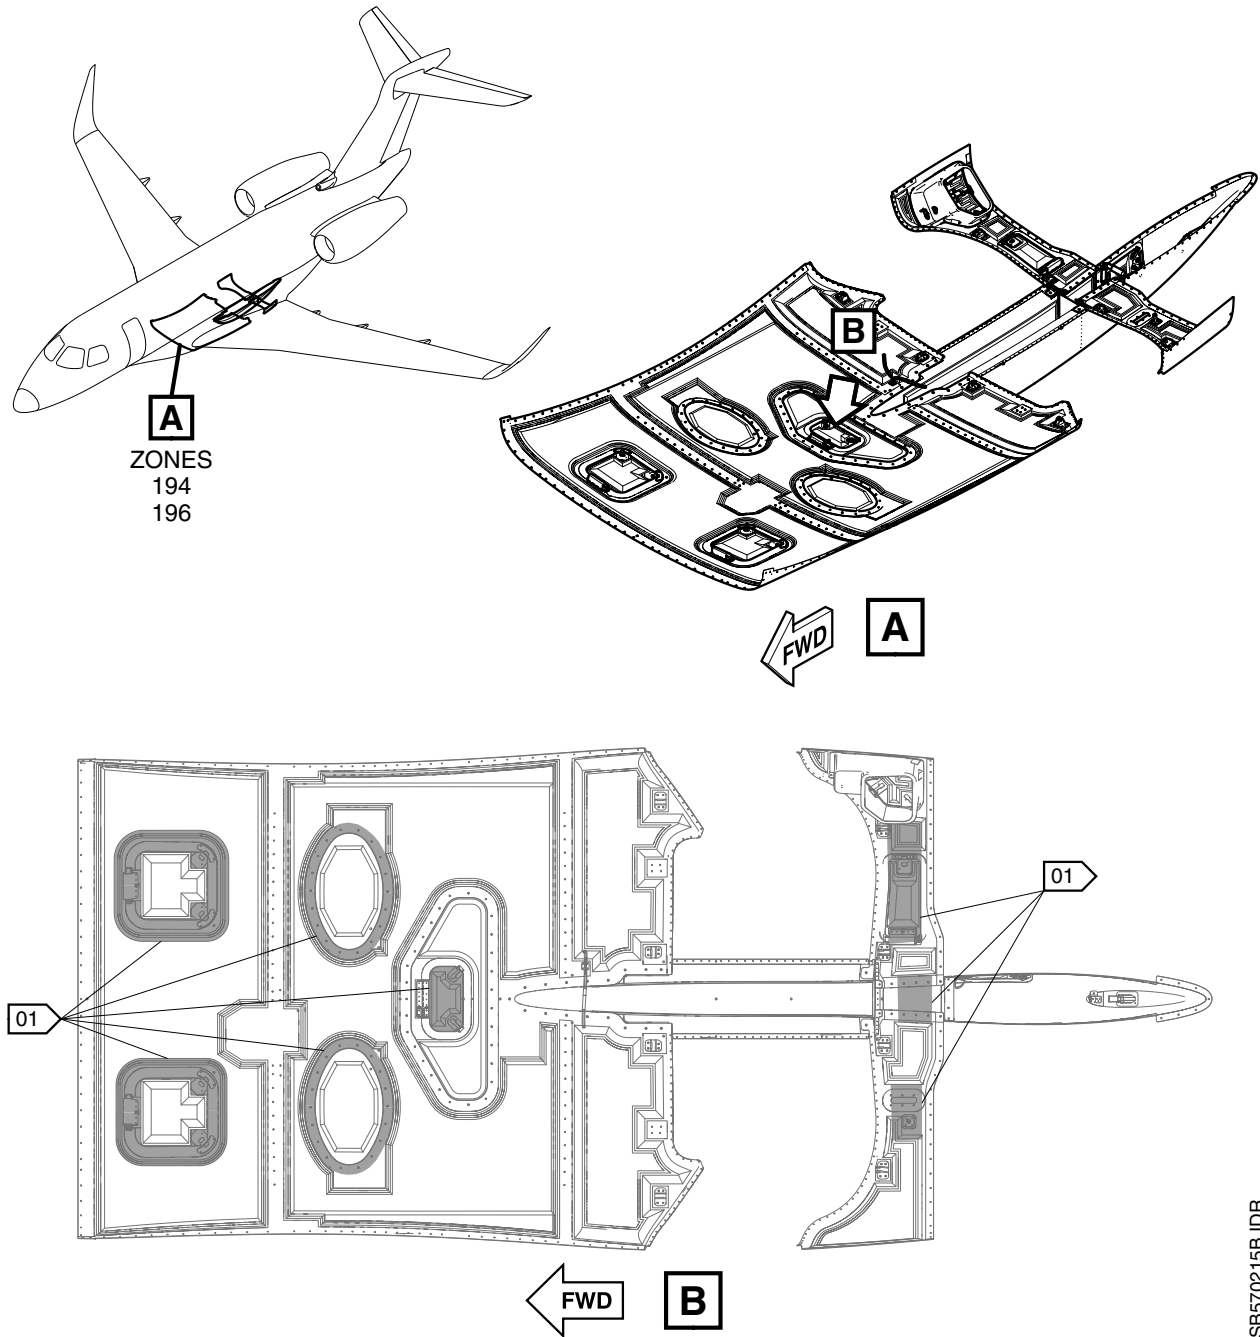
FIGURE 7 - WING-TO-FUSELAGE CENTRAL FAIRING INSPECTION - GROUP 1  
(Sheet 1 of 1)

**01** VERIFY IN THE AIRCRAFT LOG-BOOK WHETHER IT HAS USED ALLOWABLE DAMAGE INSTRUCTION **FOR THICKNESS REDUCTION** (DAMAGE AFFECTING UP TO 1 PLY) IN THE SHADED AREA.

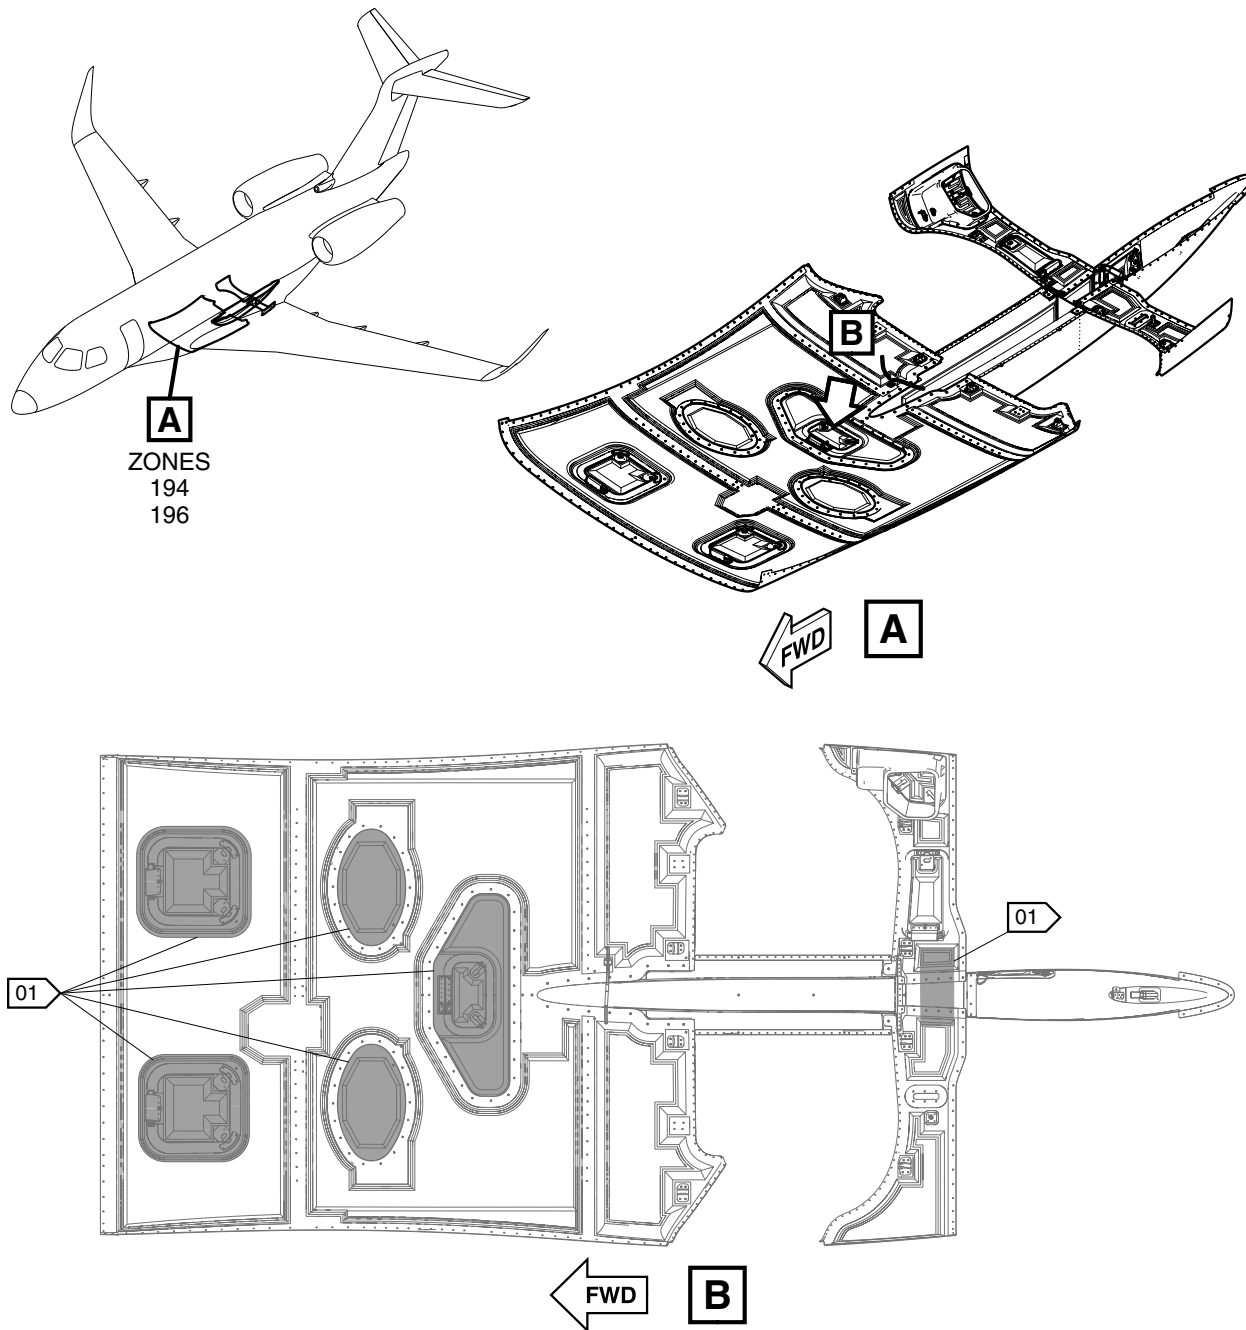
FIGURE 8 - WING-TO-FUSELAGE CENTRAL FAIRING INSPECTION - GROUP 1  
(Sheet 1 of 1)

**01** VERIFY IN THE AIRCRAFT LOG-BOOK WHETHER IT HAS USED ALLOWABLE DAMAGE INSTRUCTION **FOR THICKNESS REDUCTION** (DAMAGE AFFECTING UP TO 2 PLIES) IN THE SHADED AREA.

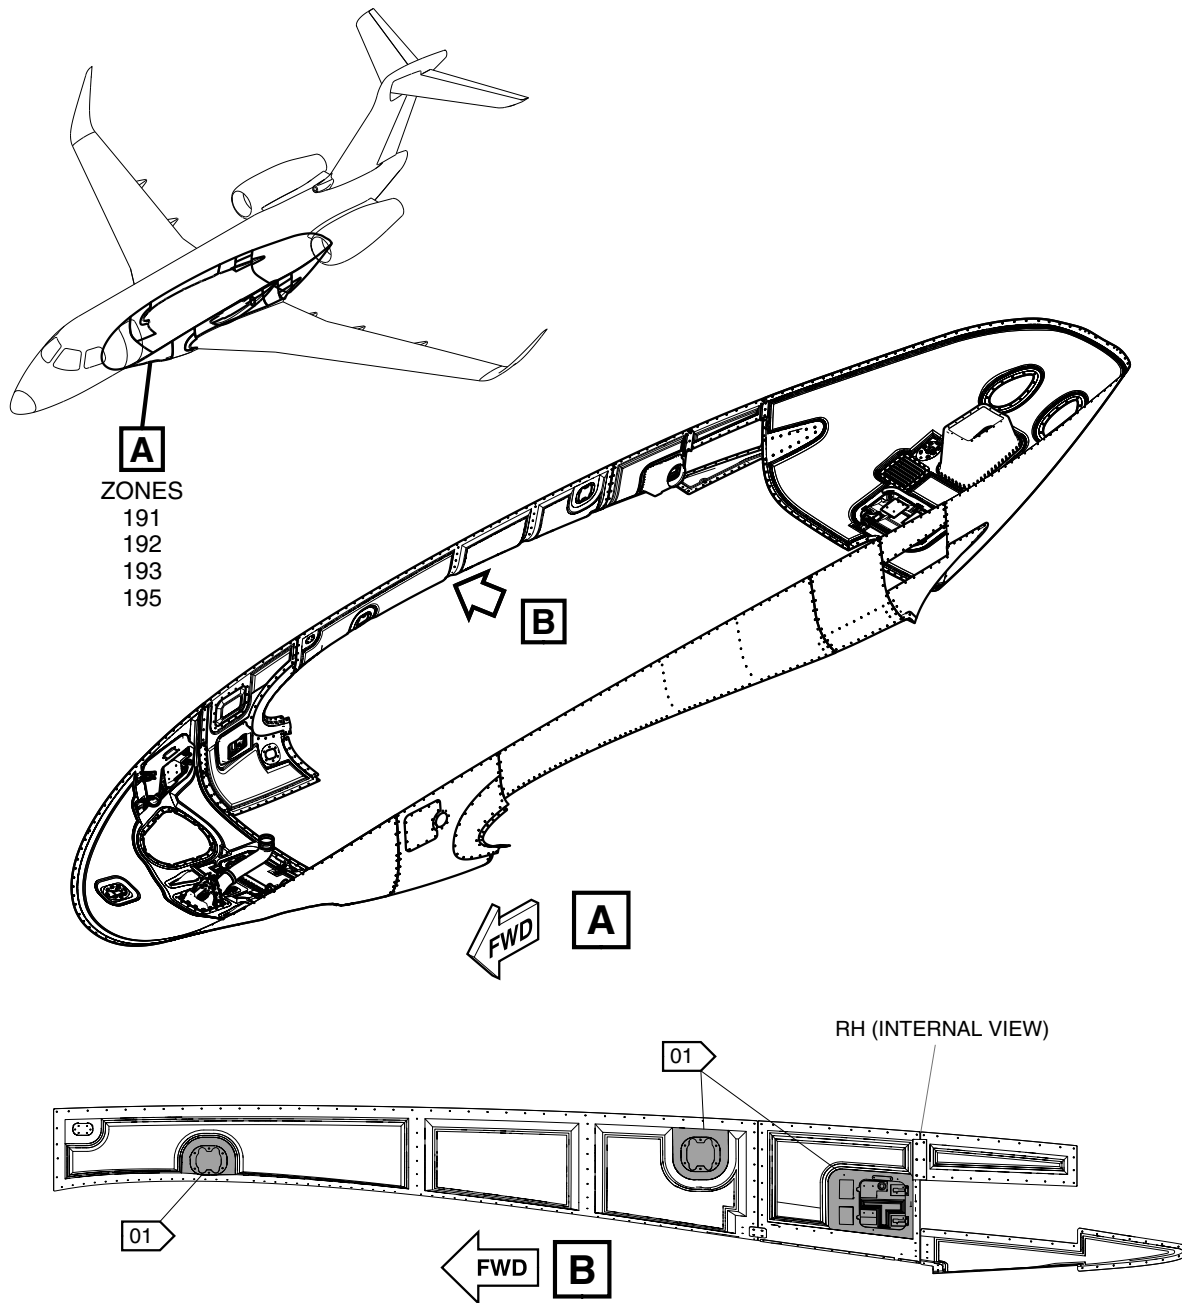
FIGURE 9 - WING-TO-FUSELAGE LATERAL FAIRING INSPECTION - GROUP 1  
(Sheet 1 of 1)

**01** VERIFY IN THE AIRCRAFT LOG-BOOK WHETHER IT HAS USED ALLOWABLE DAMAGE INSTRUCTION **FOR THICKNESS REDUCTION** IN THE SHADED AREA.

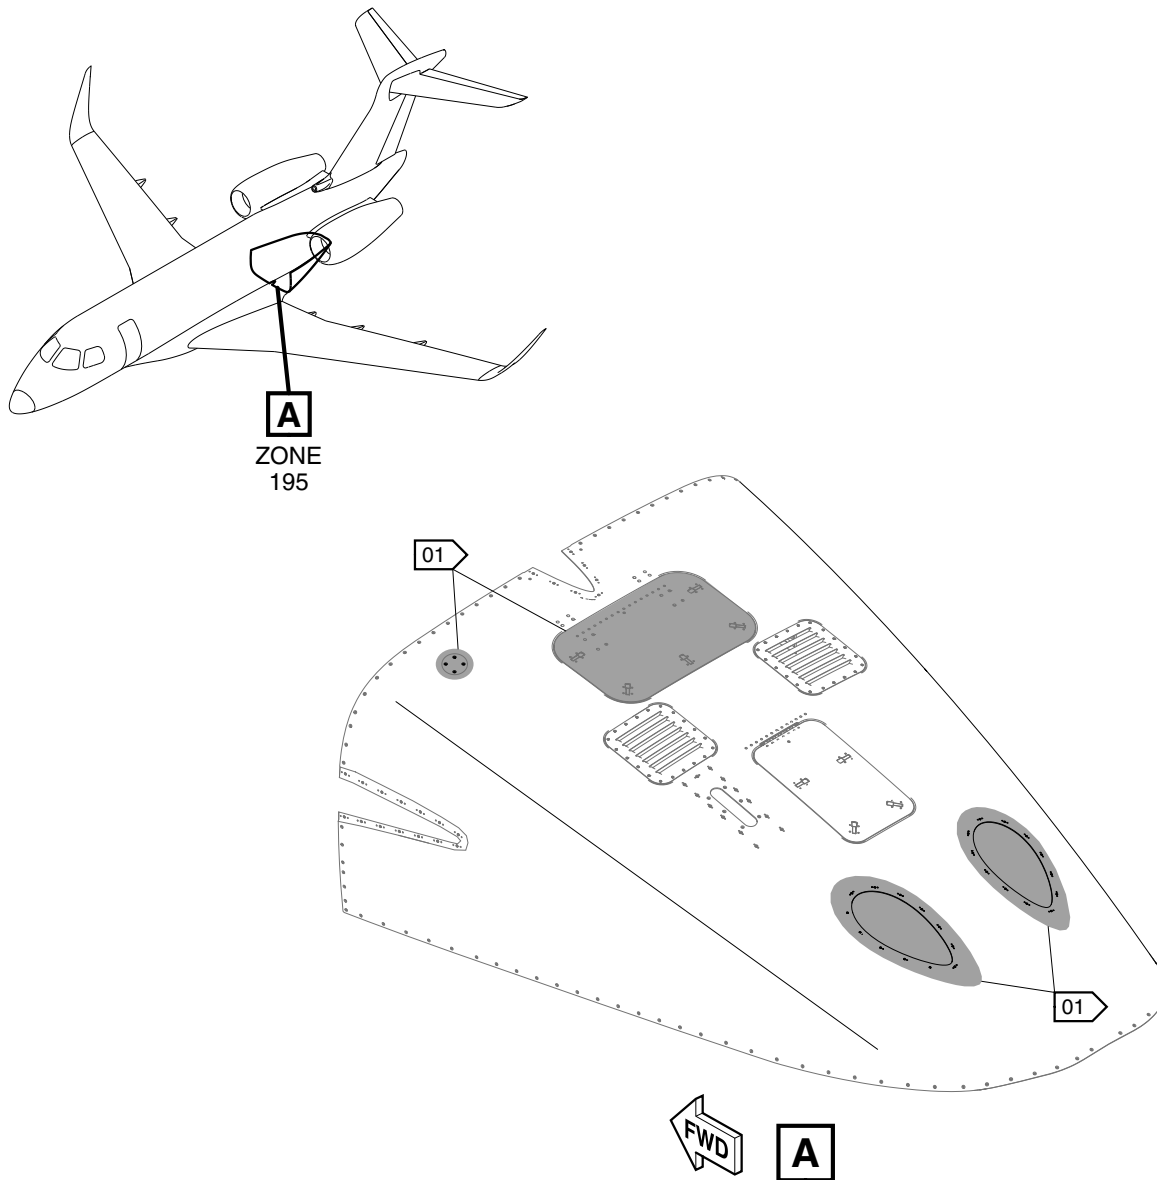
FIGURE 10 - WING-TO-FUSELAGE REAR FAIRING INSPECTION - GROUP 1  
(Sheet 1 of 1)

**01** VERIFY IN THE AIRCRAFT LOG-BOOK WHETHER IT HAS USED ALLOWABLE DAMAGE INSTRUCTION **FOR THICKNESS REDUCTION** (DAMAGE AFFECTING UP TO 1 PLY) IN THE SHADED AREA.

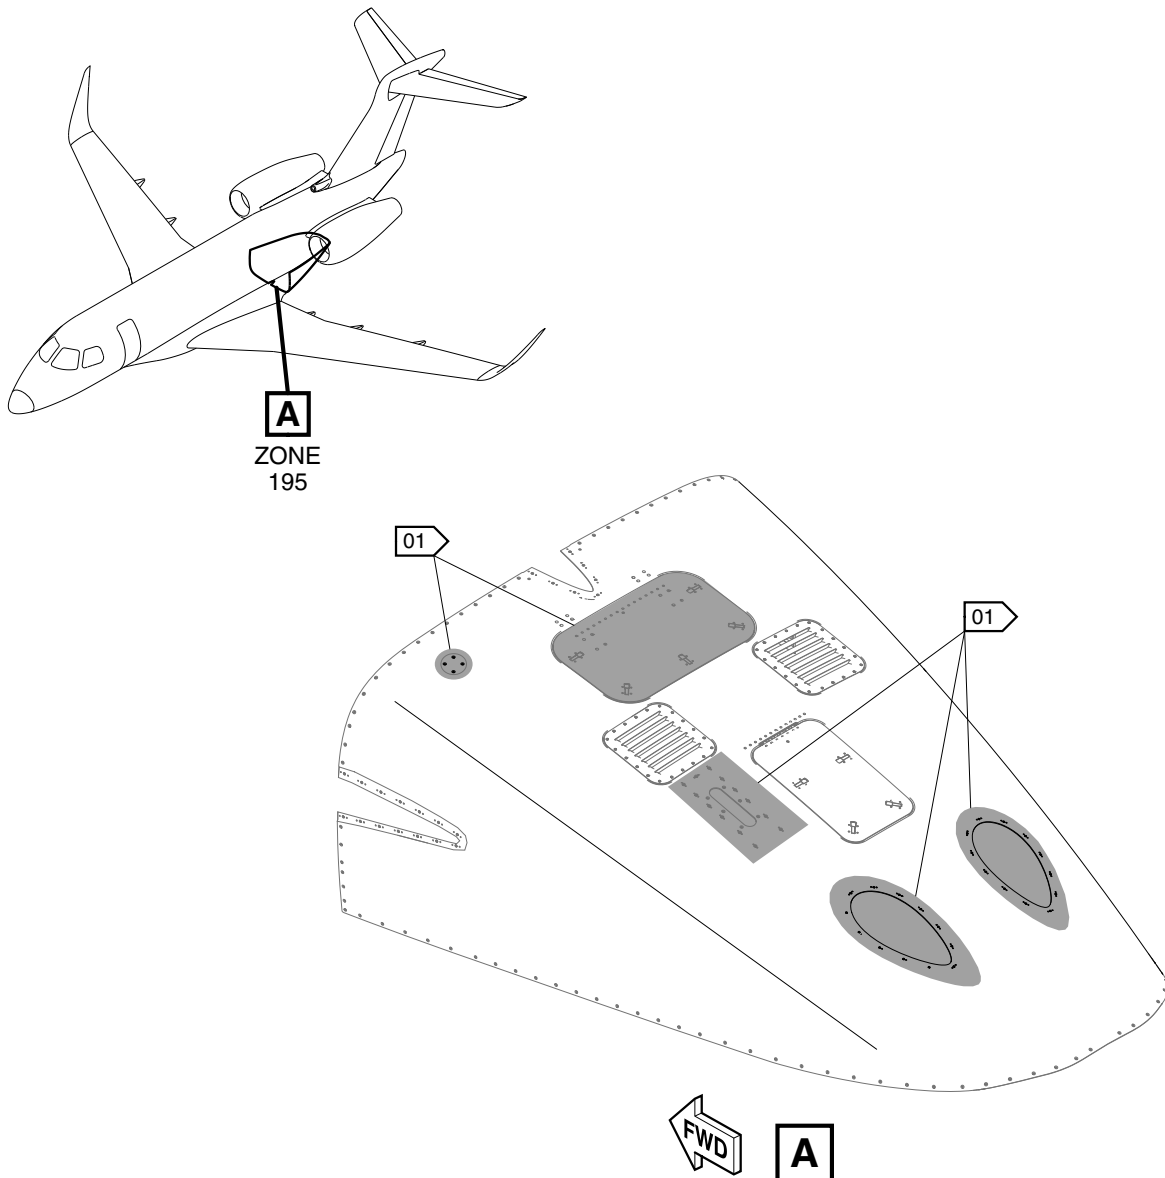
FIGURE 11 - WING-TO-FUSELAGE REAR FAIRING -ZONING FOR THICKNESS  
REDUCTION INSPECTION - GROUP 1  
(Sheet 1 of 1)

**01** VERIFY IN THE AIRCRAFT LOG-BOOK WHETHER IT HAS USED ALLOWABLE DAMAGE INSTRUCTION **FOR THICKNESS REDUCTION** (DAMAGE AFFECTING UP TO 2 PLYS) IN THE SHADED AREA.

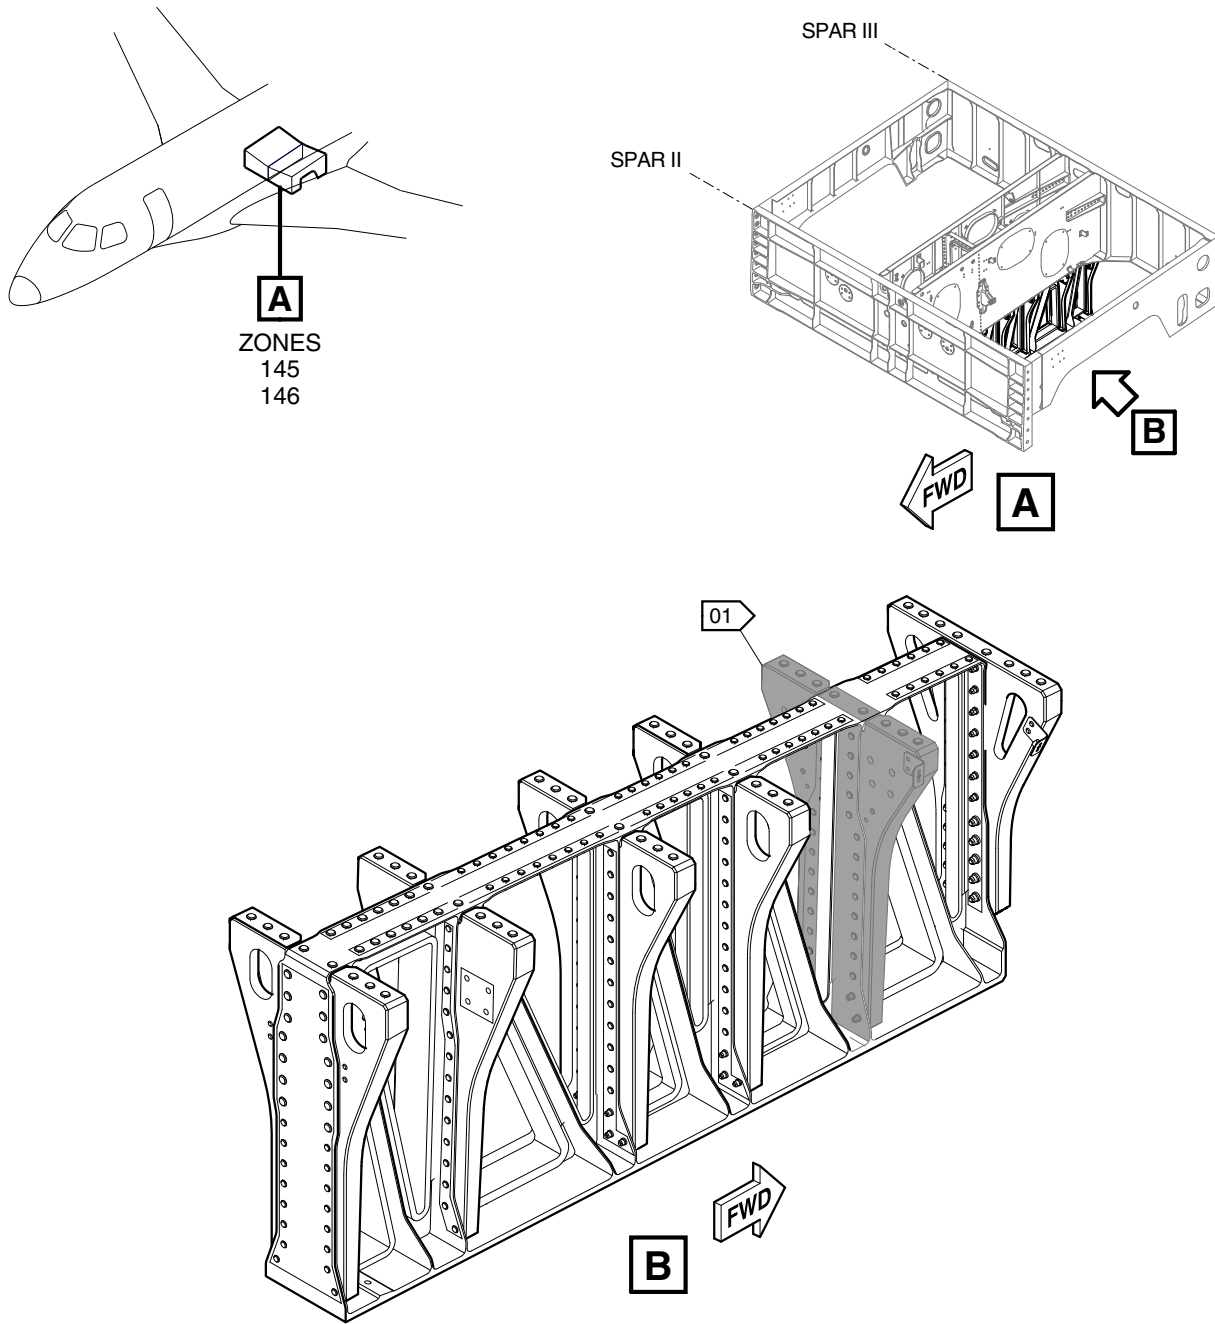
FIGURE 12 - WING STUB SKID MAIN STRUCTURE INSPECTION - GROUP 1  
(Sheet 1 of 1)

**01** VERIFY IN THE AIRCRAFT LOG-BOOK WHETHER IT HAS USED ALLOWABLE DAMAGE INSTRUCTION **FOR THICKNESS REDUCTION** IN THE SHADED AREA.

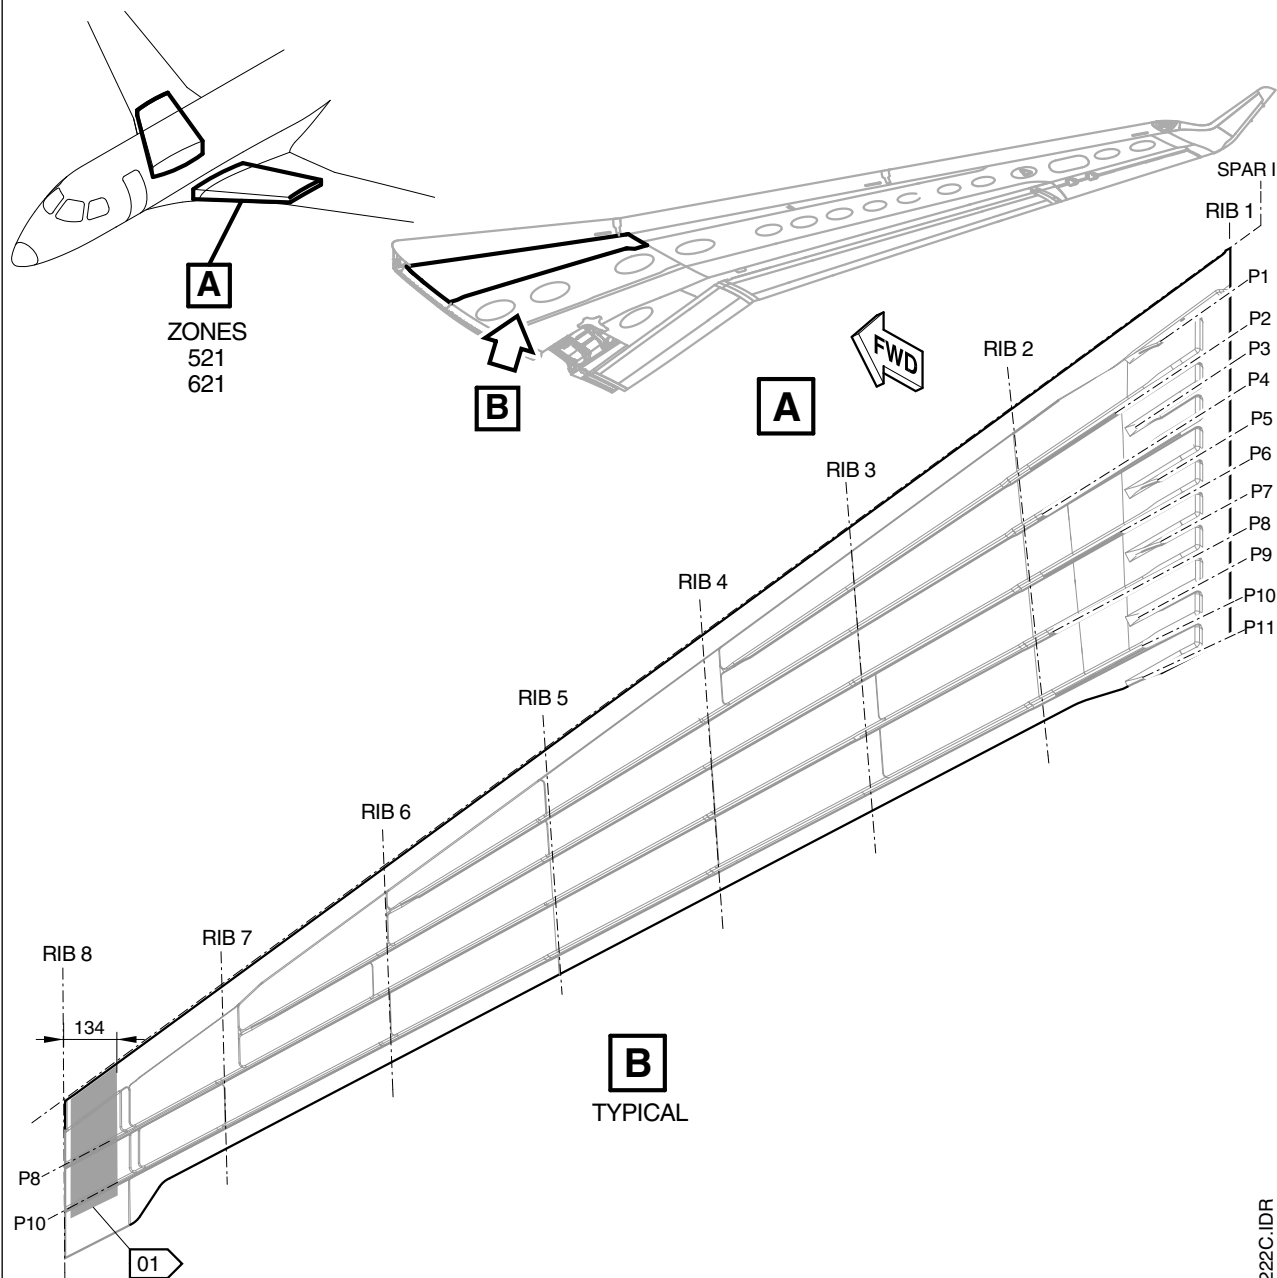
FIGURE 14 - WING FRONT ROOT LOWER SKIN INSPECTION - GROUP 1 THRU GROUP 4 AND POST MOD SB550-00-0011  
(Sheet 1 of 1)

**01** VERIFY IN THE AIRCRAFT LOG-BOOK WHETHER IT HAS USED ALLOWABLE DAMAGE INSTRUCTION **FOR THICKNESS REDUCTION** IN THE SHADED AREA.

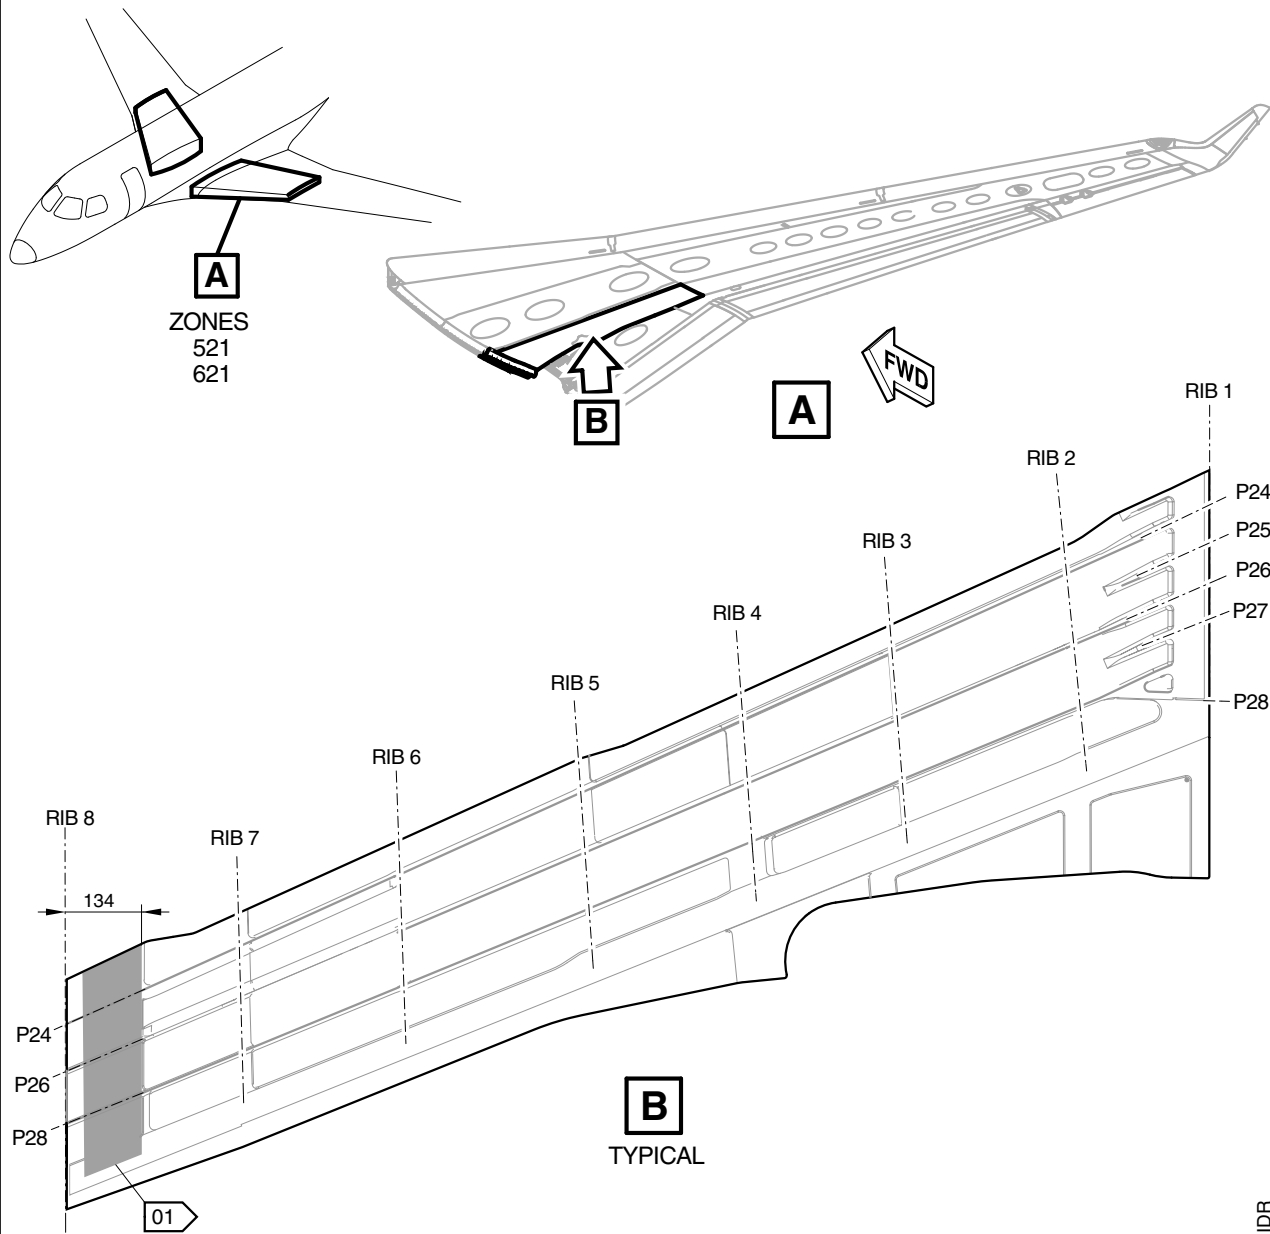
FIGURE 16 - WING REAR ROOT LOWER SKIN INSPECTION - GROUP 1 THRU GROUP 4  
AND POST MOD SB550-00-0011  
(Sheet 1 of 1)

**01** VERIFY IN THE AIRCRAFT LOG-BOOK WHETHER IT HAS USED ALLOWABLE DAMAGE INSTRUCTION **FOR THICKNESS REDUCTION** IN THE SHADED AREA.

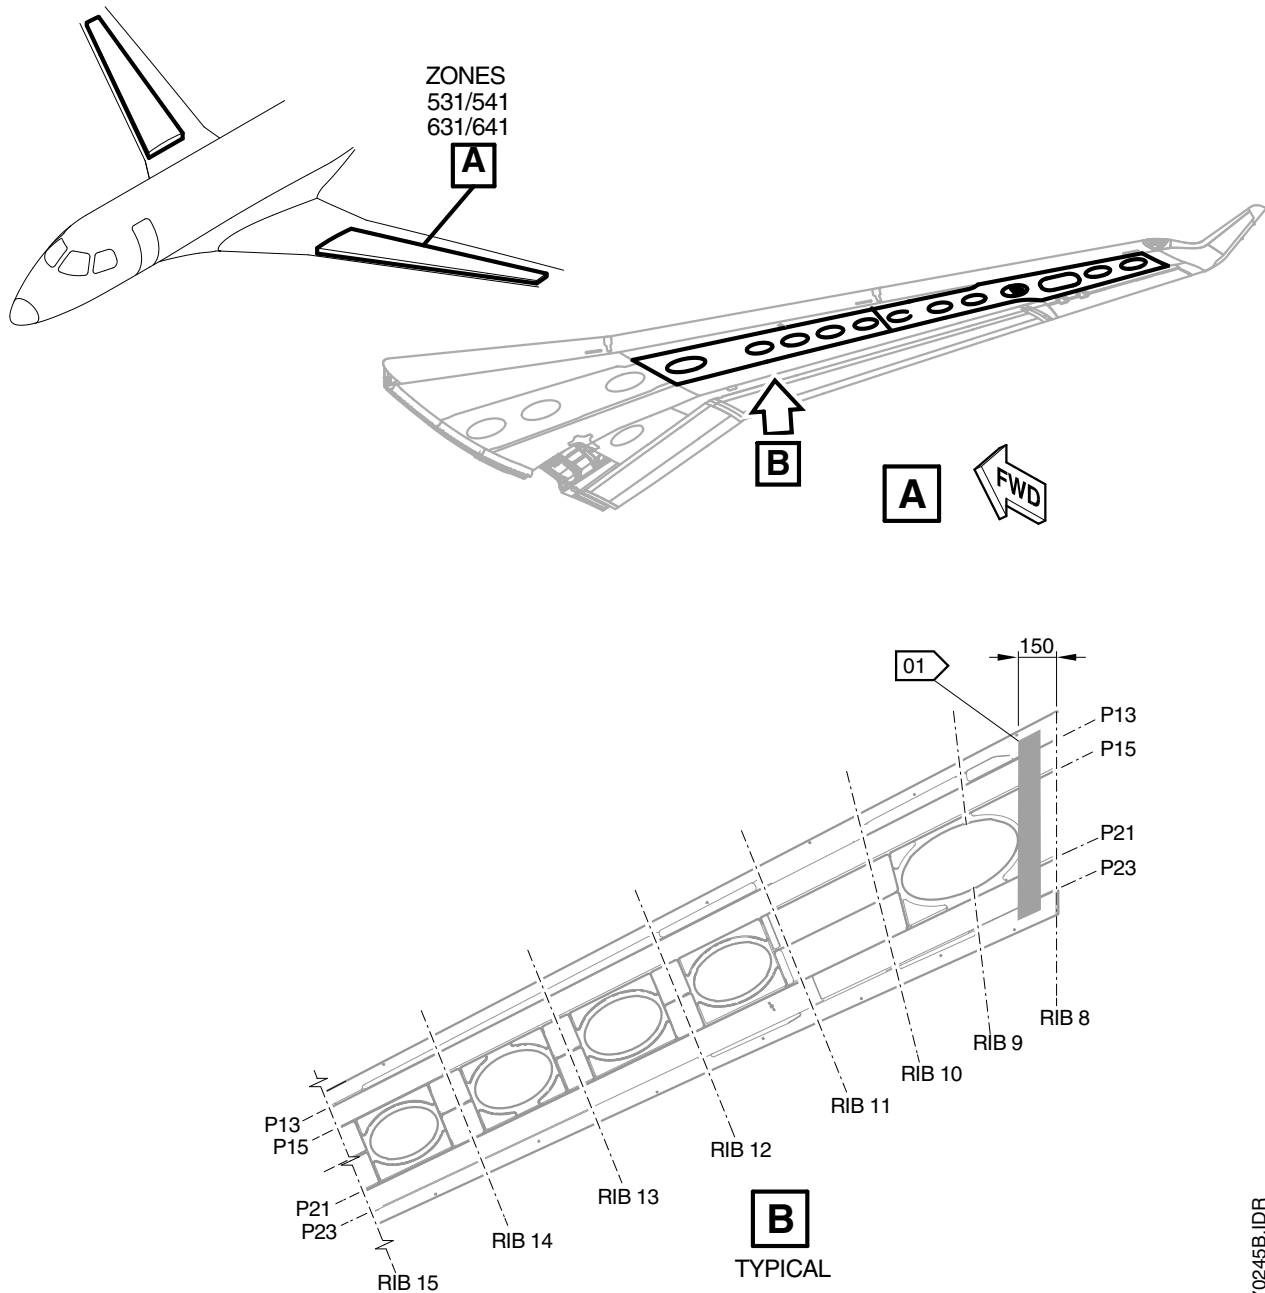
FIGURE 18 - WING CENTRAL TIP LOWER SKIN INSPECTION - GROUP 1 THRU GROUP 4  
AND POST MOD SB550-00-0011  
(Sheet 1 of 1)

**01** VERIFY IN THE AIRCRAFT LOG-BOOK WHETHER IT HAS USED ALLOWABLE DAMAGE INSTRUCTION **FOR THICKNESS REDUCTION** IN THE SHADED AREA.
