**WINGS - STRUCTURAL REPAIR ALLOWABLE DAMAGE INSPECTION**

Embraer has identified a quality escape in Structural Repair Manual (SRM) 3858, associated with discrepancies in some allowable damage instructions. Structural Repair Manual (SRM) 3858 revision 13th has already been released to address the necessary corrections.

To inspect the aircraft log book associated with allowable damage instructions for the regions affected by the quality escape and take necessary actions if applicable.

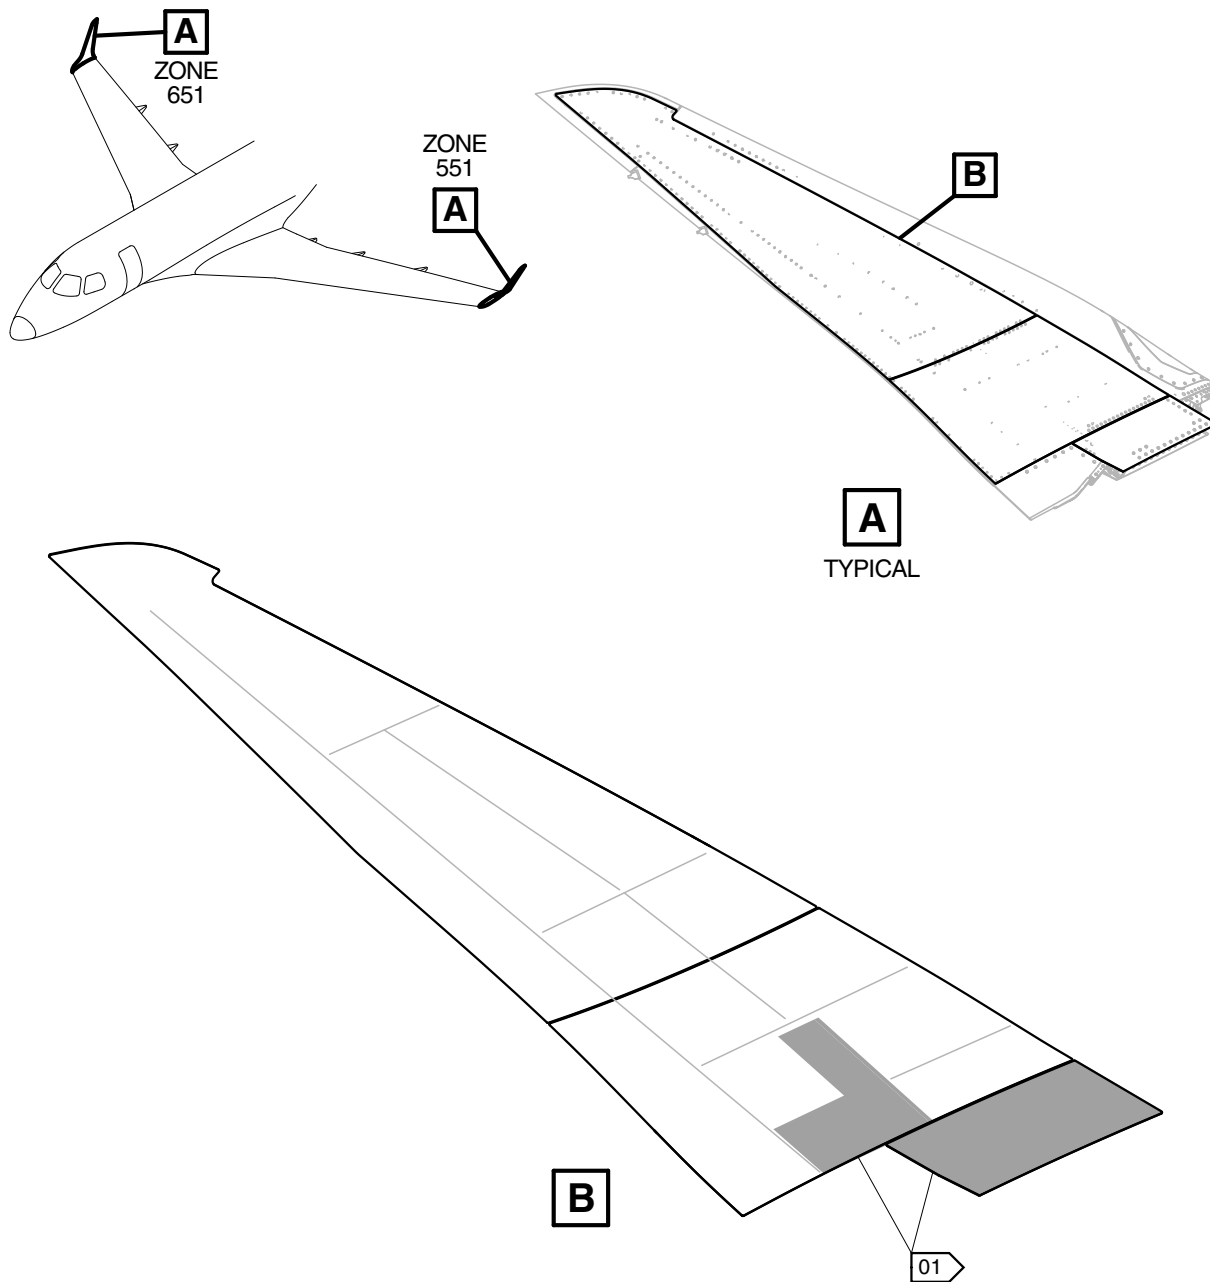
FIGURE 20 - WINGLET LEADING UPPER SKIN INSPECTION - GROUP 1, GROUP 2 AND  
POST MOD SB550-00-0011  
(Sheet 1 of 1)

**01** VERIFY IN THE AIRCRAFT LOG-BOOK WHETHER IT HAS USED ALLOWABLE DAMAGE INSTRUCTION **FOR THICKNESS REDUCTION** IN THE SHADED AREA.

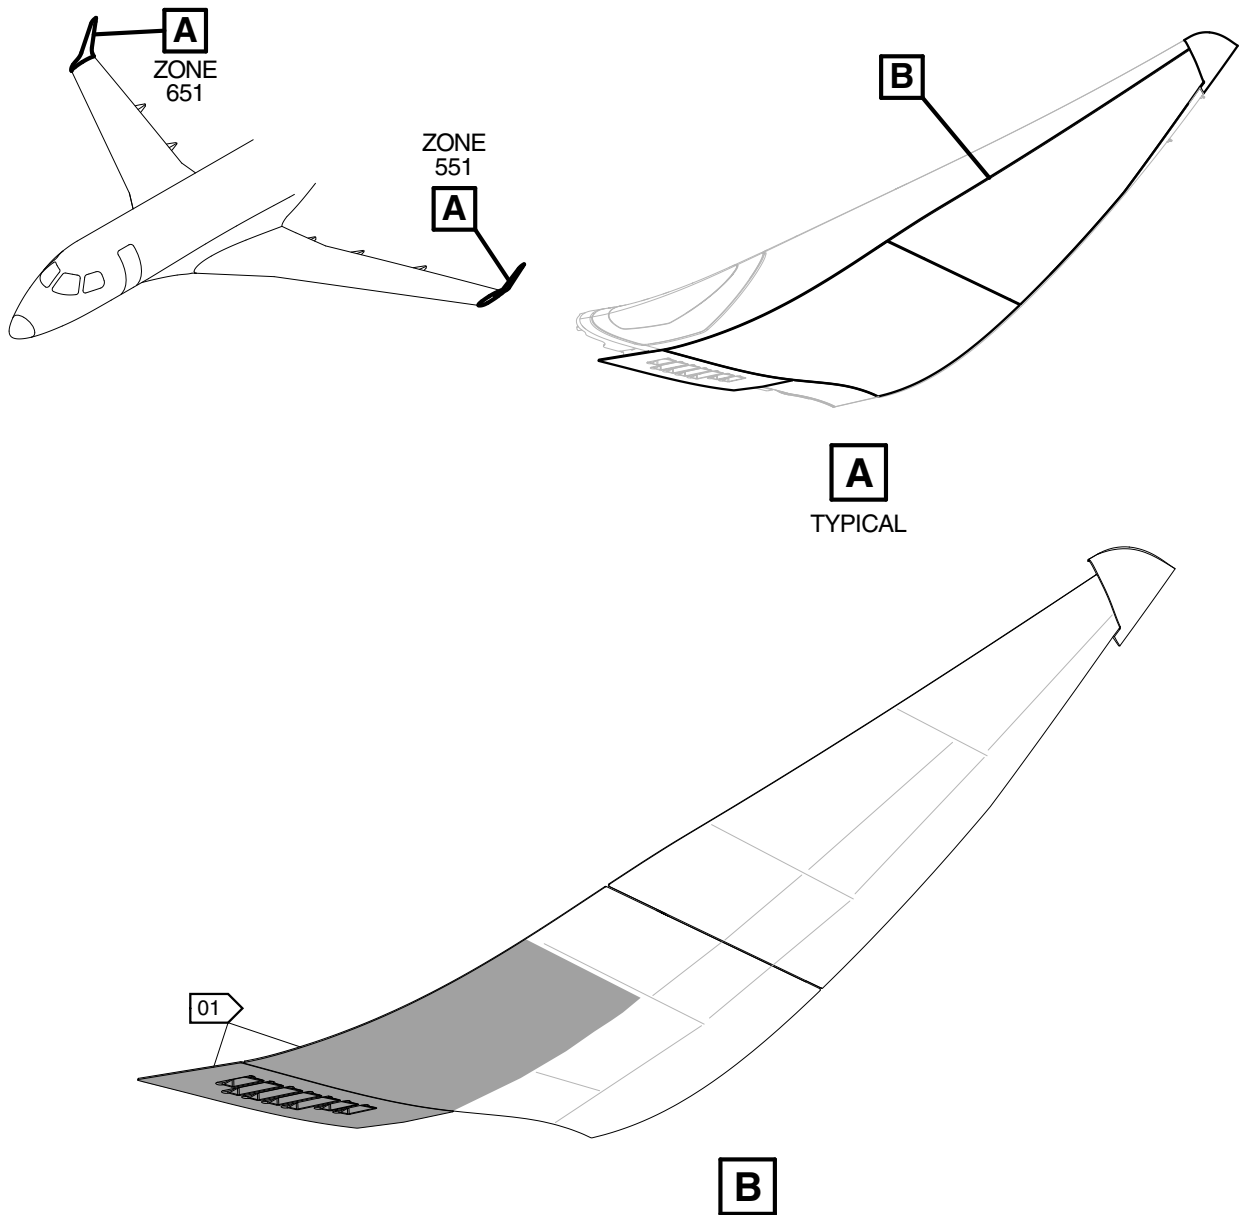
FIGURE 21 - WINGLET LEADING LOWER SKIN INSPECTION - GROUP 1, GROUP 2 AND  
POST MOD SB550-00-0011  
(Sheet 1 of 1)

**01** VERIFY IN THE AIRCRAFT LOG-BOOK WHETHER IT HAS USED ALLOWABLE DAMAGE INSTRUCTION **FOR THICKNESS REDUCTION** IN THE SHADED AREA.

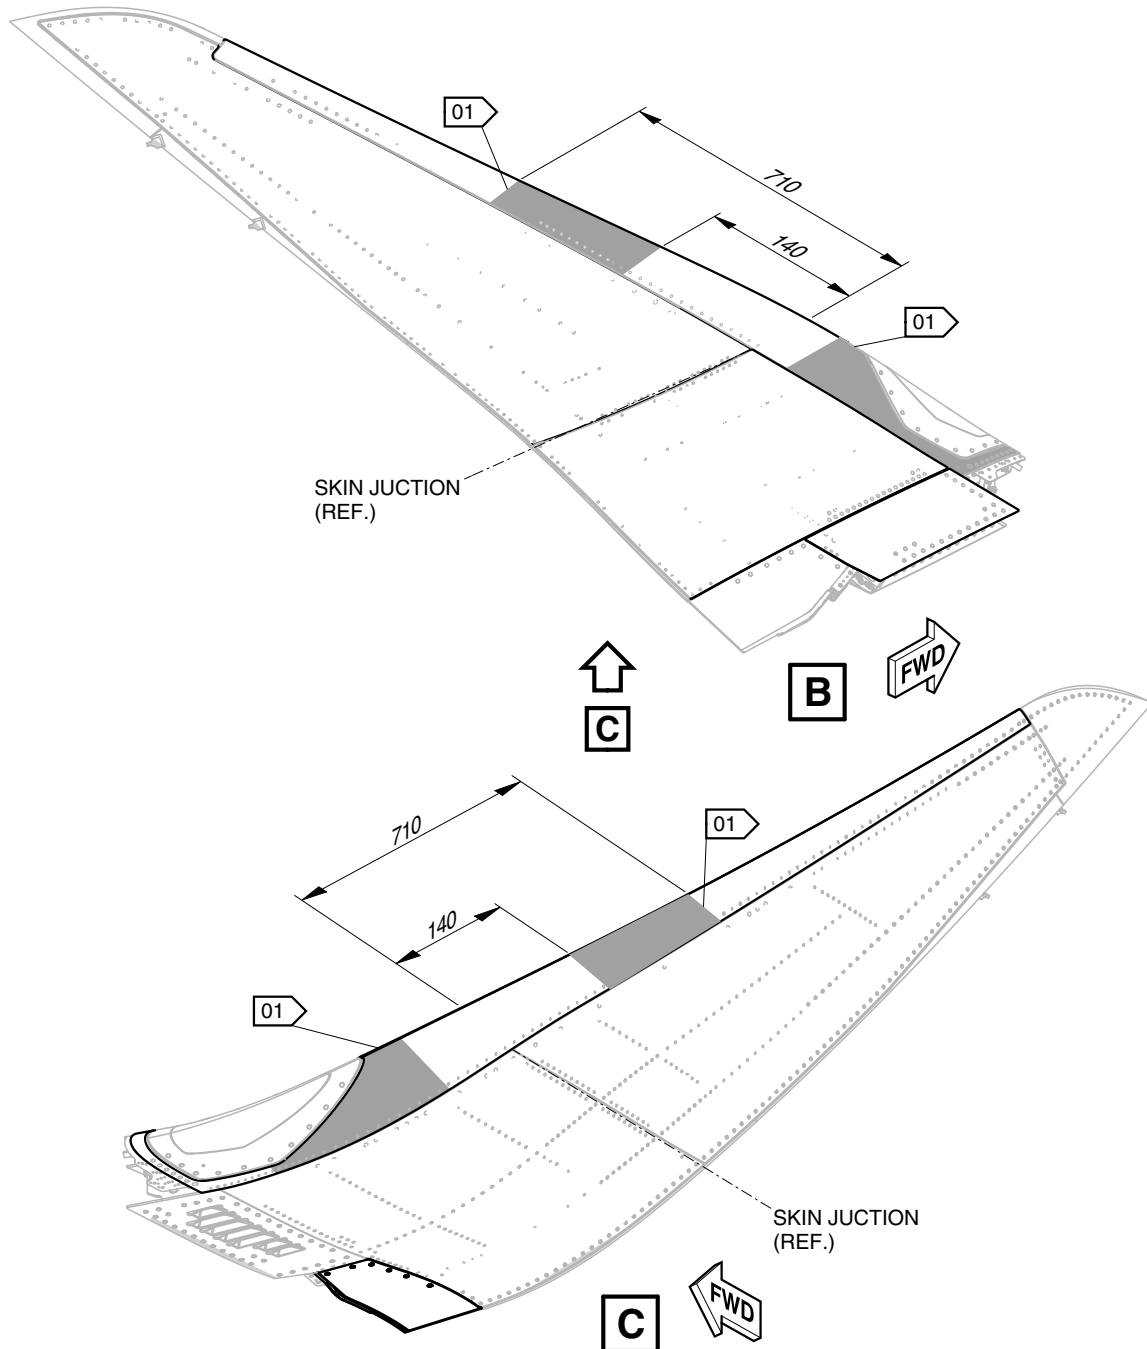
FIGURE 22 - WINGLET LEADING-EDGE COMPOSITE INSPECTION - GROUP 1, GROUP 2  
AND POST MOD SB550-00-0011  
(Sheet 2 of 2)

01 VERIFY IN THE AIRCRAFT LOG-BOOK WHETHER IT HAS USED ALLOWABLE DAMAGE INSTRUCTION **FOR THICKNESS REDUCTION** (DAMAGE AFFECTING UP TO 2 PLIES) IN THE SHADED AREA.

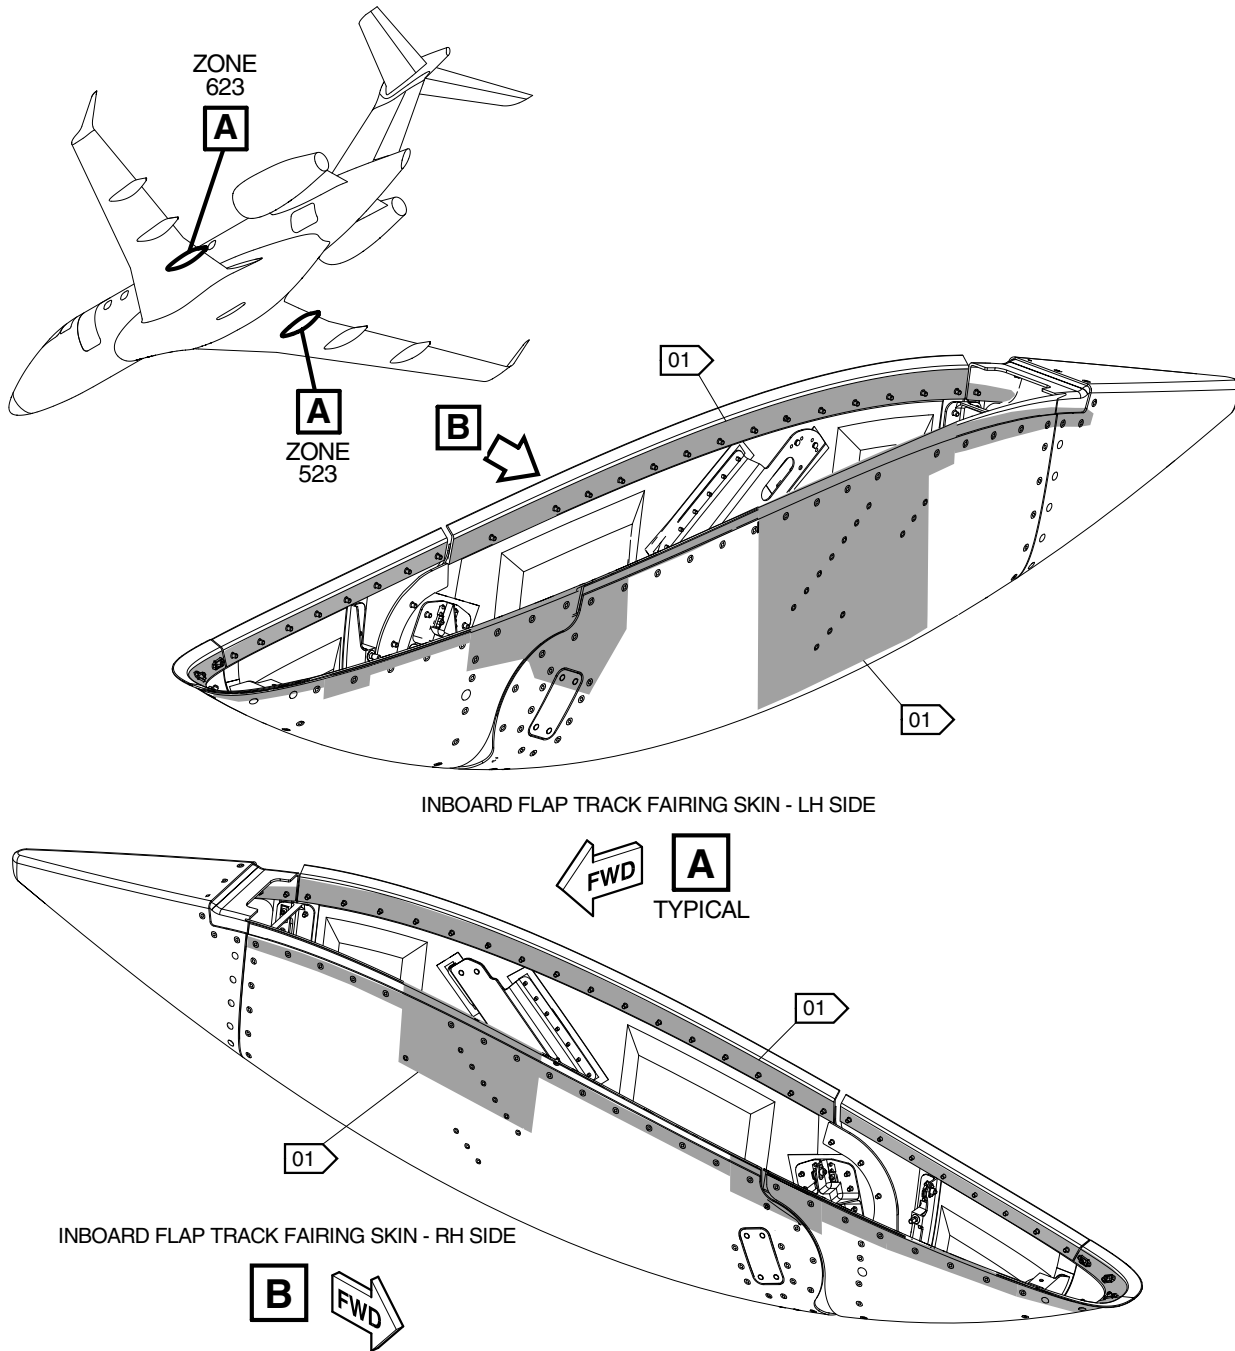
FIGURE 23 - INBOARD FLAP TRACK FAIRING SKIN INSPECTION - GROUP 1 THRU GROUP 4 AND POST MOD SB550-00-0011  
(Sheet 1 of 1)

01 VERIFY IN THE AIRCRAFT LOG-BOOK WHETHER IT HAS USED **ALLOWABLE DAMAGE** INSTRUCTION IN THE SHADED AREA.

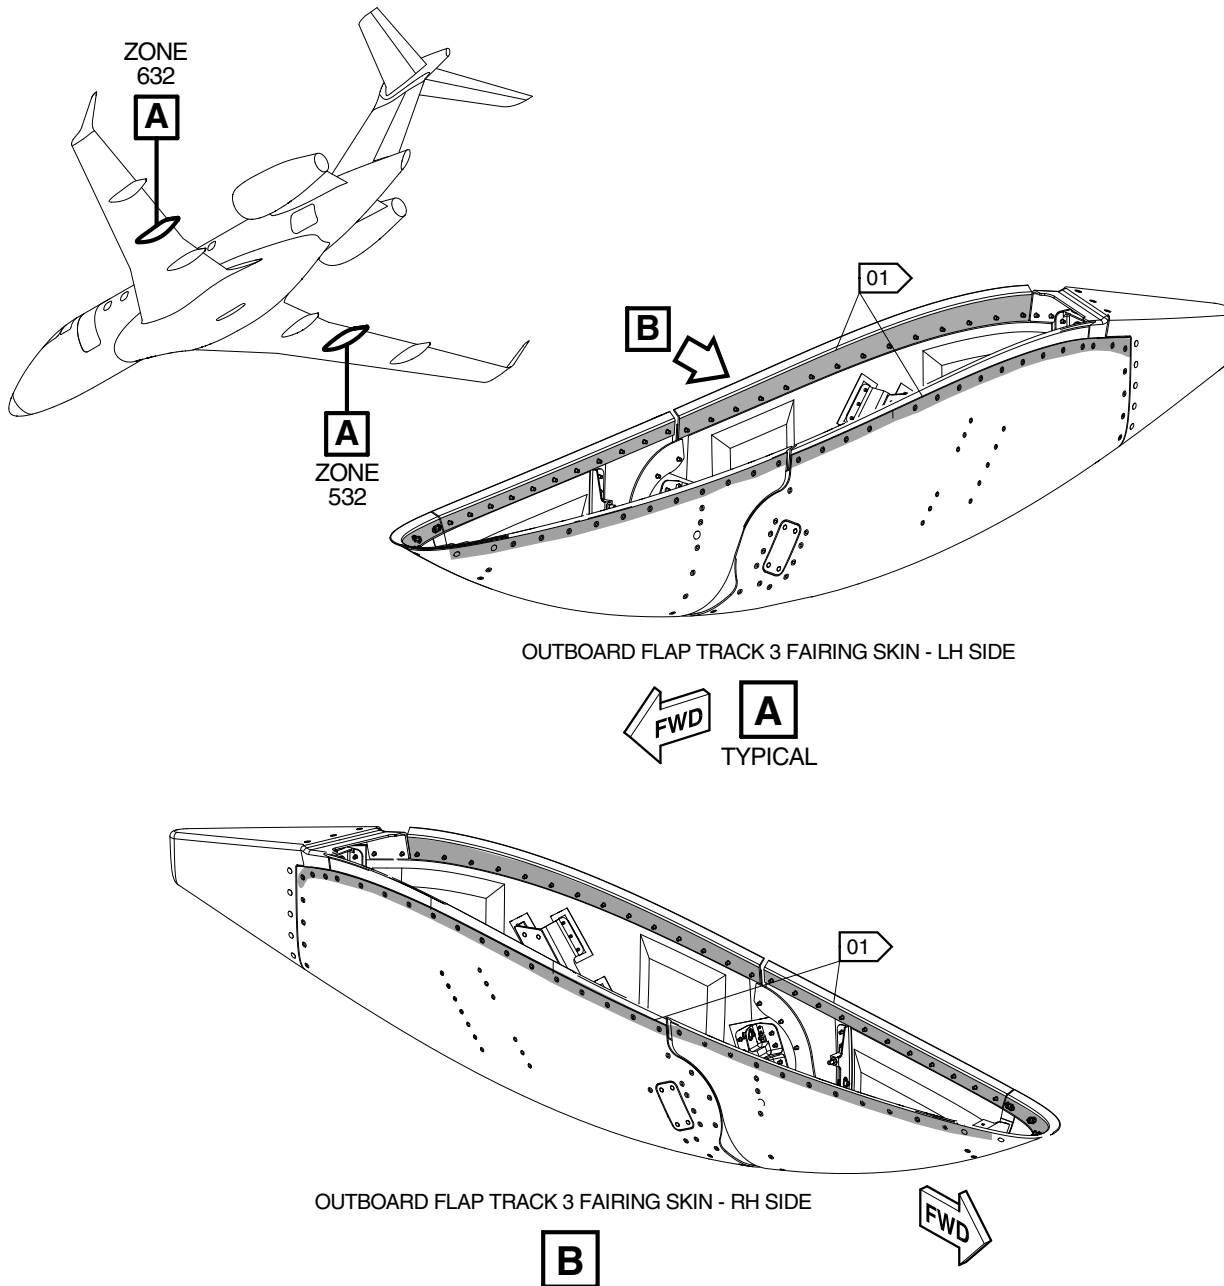
FIGURE 25 - OUTBOARD FLAP TRACK 3 FAIRING SKIN INSPECTION - GROUP 1 THRU GROUP 4 AND POST MOD SB550-00-0011  
(Sheet 1 of 1)

01 VERIFY IN THE AIRCRAFT LOG-BOOK WHETHER IT HAS USED **ALLOWABLE DAMAGE** INSTRUCTION IN THE SHADED AREA.

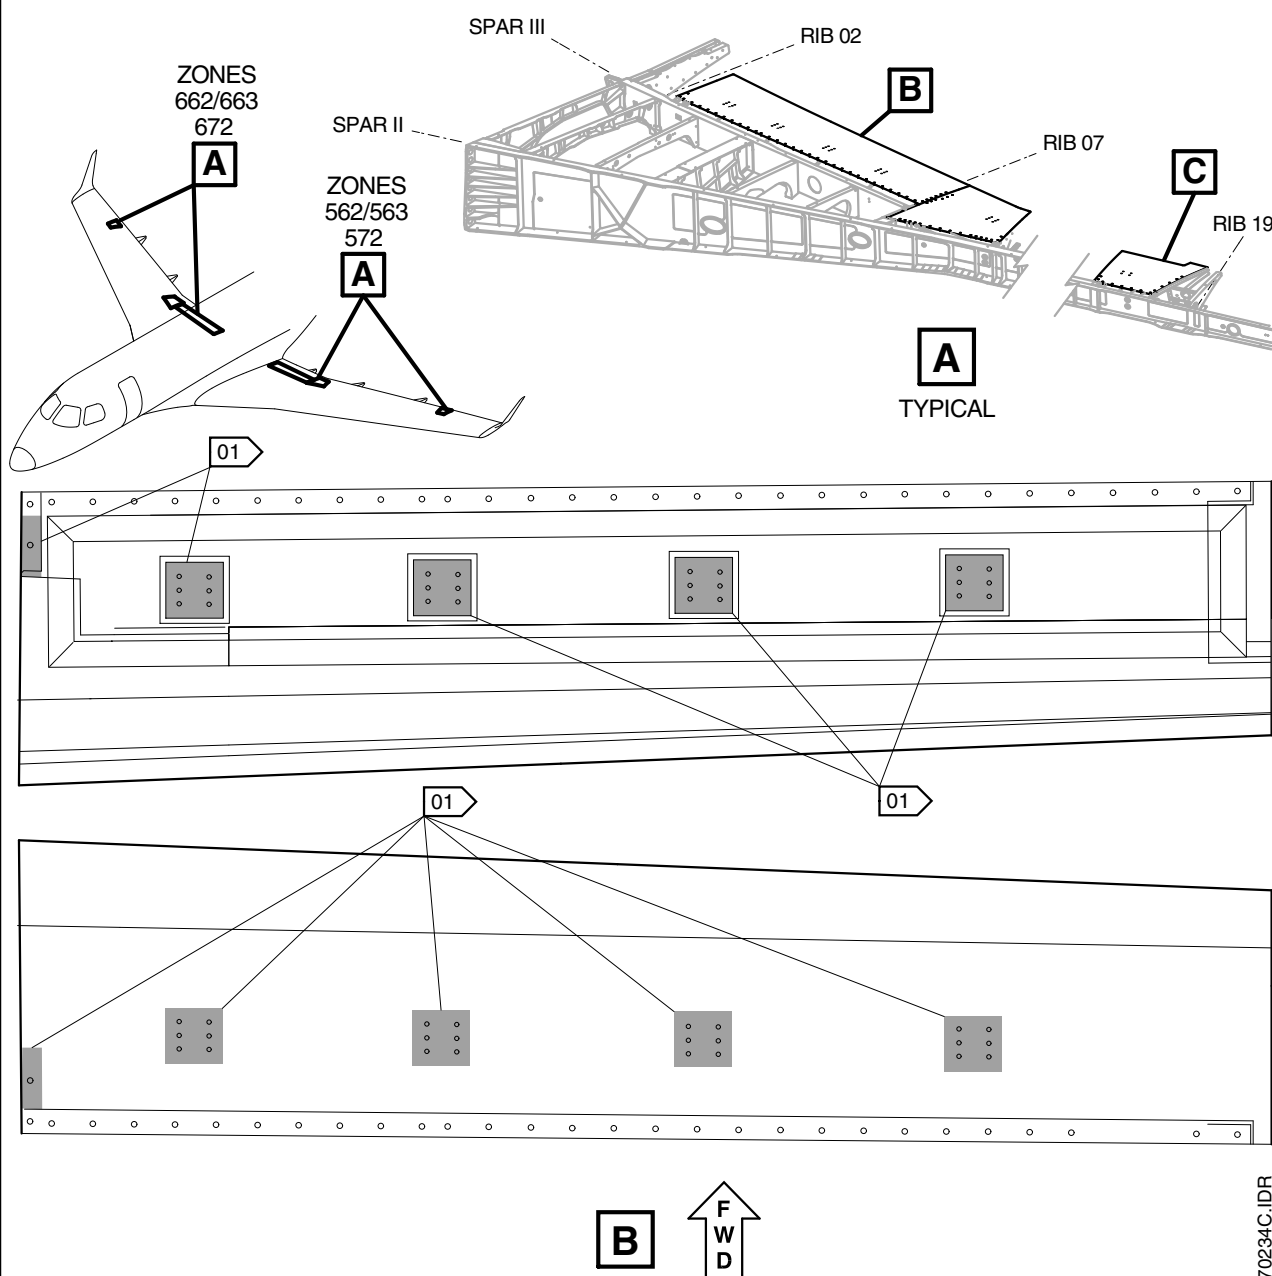
FIGURE 26 - UPPER SHROUD FIXED 1 SKIN - BOTTOM VIEW INSPECTION - GROUP 1  
THRU GROUP 4 AND POST MOD SB550-00-0011  
(Sheet 1 of 2)

**01** VERIFY IN THE AIRCRAFT LOG-BOOK WHETHER IT HAS USED ALLOWABLE DAMAGE INSTRUCTION **FOR HOLES AND PUNCTURES** IN THE SHADED AREA.

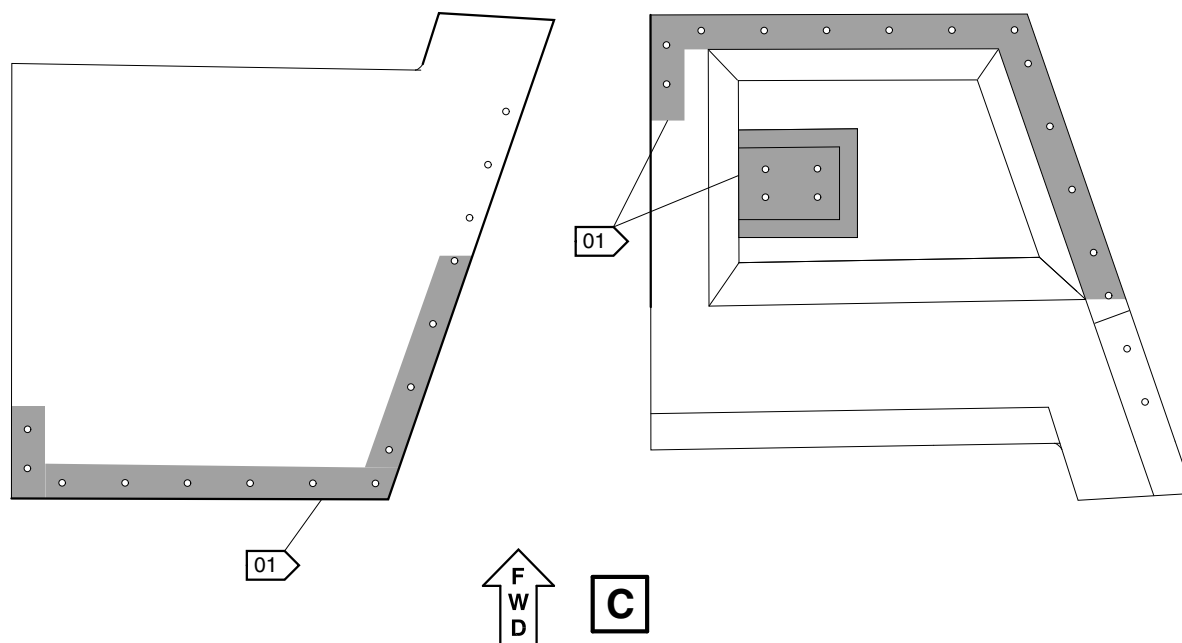
FIGURE 26 - UPPER SHROUD FIXED 1 SKIN - BOTTOM VIEW INSPECTION - GROUP 1  
THRU GROUP 4 AND POST MOD SB550-00-0011  
(Sheet 2 of 2)

**01** VERIFY IN THE AIRCRAFT LOG-BOOK WHETHER IT HAS USED ALLOWABLE DAMAGE INSTRUCTION **FOR HOLES AND PUNCTURES** IN THE SHADED AREA.

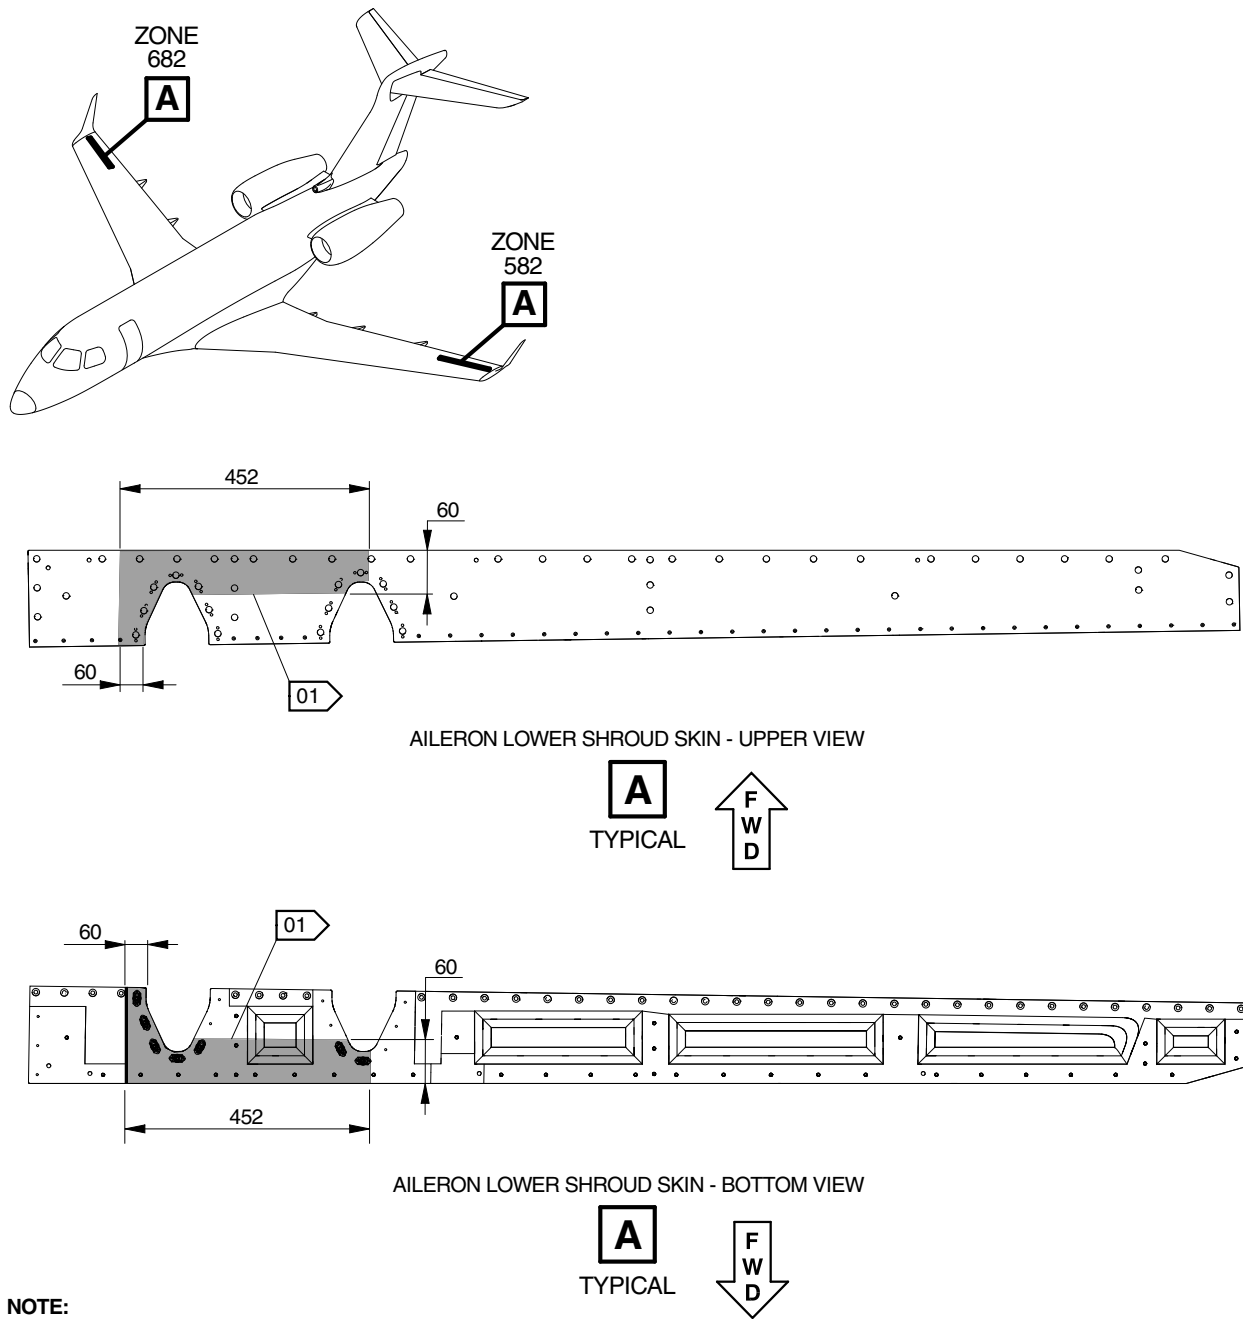
FIGURE 28 - AILERON LOWER SHROUD SKIN INSPECTION - GROUP 1 THRU GROUP 4  
AND POST MOD SB550-00-0011  
(Sheet 1 of 1)

01 VERIFY IN THE AIRCRAFT LOG-BOOK WHETHER IT HAS USED ALLOWABLE DAMAGE INSTRUCTION **FOR THICKNESS REDUCTION** IN THE SHADED AREA.

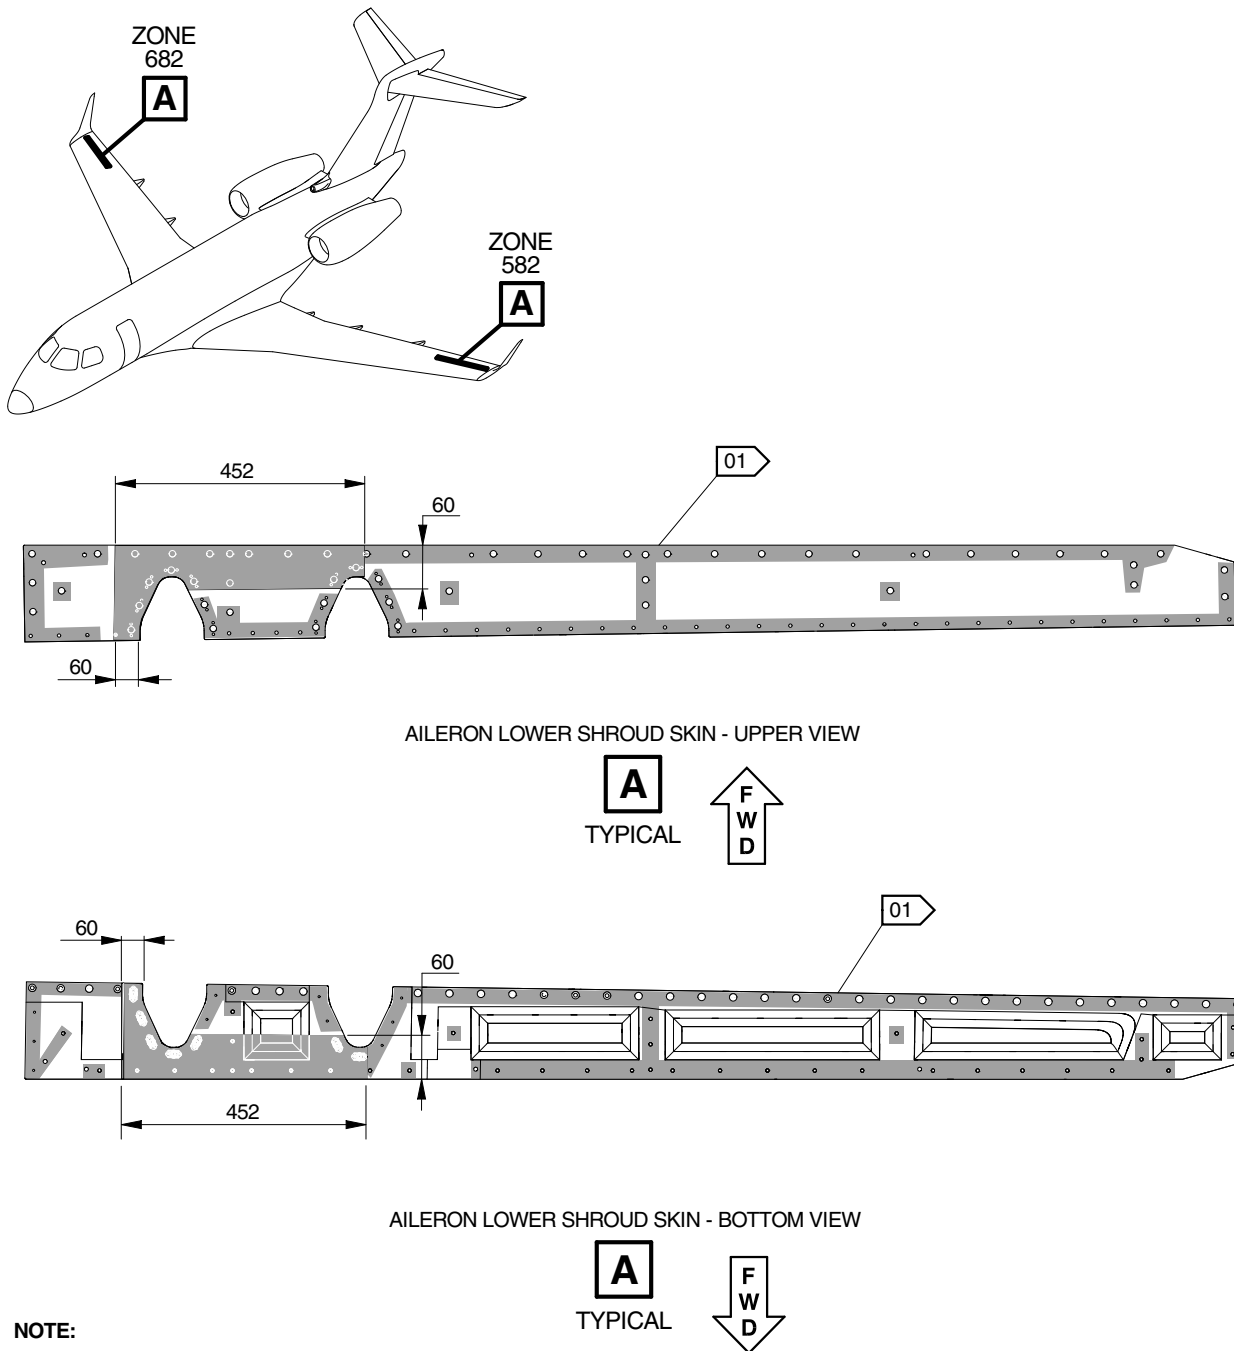
FIGURE 30 - AILERON LOWER SHROUD SKIN INSPECTION - GROUP 1 THRU GROUP 4  
AND POST MOD SB550-00-0011  
(Sheet 1 of 1)

01 VERIFY IN THE AIRCRAFT LOG-BOOK WHETHER IT HAS USED ALLOWABLE DAMAGE INSTRUCTION **FOR HOLES AND PUNCTURES** IN THE SHADED AREA.

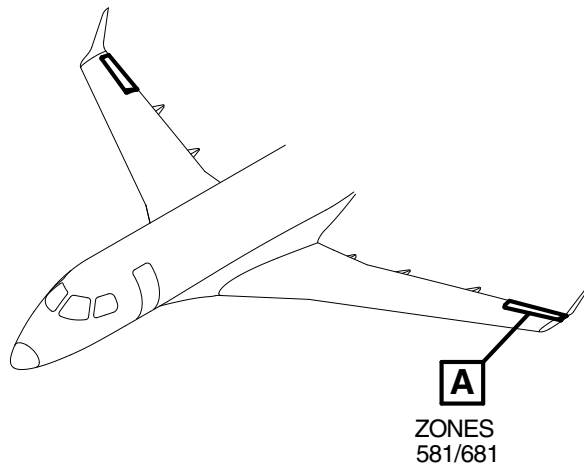
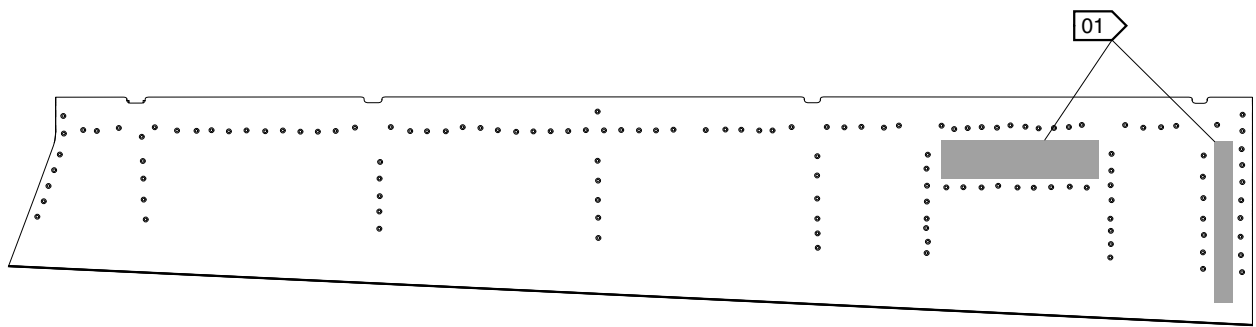
FIGURE 31 - AILERON COMPOSITE SKIN UPPER VIEW INSPECTION - GROUP 1 THRU GROUP 4 AND POST MOD SB550-00-0011  
(Sheet 1 of 1)

**01** VERIFY IN THE AIRCRAFT LOG-BOOK WHETHER IT HAS USED ALLOWABLE DAMAGE INSTRUCTION **FOR HOLES AND PUNCTURES** IN THE SHADED AREA.

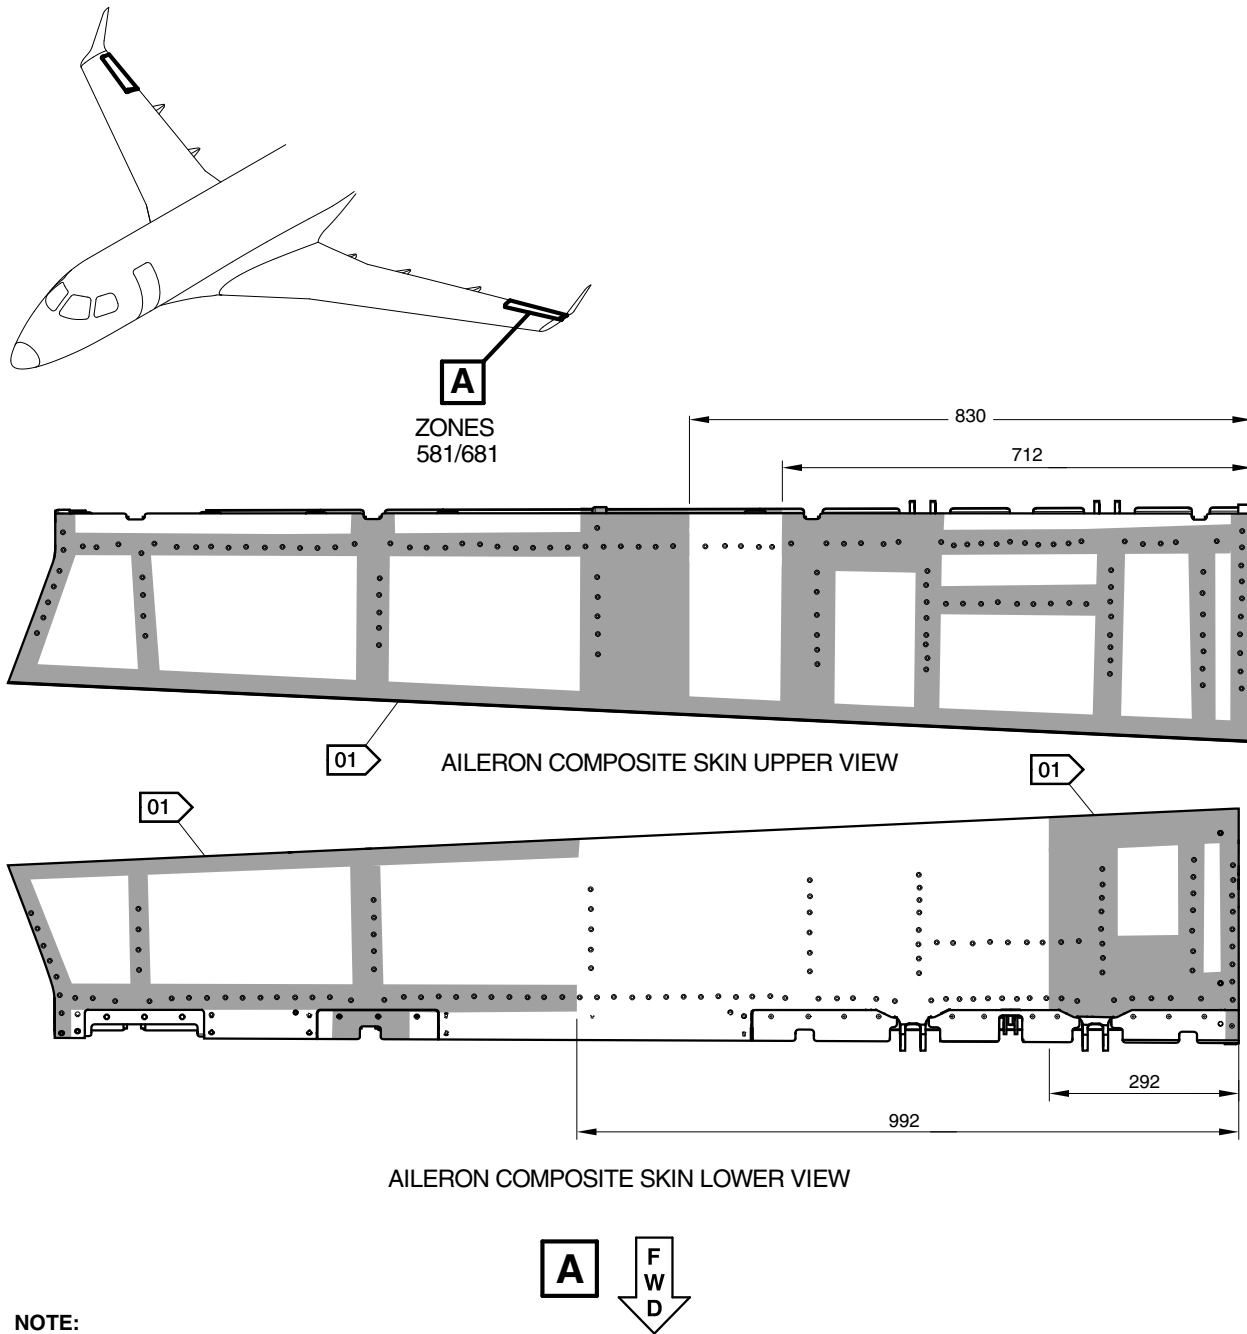
FIGURE 32 - AILERON SKIN UPPER AND LOWER VIEW INSPECTION - GROUP 1,  
GROUP 2 AND POST MOD SB550-00-0011  
(Sheet 1 of 1)

**01** VERIFY IN THE AIRCRAFT LOG-BOOK WHETHER IT HAS USED ALLOWABLE DAMAGE INSTRUCTION FOR DELAMINATION IN THE SHADED AREA.

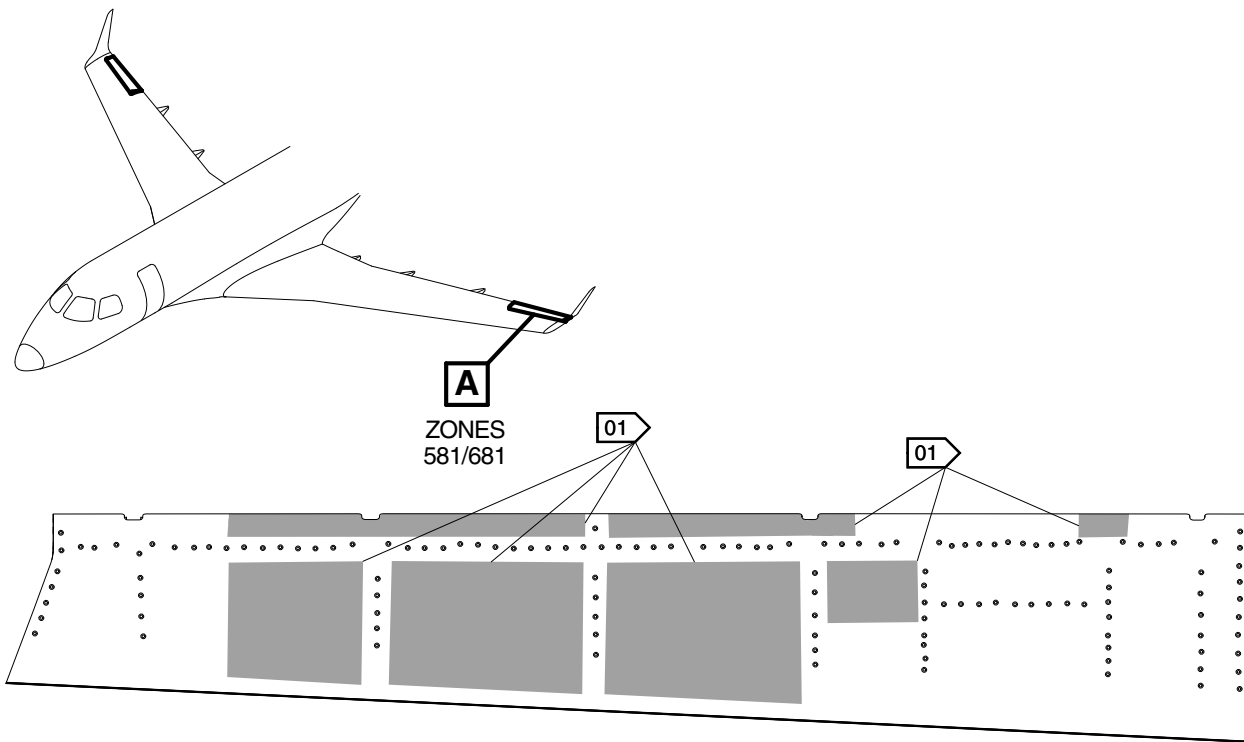
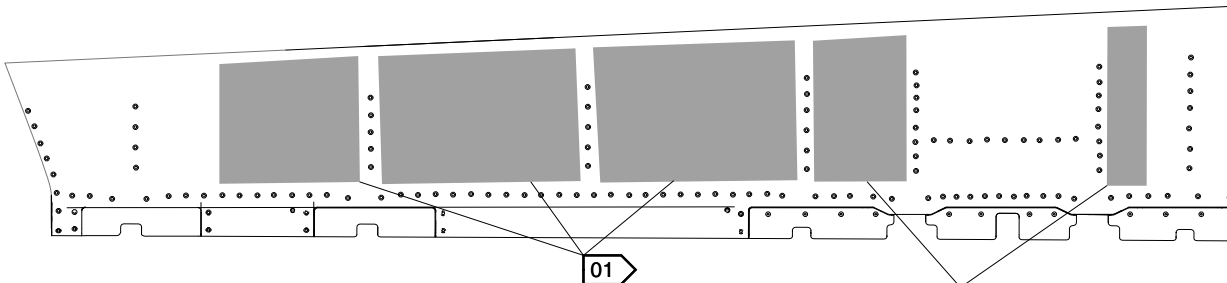
FIGURE 34 - AILERON COMPOSITE SKIN UPPER AND LOWER VIEW INSPECTION -  
GROUP 1, GROUP 2 AND POST MOD SB550-00-0011  
(Sheet 1 of 1)

**01** VERIFY IN THE AIRCRAFT LOG-BOOK WHETHER IT HAS USED ALLOWABLE DAMAGE INSTRUCTION **FOR THICKNESS REDUCTION** (DAMAGE AFFECTING UP TO 1 PLY) IN THE SHADED AREA.

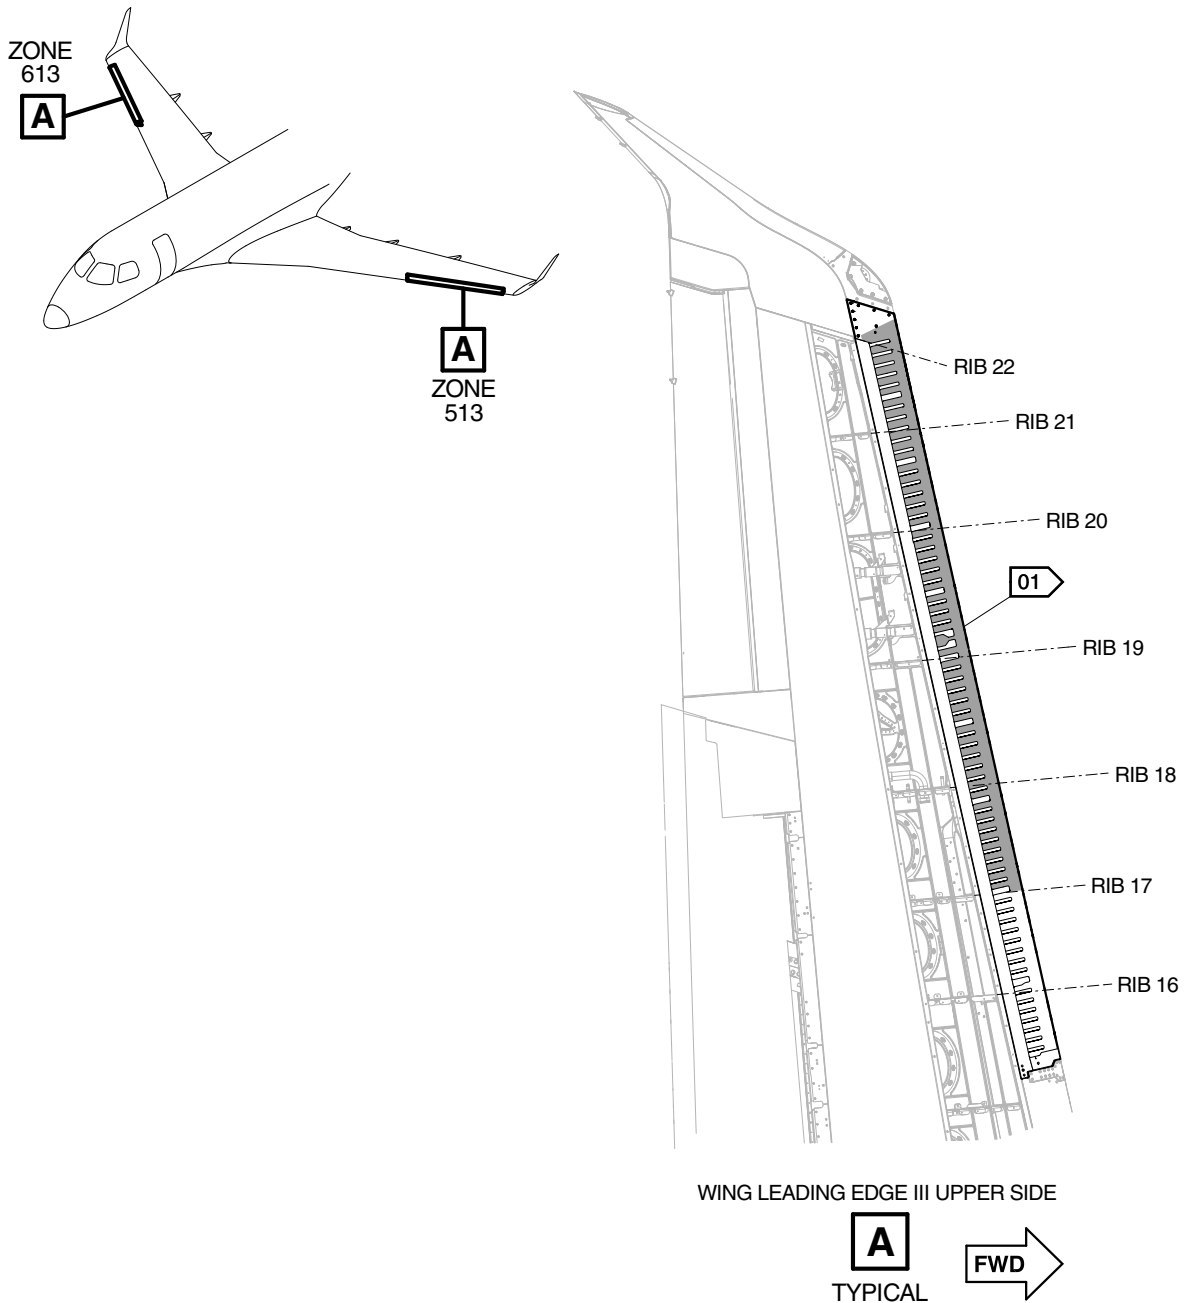
FIGURE 35 - WING LEADING EDGE III UPPER SIDE INSPECTION - GROUP 1 THRU GROUP 4 AND POST MOD SB550-00-0011  
(Sheet 1 of 1)

**01** VERIFY IN THE AIRCRAFT LOG-BOOK WHETHER IT HAS USED ALLOWABLE DAMAGE INSTRUCTION **FOR THICKNESS REDUCTION** IN THE SHADED AREA.

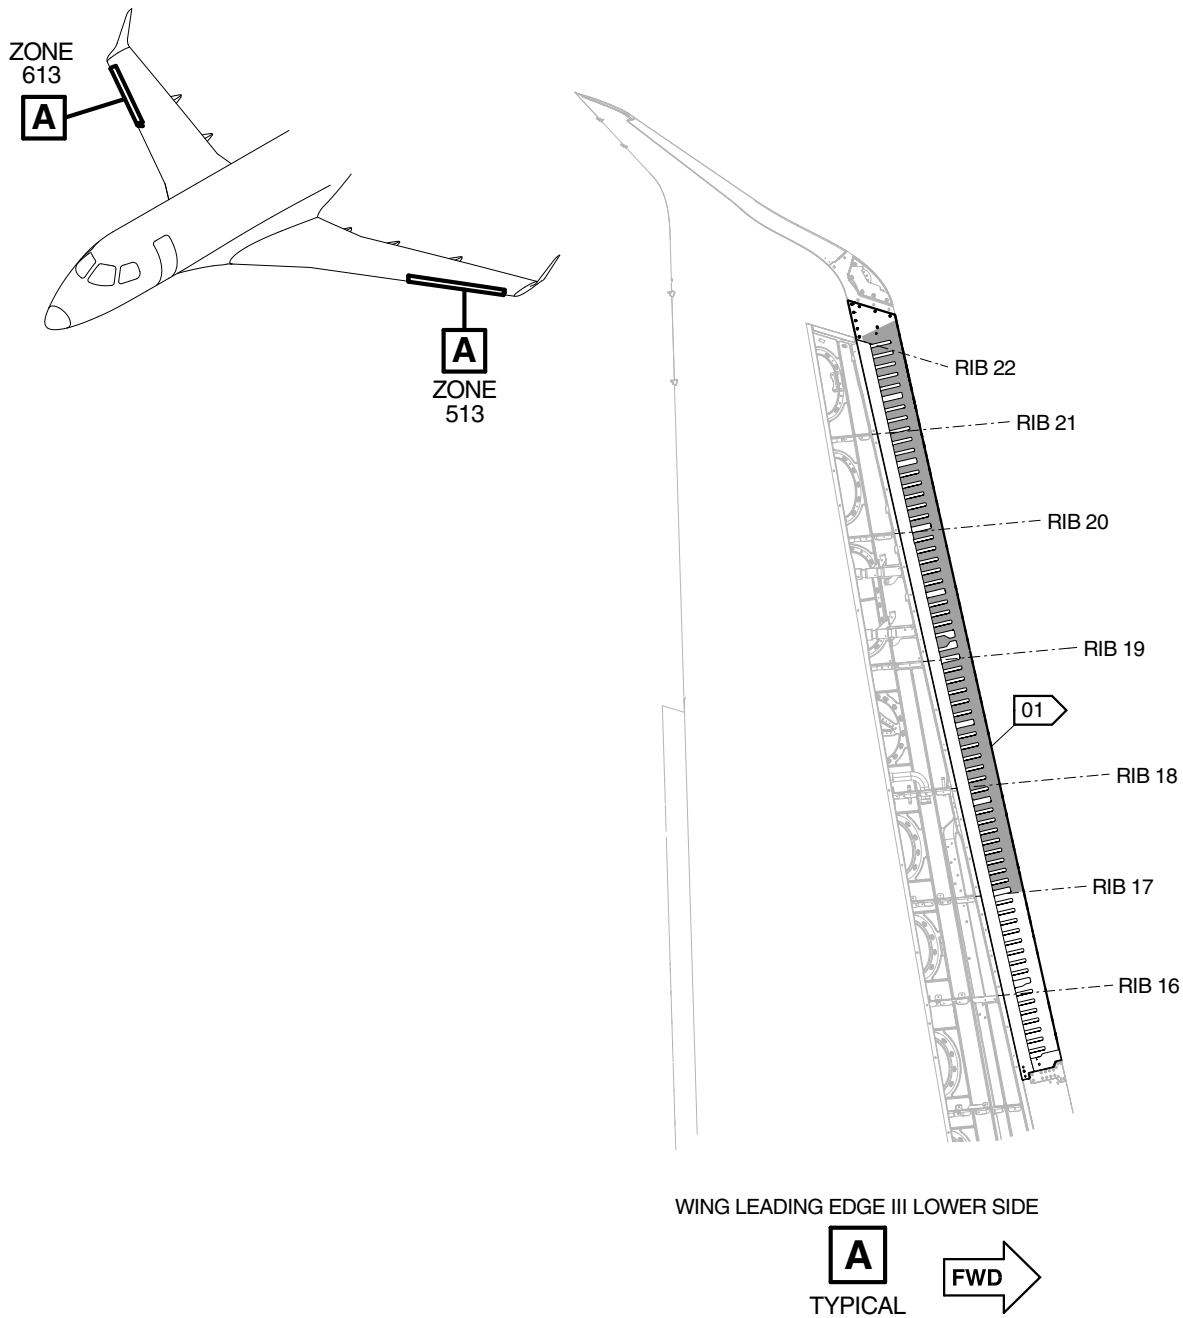
FIGURE 36 - WING LEADING EDGE III LOWER SIDE INSPECTION - GROUP 1 THRU GROUP 4 AND POST MOD SB550-00-0011  
(Sheet 1 of 1)

**01** VERIFY IN THE AIRCRAFT LOG-BOOK WHETHER IT HAS USED ALLOWABLE DAMAGE INSTRUCTION **FOR THICKNESS REDUCTION** IN THE SHADED AREA.
