## SERVICE BULLETIN TRANSMITTAL SHEET

| Service Bulletin No.: V2/0005 | Date of Original Issue: 26-March-2012 |

### CORROSION INSPECTION – ELEVATOR CONTROL ROD AND ELEVATOR ACTUATING LEVER ON THE CONTROL COLUMN

# ***DHC-2 Beaver***

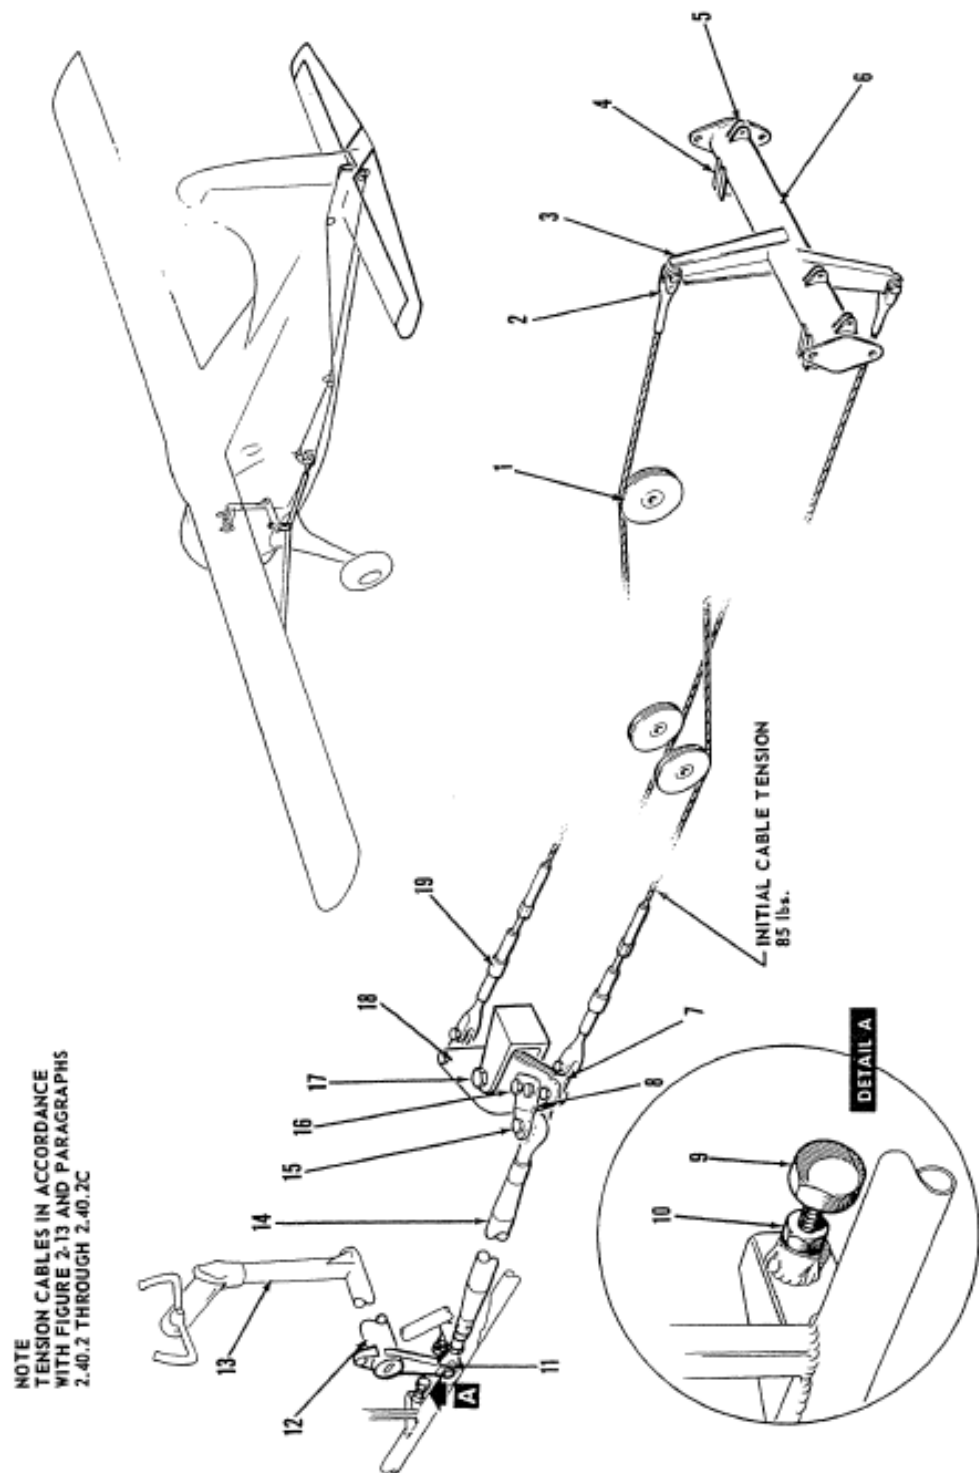
FIGURE 1

- (a) Gain access to the elevator actuating lever (11, Figure 1) on the control column, the elevator control rod assembly (14, Figure 1) and bell crank (18, Figure 1) as follows:

1. With a strong light and a 10x magnifying glass, inspect the exterior of the elevator control rod C2CF619A (14, Figure 1) for MK I and MK II and the elevator control rods C2CF619A and CT2CF1021-1 (14 & 15, Figure 3) for MK III as follows:

2. Visually inspect the elevator actuating lever and the control column torque tube (Item 11 & 12 in Figure 1 or Item 16 & 17 in Figure 3) in situ as follows:
  - (a) Thoroughly clean the inside and outside of the fork area on the elevator actuating lever in situ.
  - (b) With a strong light and a 10x magnifying glass (and/or a mirror as required), inspect the elevator actuating lever and the control column torque tube for cracking, distortion, corrosion and/or other damage.

- (b) Touchup surface finish as required (on bare metal surface, if any). Apply corrosion preventive compound LPS3 (or equivalent) to the inside and outside of the fork area on the elevator actuating lever (11, Figure 1), and to the control rod (14, Figure 1) exterior surface to cover approximately 12" from the rod forward end.

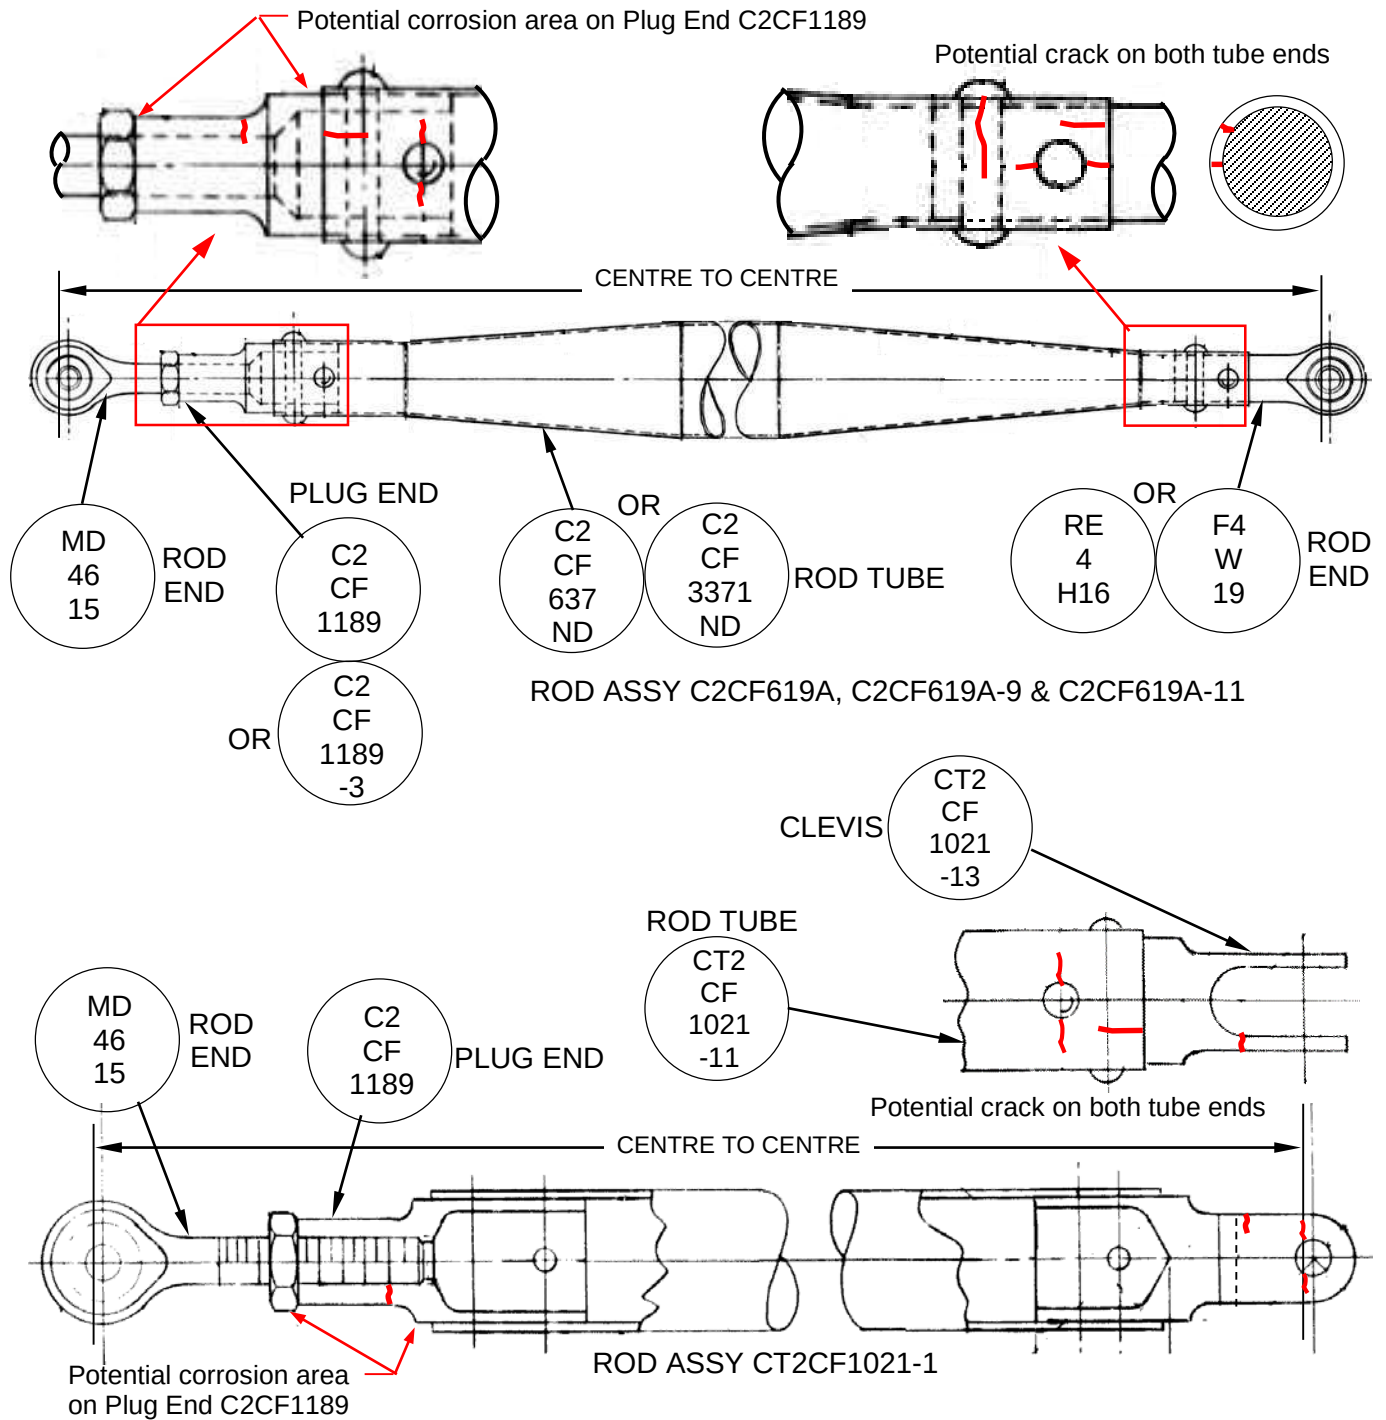
FIGURE 2

- (a) Thoroughly clean the entire control rod (including the Plug End (C2CF1189, Figure 2).
  - (b) Inspect the C2CF1189 Plug End closely for signs of corrosion, cracking and/or other damage, particularly in the area where the diameter changes, at the mating surface with the steel nut and at the edge of the rod tube (see Figure 2).

- (c) Inspect the rod tube closely for signs of corrosion, cracking and/or other damage, particularly at the rivet attach points and in the area where the tube diameter changes at both tube ends (see Figure 2).

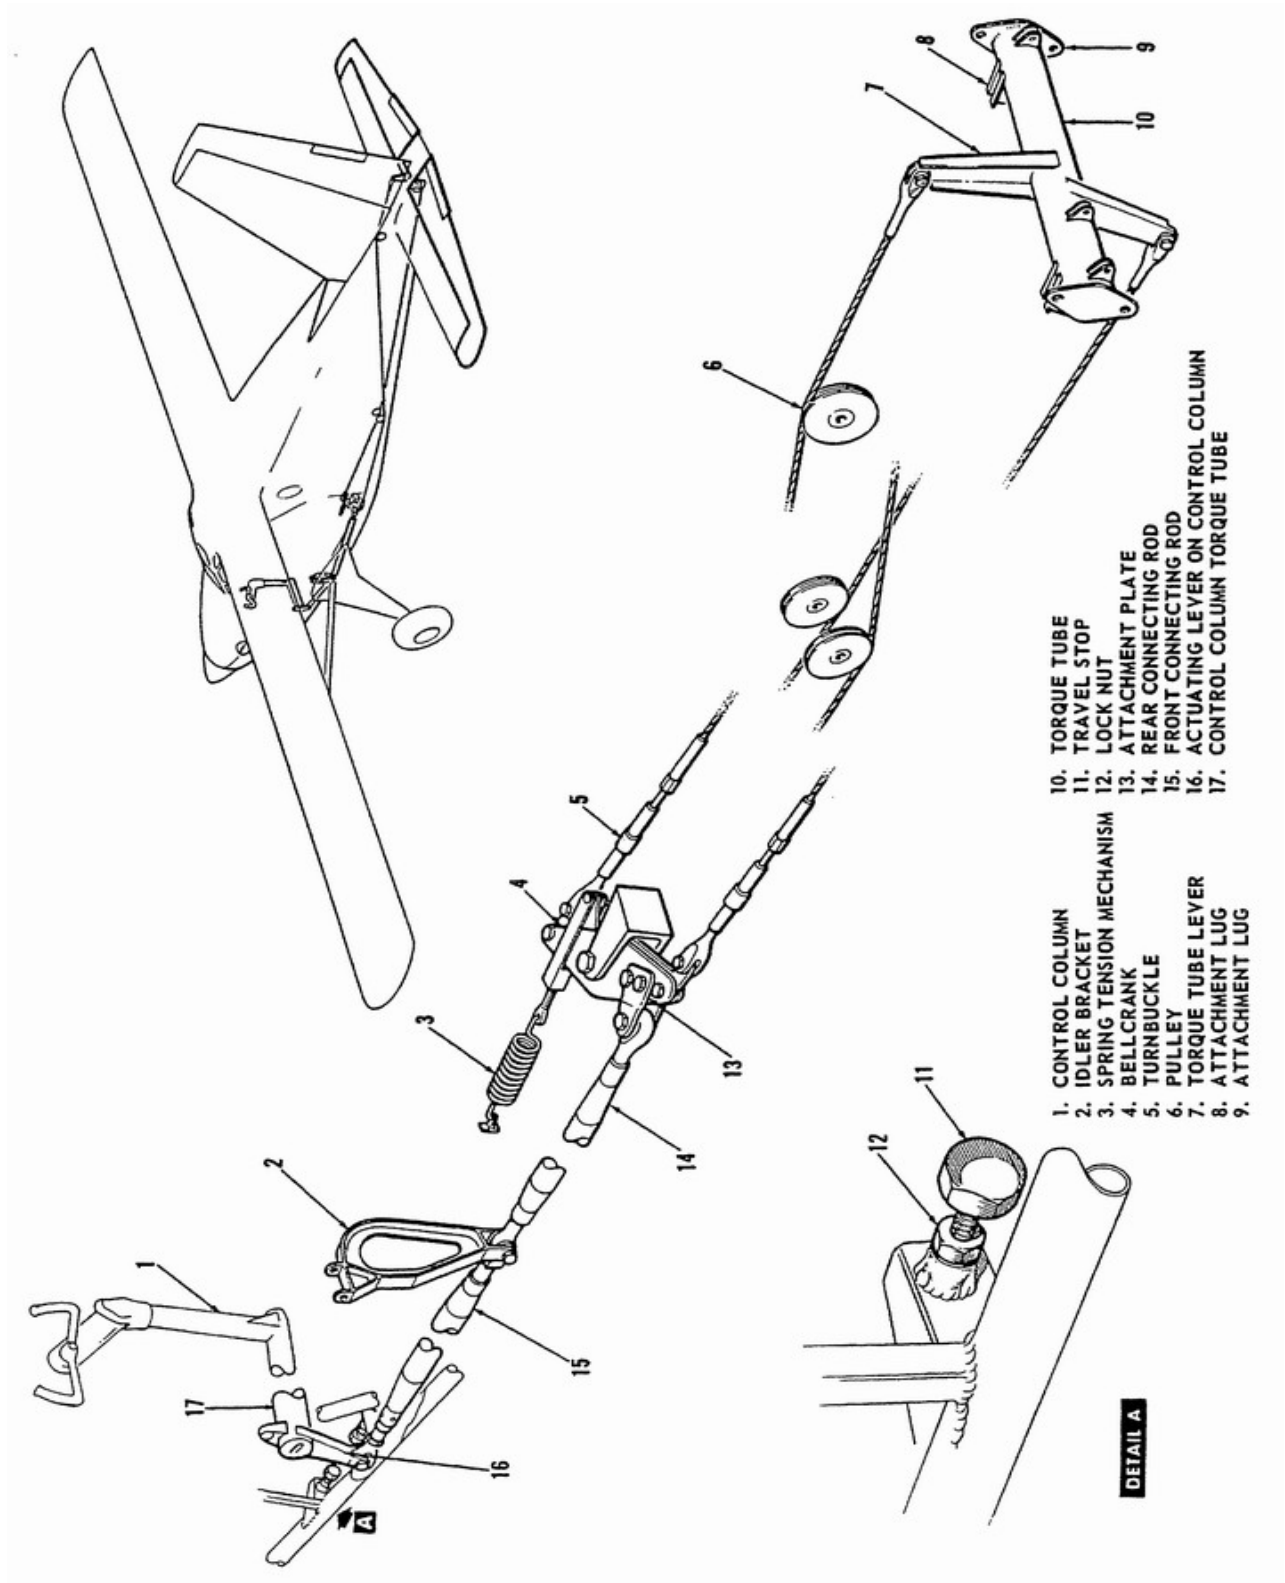
FIGURE 3

3. Visually inspect the idle bracket and spring (2 & 3, Figure 3), bellcrank, cable turnbuckle and attachment plate (8, 18 & 19 in Figure 1,; 4, 5 & 13 in Figure 3) as follows:
  - (a) Thoroughly clean the parts listed in Paragraph 3 above in situ.
  - (b) With a light and a 10x magnifying glass (and/or a mirror as required), inspect the parts listed in Paragraph 3 above and associated attachment hardware for cracking, distortion, corrosion and/or other damage.

- (b) Touchup surface finish as required (on bare metal surface, if any). Apply corrosion preventive compound LPS3 (or equivalent) to the inside and outside of the fork area on the elevator actuating lever (16, Figure 3), and to the entire exterior surface of the control rod (15, Figure 3), as well as 12" (from the rod forward end) of the exterior surface of the control rod (14, Figure 3).
