767

**Number:** 767-27-0201  
**Date:** June 27, 2007  
**ATA System:** 2731

**SUBJECT:** FLIGHT CONTROLS - Elevator - Repetitive Pogo Check

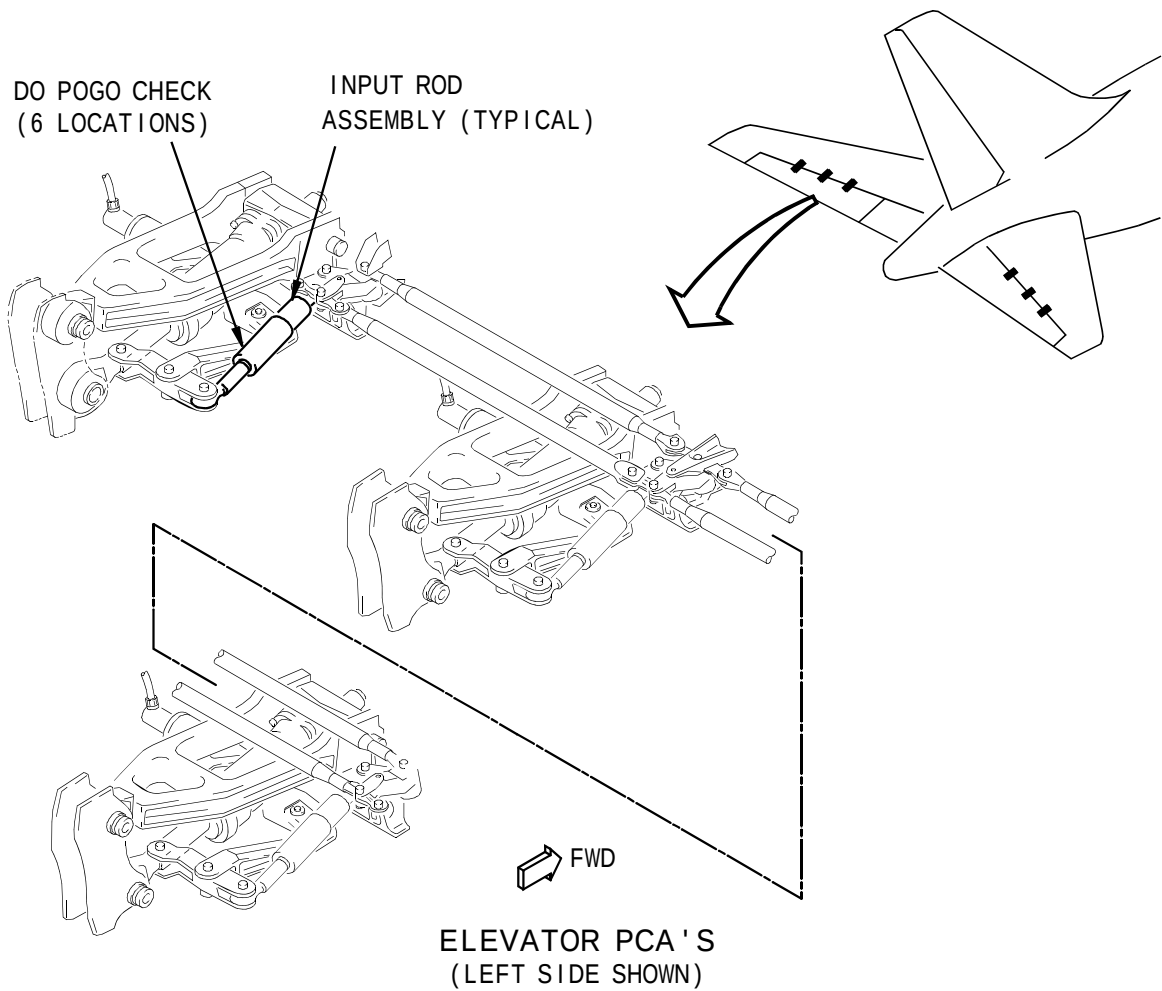
479835

Do a pogo check of the input rod assembly on each of the six elevator PCAs.
