757

**Number:** 757-57A0075 RB

**SUBJECT:** WINGS - Center Wing - Rear Spar on Lower Wing Skin - Inspection

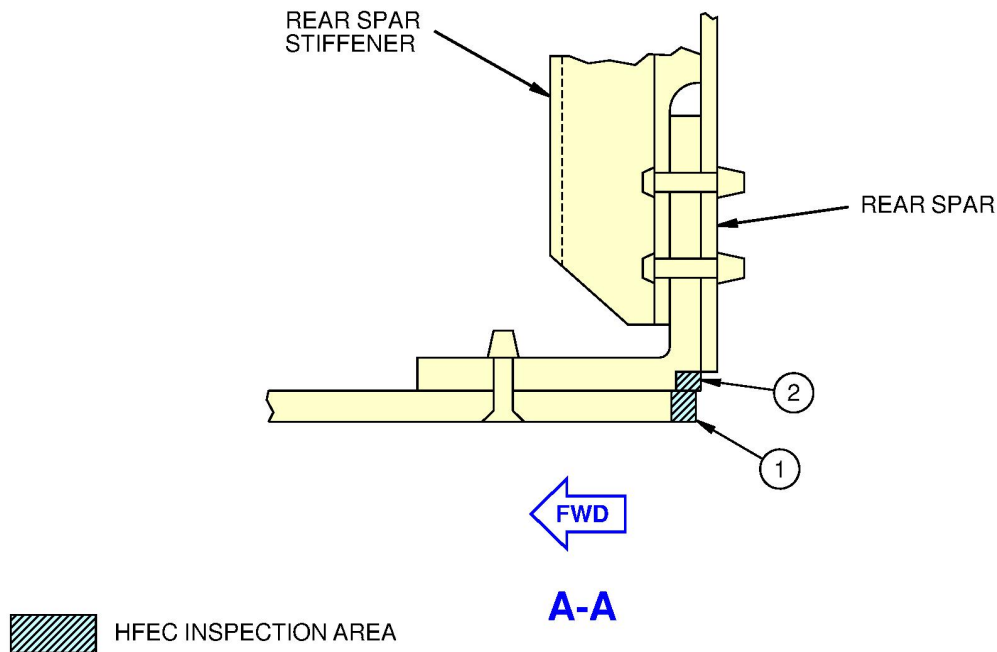
**FIGURE 1: CENTER WING BOX - REAR SPAR, LOWER SKIN AND LOWER CHORD - OPTION 1 SURFACE HFEC INSPECTION (SHEET 3 OF 3)**

| Step | Task | Name | Identification | Qty | More Data |
|---|---|---|---|---|---|
| (a) Do an external surface HFEC inspection on the edge of lower skin at the rear spar for any crack in accordance with 757 NDT Manual Part 6, 51-00-01 or 757 NDT Manual Part 6, 51-00-19. | | | | | |
| (b) Do an external surface HFEC inspection on the edge of the rear spar lower chord for any crack in accordance with 757 NDT Manual Part 6, 51-00-01 or 757 NDT Manual Part 6, 51-00-19 as an accepted procedure. | | | | | |

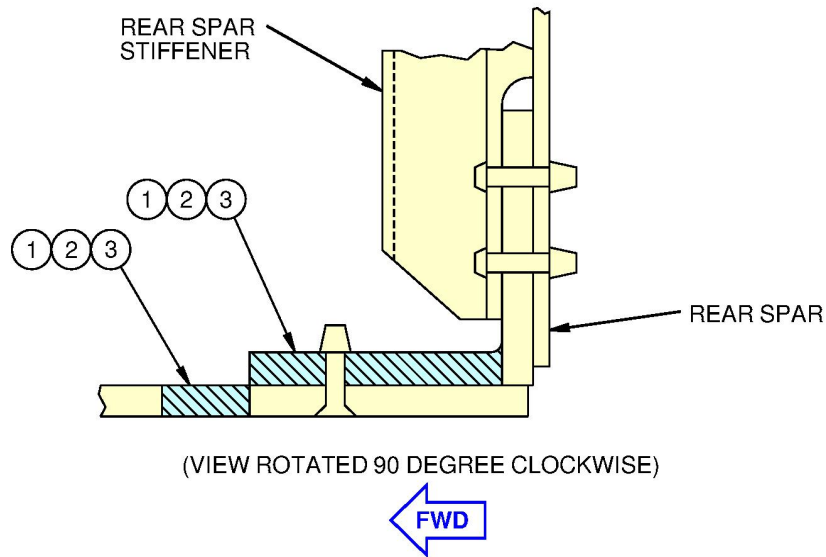
**FIGURE 2: CENTER WING BOX - REAR SPAR, LOWER SKIN AND LOWER CHORD - OPTION 2 DETAILED INSPECTION  
(SHEET 3 OF 3)**

(b) Do an internal detailed inspection of lower skin at the rear spar for any crack.

(c) Do an internal detailed inspection of the rear spar lower chord for any crack.

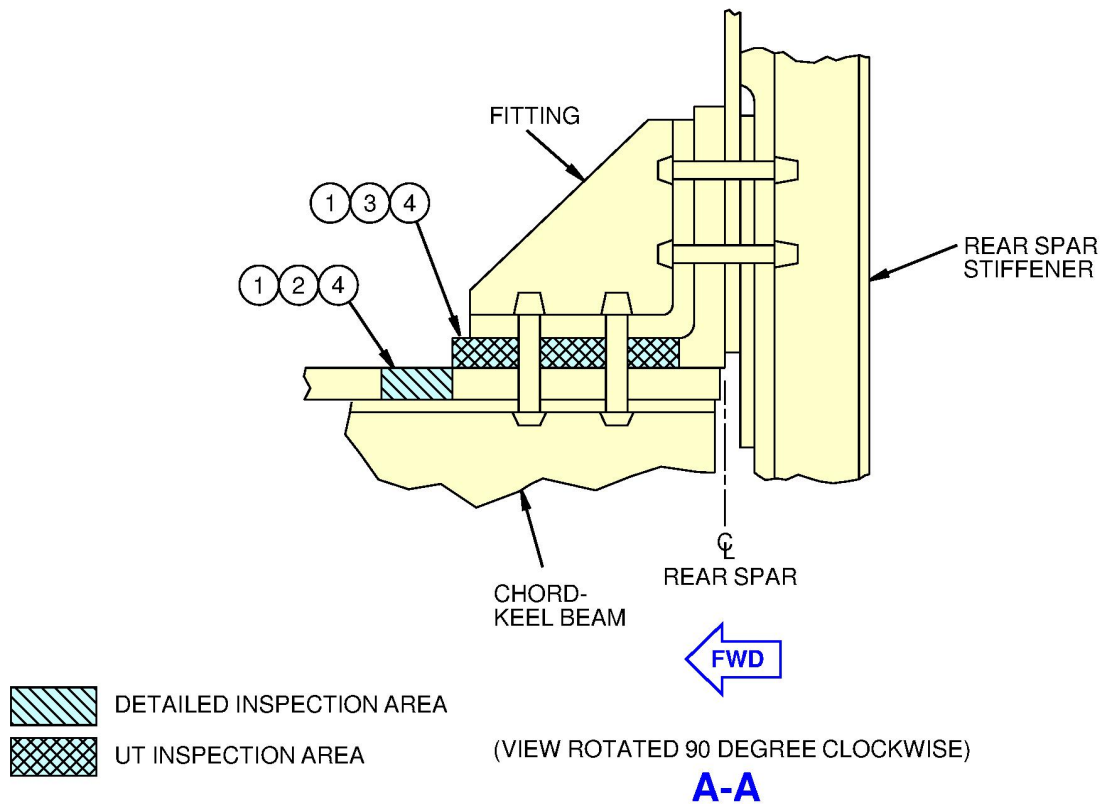
| Step | Task | Name | Identification | Qty | More Data |
|---|---|---|---|---|---|
| (b) Do an internal detailed inspection of the lower skin at the rear spar for any crack. | | | | | |

| Step | Task | Name | Identification | Qty | More Data |
|---|---|---|---|---|---|
| (c) | Do an internal ultrasonic inspection of the center wing box rear spar lower chord for any crack in accordance with 757 NDT Manual Part 4 57-10-01. | | | | |

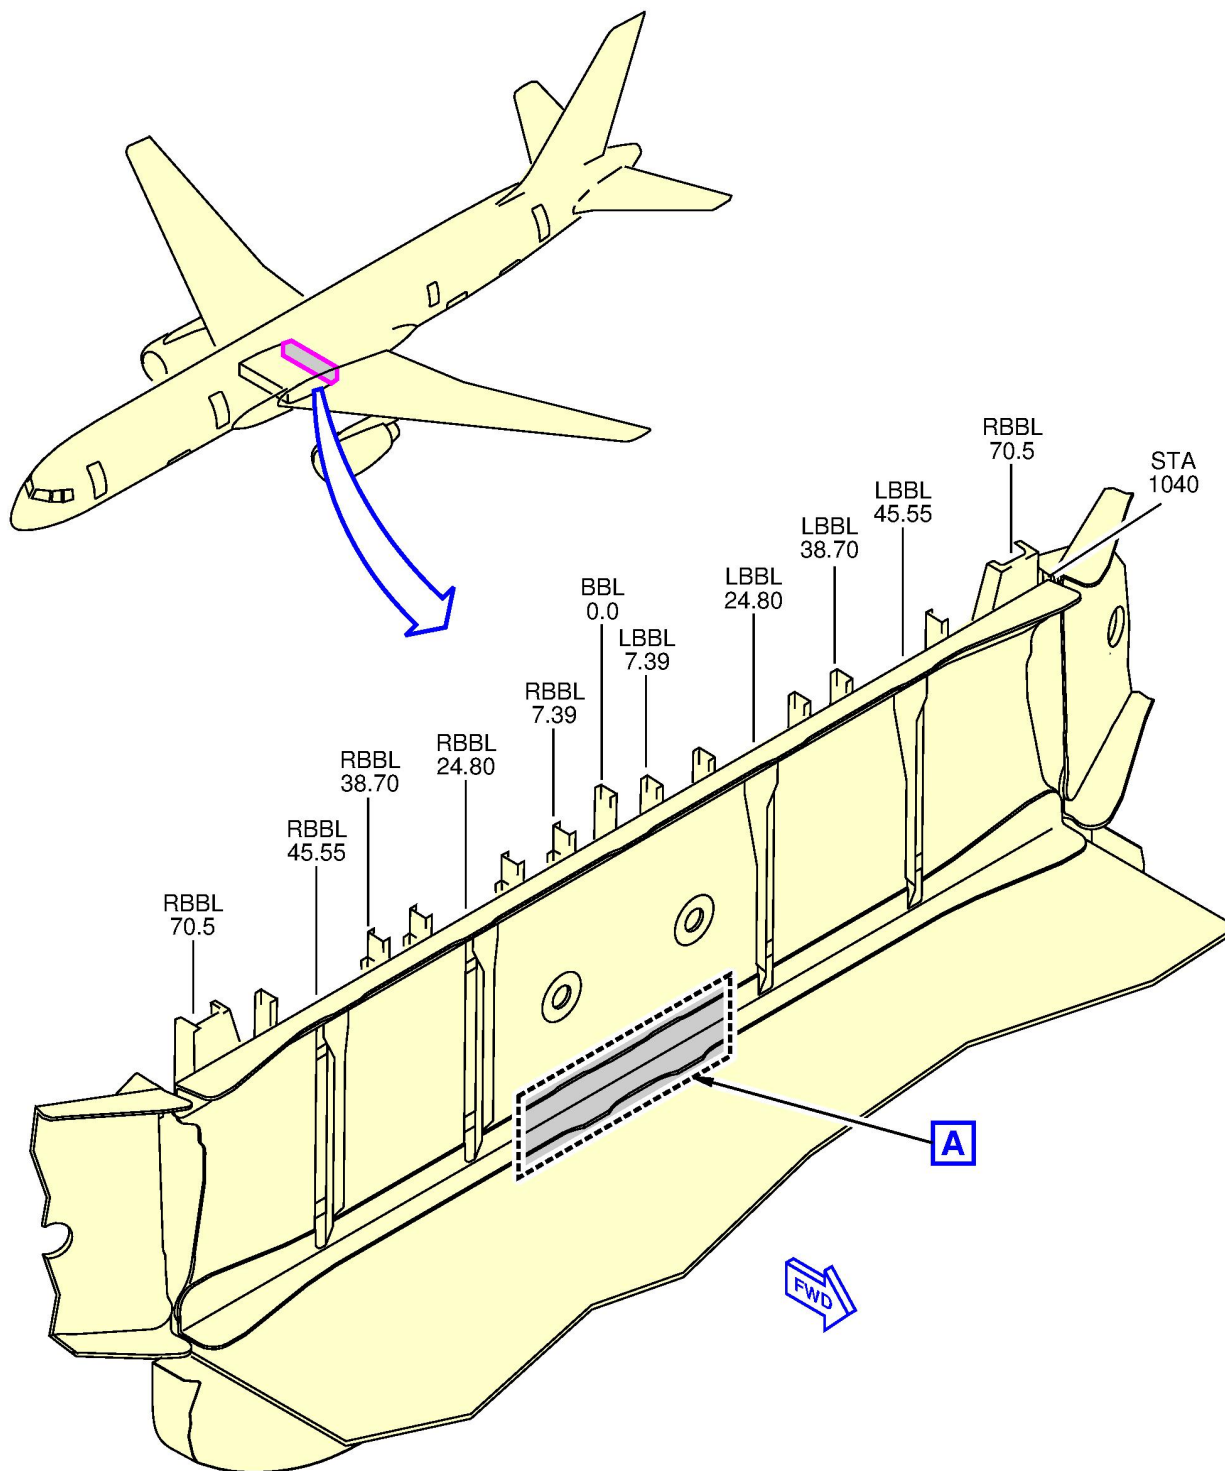
**FIGURE 4: CENTER WING BOX - REAR SPAR, LOWER SKIN AND LOWER CHORD - INTERNAL DETAILED INSPECTION (SHEET 1 OF 3)**

| Step | Task | Name | Identification | Qty | More Data |
|---|---|---|---|---|---|
| (b) Do an internal detailed inspection of lower skin at the rear spar for any crack. | | | | | |
| (c) Do an internal detailed inspection of the rear spar lower chord for any crack. | | | | | |
