# 757

**Number:** 757-53A0103

**SUBJECT:** FUSELAGE - Section 43 and Section 46 - Structure - Inspection and Modification of  
Open Holes on Frame Webs Between Stringers S-20 and S-25

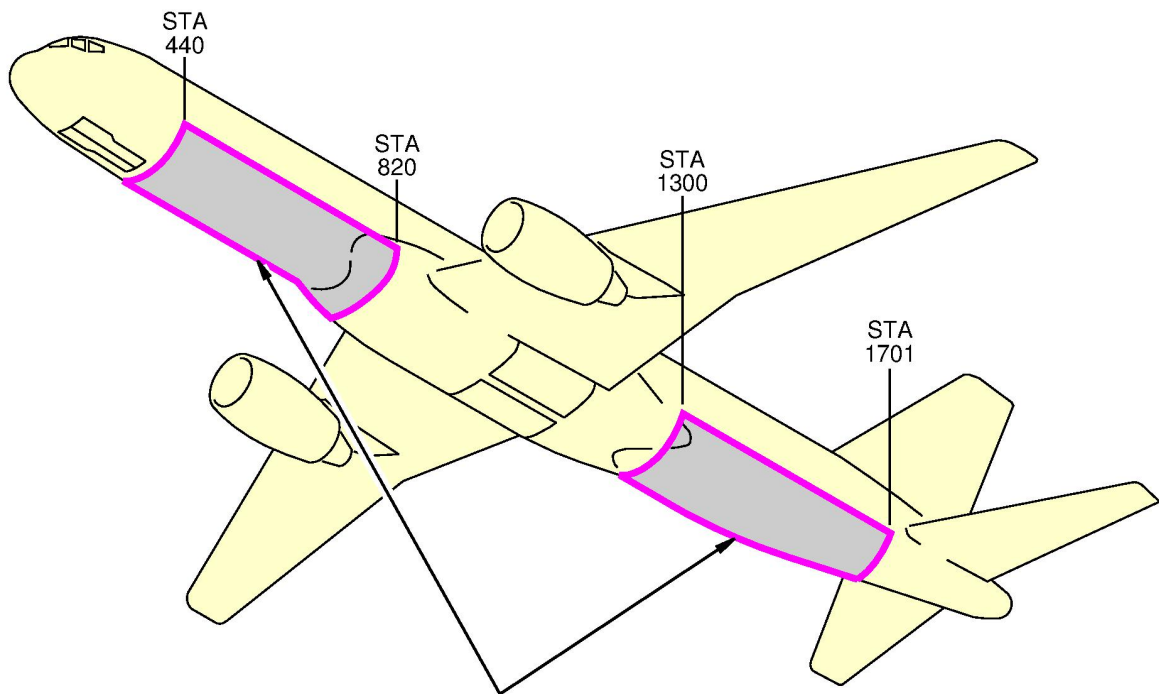
BETWEEN STRINGERS S-20 TO S-25, FROM STA 440 TO STA 820 AND FROM STA 1300 TO STA 1701, INSPECT THE FRAME WEBS FOR ANY OPEN COORDINATING HOLES, TOOLING HOLES AND INSULATION BLANKET ATTACHMENT HOLES. DO AN OPEN HOLE HIGH FREQUENCY EDDY CURRENT INSPECTION OF ALL OPEN HOLES FOR ANY CRACK.

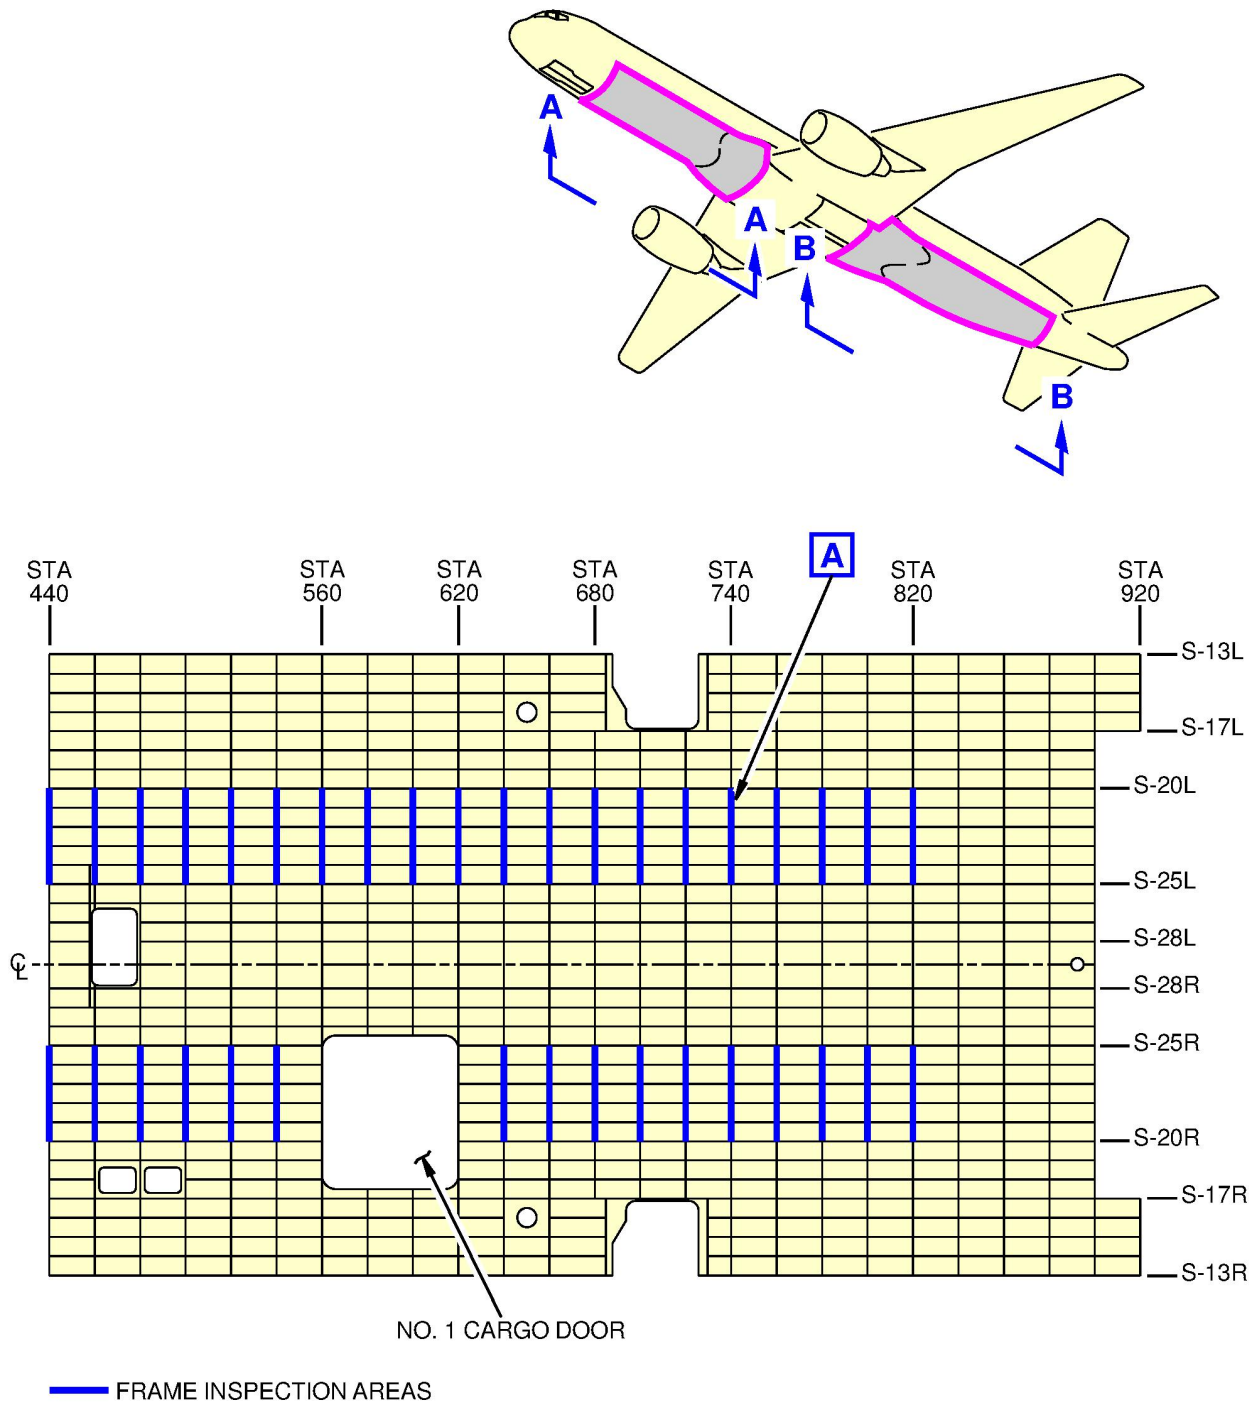
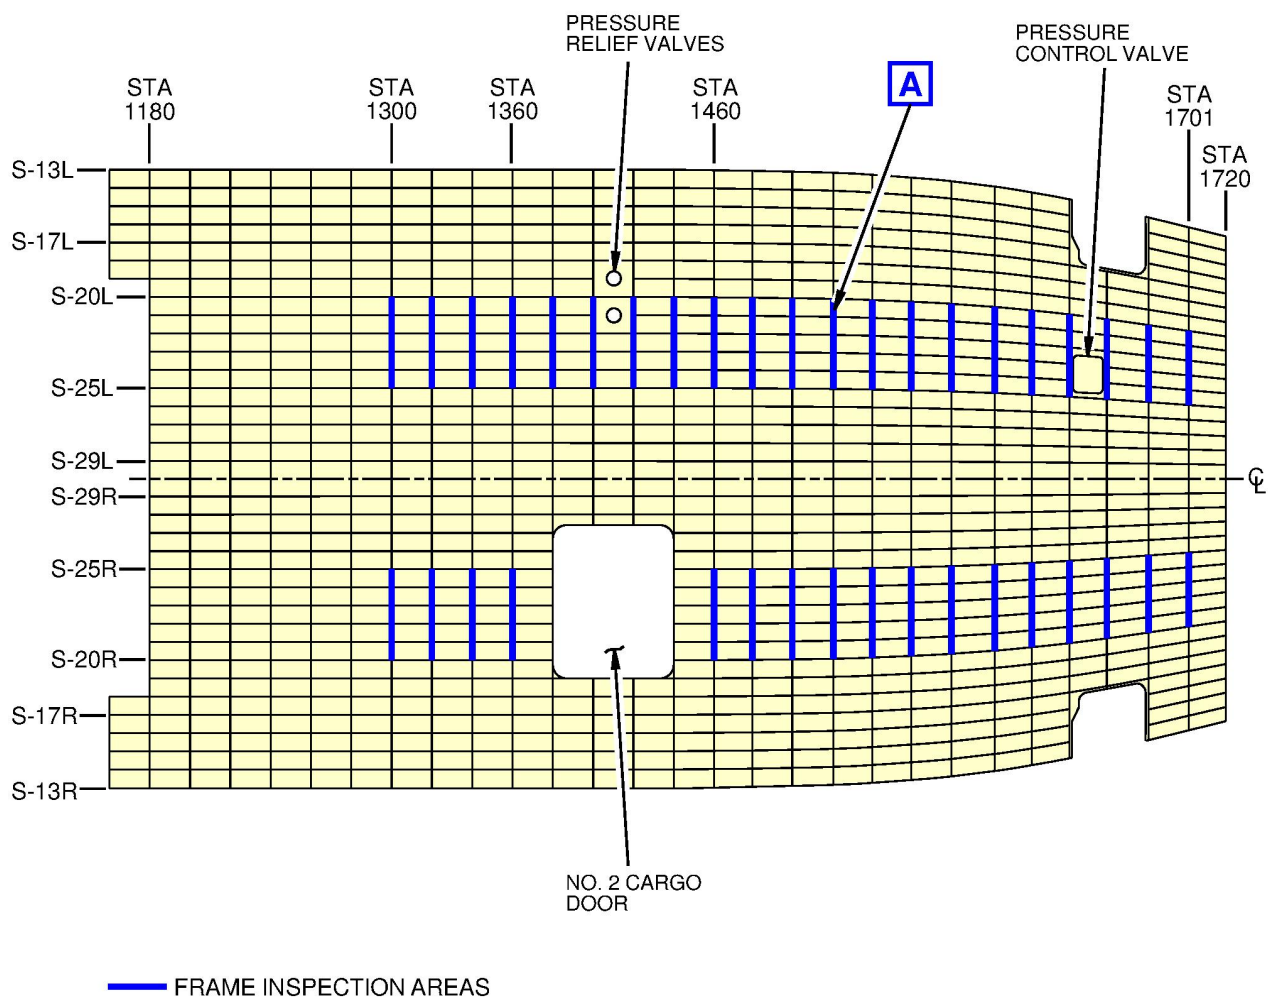
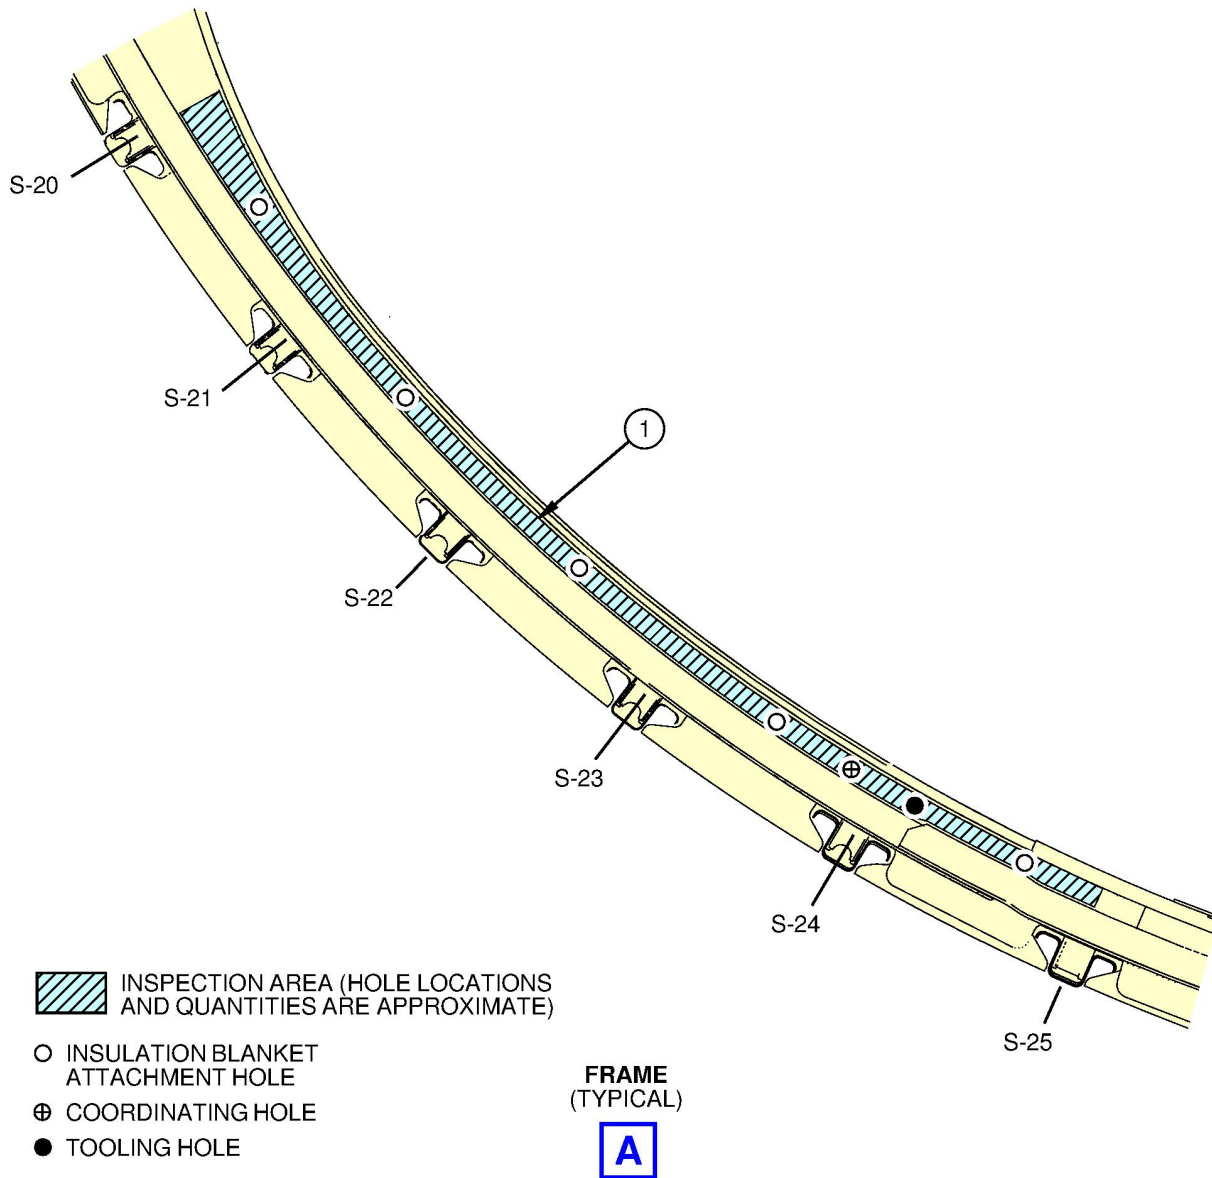
**FIGURE 1: OPEN HOLE HIGH FREQUENCY EDDY CURRENT INSPECTIONS BETWEEN STRINGERS S-20 AND S-25 FROM STA 440 TO STA 820 AND FROM STA 1300 TO STA 1701 (SHEET 3 OF 4)**

| Step | Task | Name | Identification | Qty | More Data |
|---|---|---|---|---|---|
| (b) Do an open hole high frequency eddy current (HFEC) inspection of all open coordinating holes, tooling holes and insulation blanket attachment holes for any crack in accordance with 757 NDT Manual Part 6, 51-00-16. | | | | | |

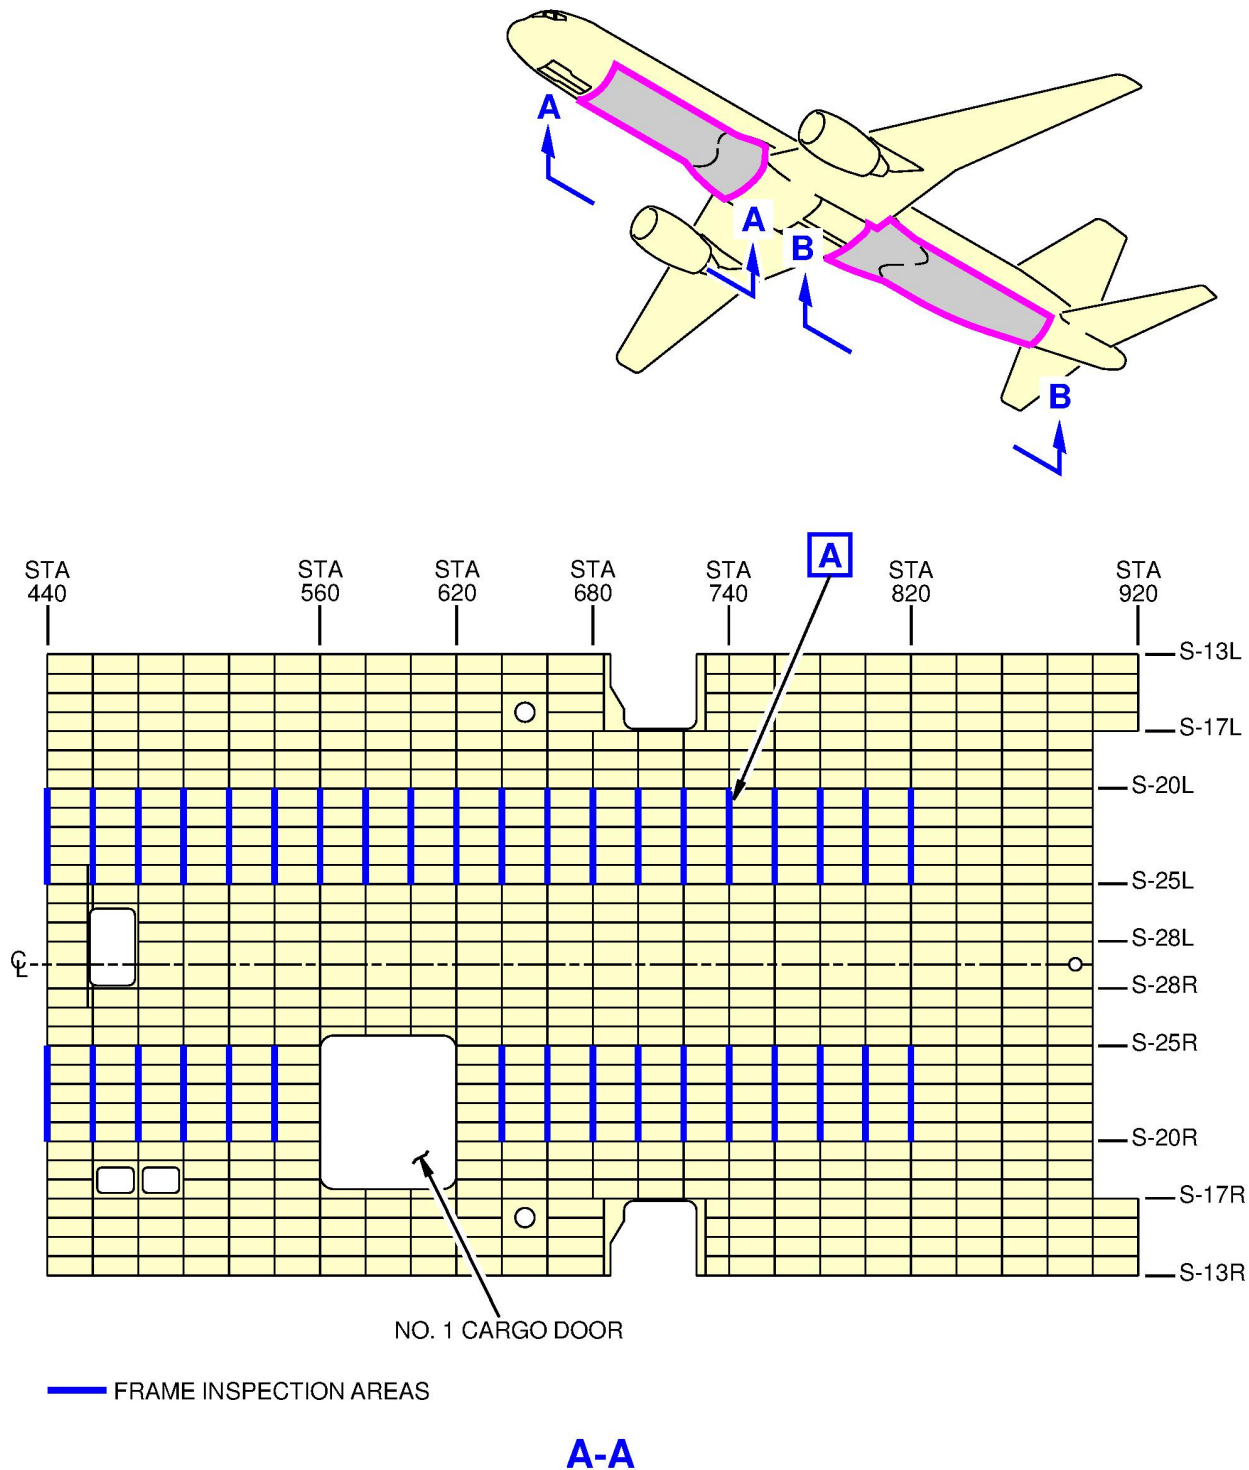
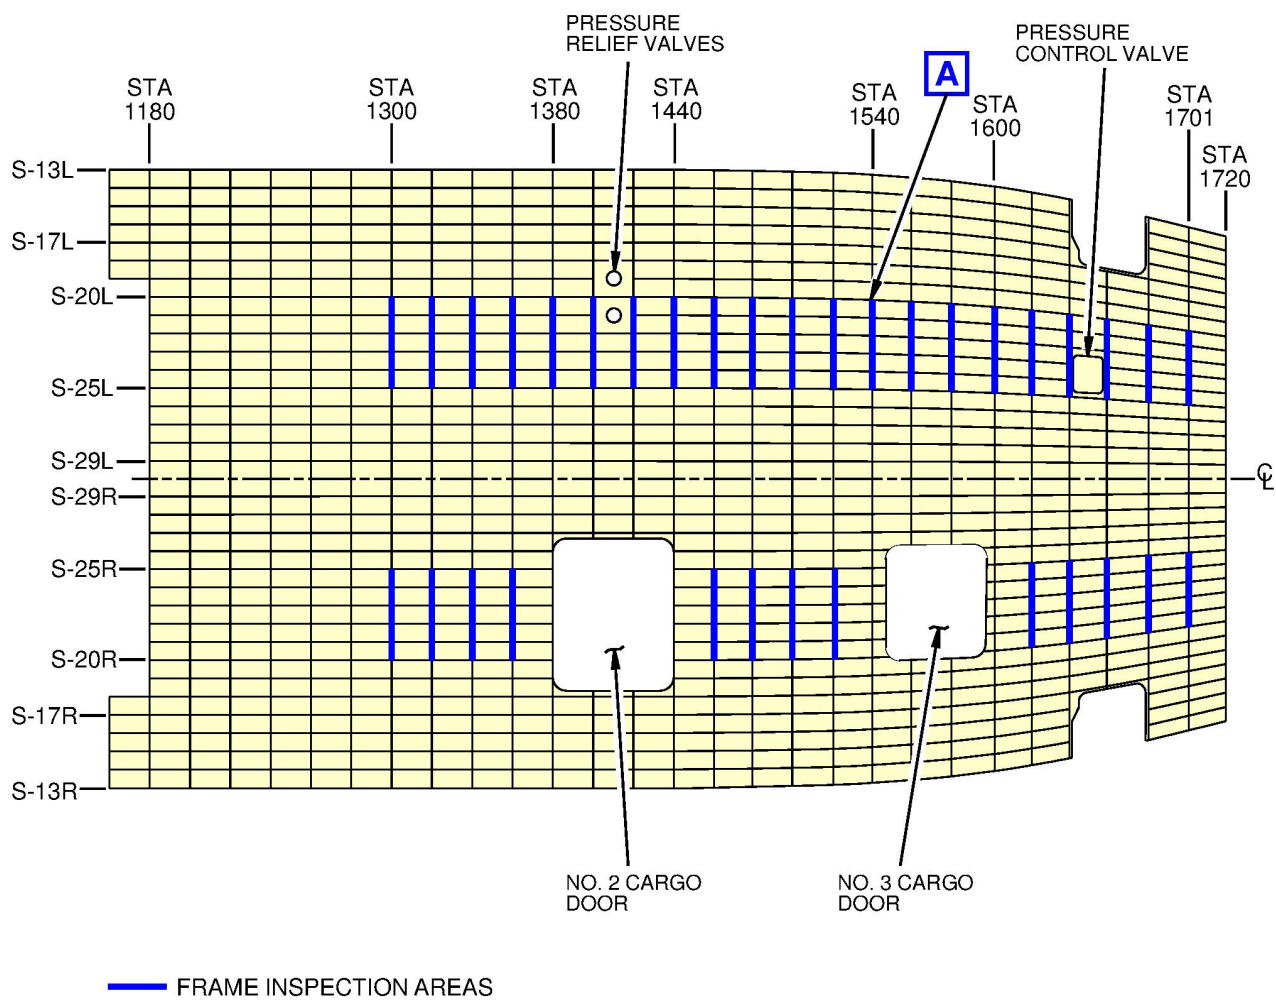
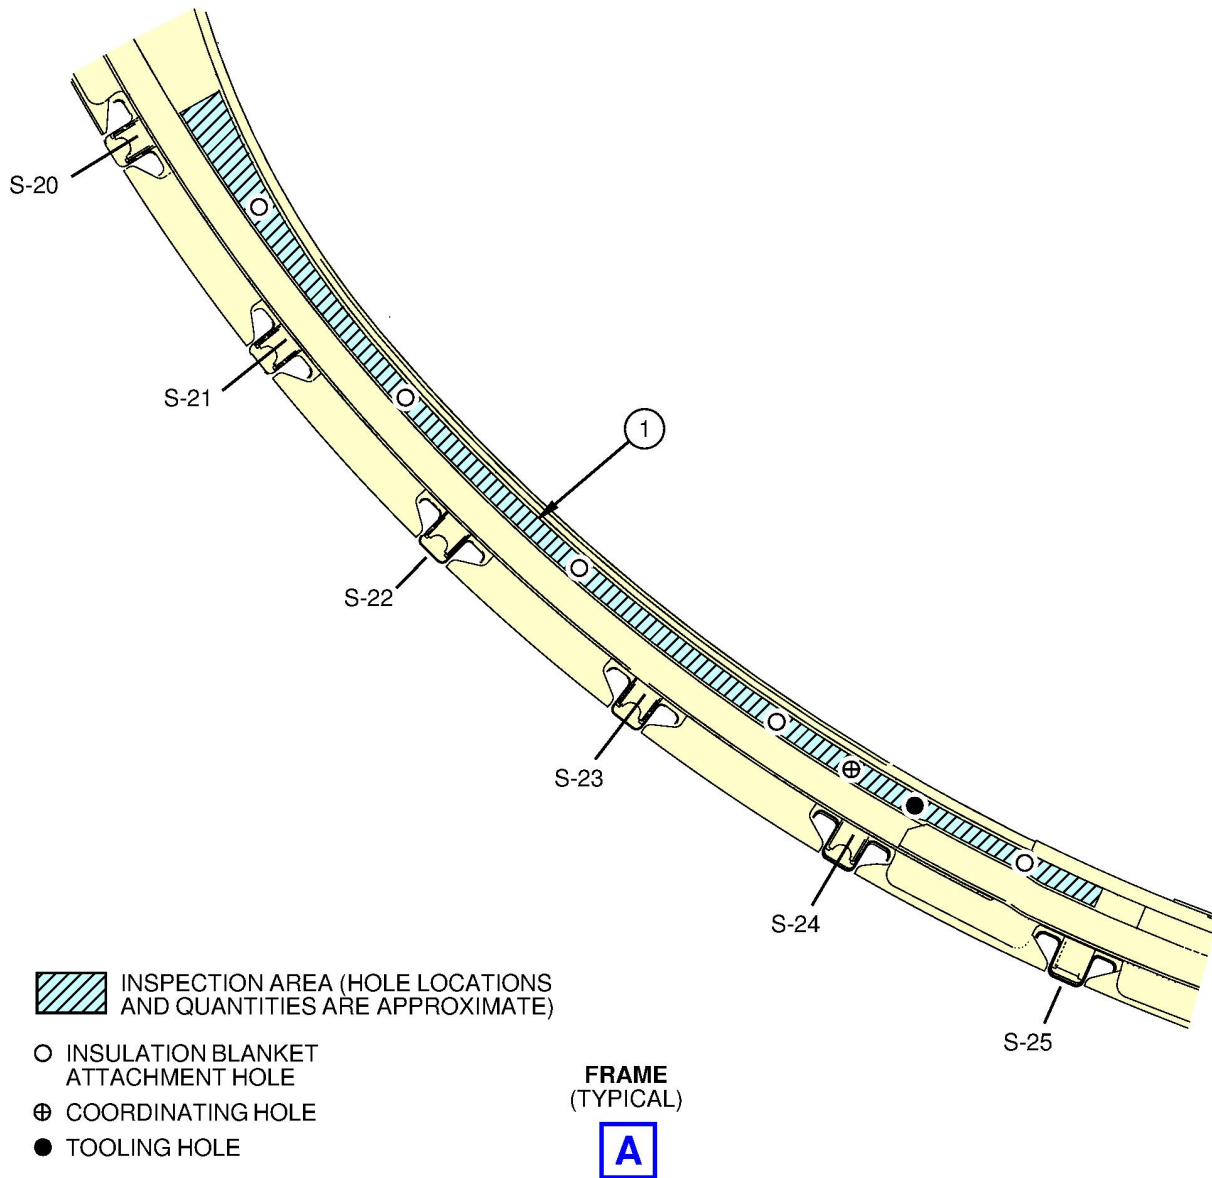
**FIGURE 2: OPEN HOLE HIGH FREQUENCY EDDY CURRENT INSPECTIONS BETWEEN STRINGERS S-20 AND S-25 FROM STA 440 TO STA 820 AND FROM STA 1300 TO STA 1701 (SHEET 1 OF 4)**

| Step | Task | Name | Identification | Qty | More Data |
|---|---|---|---|---|---|
| (b) Do an open hole high frequency eddy current (HFEC) inspection of all open coordinating holes, tooling holes and insulation blanket attachment holes for any crack in accordance with 757 NDT Manual Part 6, 51-00-16. | | | | | |
