757

## Service Bulletin

**Number:** 757-30-0019  
**Date:** July 19, 2006  
**Revision 2:** April 19, 2010  
**ATA System:** 3041 5611

**SUBJECT:** ICE AND RAIN PROTECTION - Flight Compartment Window Anti-Icing - Windshield Inspection and Replacement

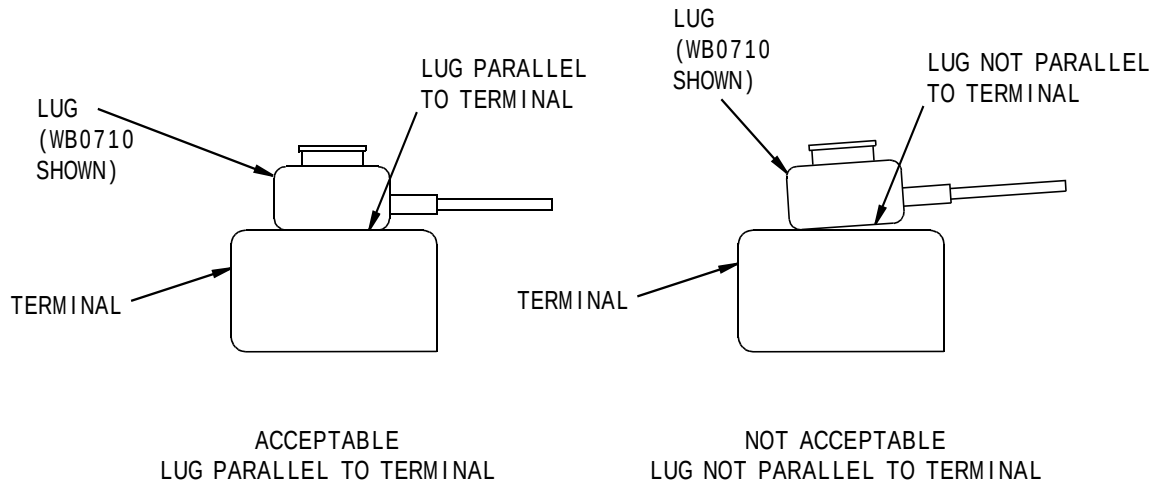
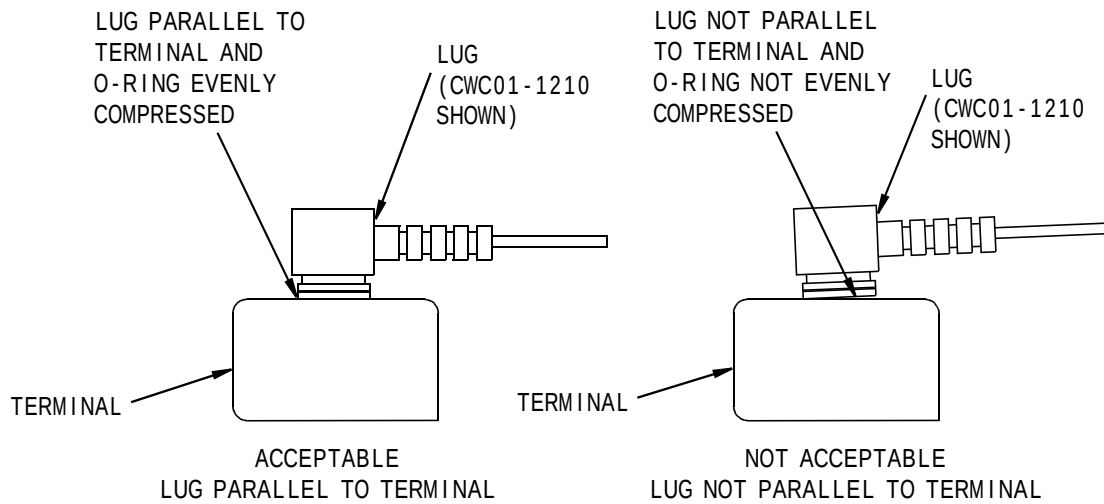
FIGURE 1: INSPECTION OF THE LEFT WINDSHIELD  
(SHEET 2 OF 5)

| STEP | TASK | NAME | IDENTIFICATION | QTY | MORE DATA |
|---|---|---|---|---|---|
| | <b>NOTE:</b> If the terminal lug moves while applying light manual pressure to the strain-relief on the lug, then the screw that attaches it must be tightened. There are four causes for a loose terminal.<br>1-The screw is not tightened to the correct torque.<br>2-The terminal is damaged.<br>3-The incorrect screw is installed. The correct screw part number is given in SWPM 20-64-16 and Illustrated Parts Catalog 757 IPC 30-41-52.<br>4-The screw is cross threaded. | | | | |
| | <b>NOTE:</b> If the lug shows signs of arcing, blueing, overheating or melting, replace the lug and windshield. | | | | |

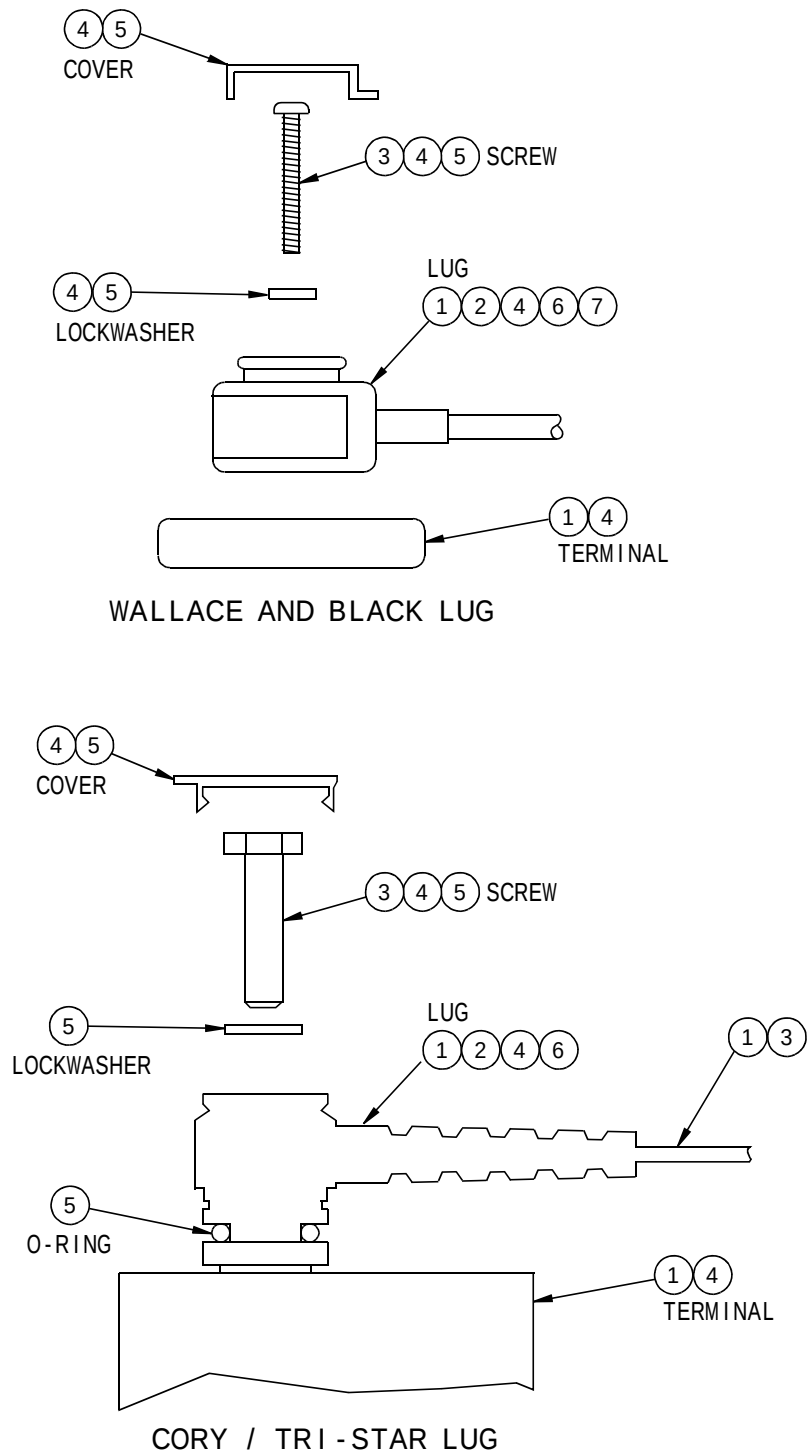
**FIGURE 1: INSPECTION OF THE LEFT WINDSHIELD  
(SHEET 3 OF 5)**

| STEP | TASK | NAME | IDENTIFICATION | QTY | MORE DATA |
|---|---|---|---|---|---|
| | <b>NOTE:</b> If the terminal lug or cap has melted, replace the shipside terminal lug and windshield. | | | | |
| | <b>NOTE:</b> If the terminal block has melted, distorted or cracked, replace the windshield. | | | | |
| <b>NOTE:</b> If the shipside wire insulation is melted or discolored, then repair or replace shipside wiring as necessary. Refer to Standard Wiring Practices Manual SWPM 20-10-13 as an accepted procedure. | | | | | |

| STEP | TASK | NAME | IDENTIFICATION | QTY | MORE DATA |
|---|---|---|---|---|---|
| | <b>NOTE:</b> If the terminal block mating surface has contamination, clean surface. Refer to SWPM 20-20-00 Cleaning Method 5 as an accepted procedure. If the terminal shows signs of arcing, blueing or overheating, the window must be replaced. | | | | |
| | <b>NOTE:</b> If the mating surface on the terminal lug has contamination, clean surface. Refer to SWPM 20-20-00 Cleaning Method 5 as an accepted procedure. If the lug cannot be cleaned or shows signs of arcing, blueing or overheating, the lug must be replaced. | | | | |
| | <b>NOTE:</b> If the lug moves with light manual pressure, replace the windshield. | | | | |

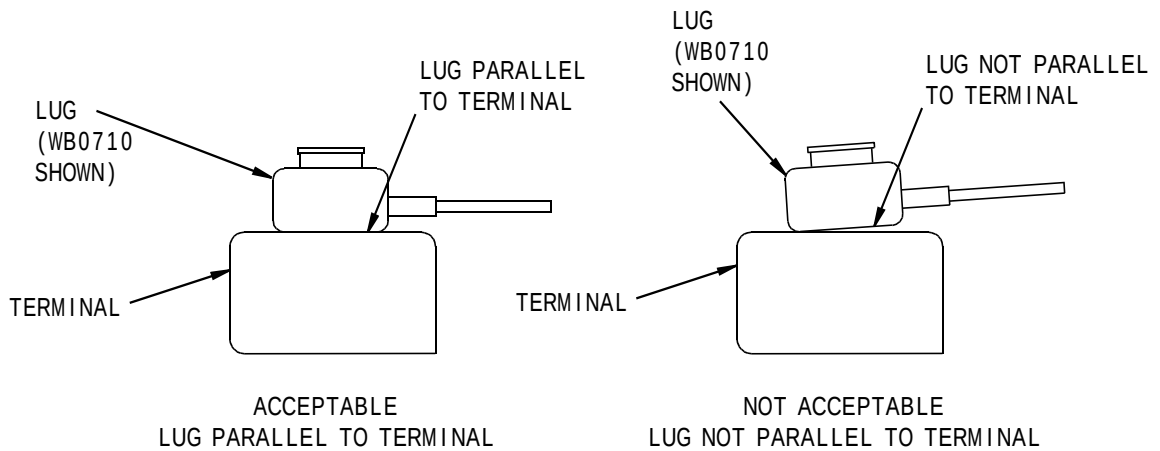
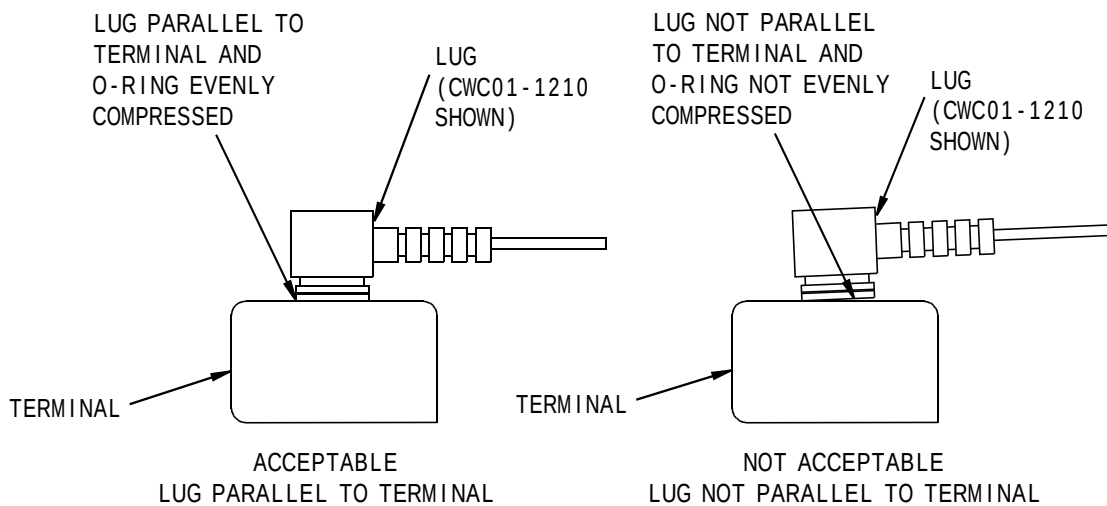
FIGURE 2: INSPECTION OF THE RIGHT WINDSHIELD  
(SHEET 2 OF 5)

| STEP | TASK | NAME | IDENTIFICATION | QTY | MORE DATA |
|---|---|---|---|---|---|
| | <b>NOTE:</b> If the terminal lug moves while applying light manual pressure to the strain-relief on the lug, then the screw that attaches it must be tightened. There are four causes for a loose terminal.<br>1-The screw is not tightened to the correct torque.<br>2-The terminal is damaged.<br>3-The incorrect screw is installed. The correct screw part number is given in SWPM 20-64-16 and Illustrated Parts Catalog 757 IPC 30-41-52.<br>4-The screw is cross threaded. | | | | |
| | <b>NOTE:</b> If the lug shows signs of arcing, blueing, overheating or melting, replace the lug and windshield. | | | | |

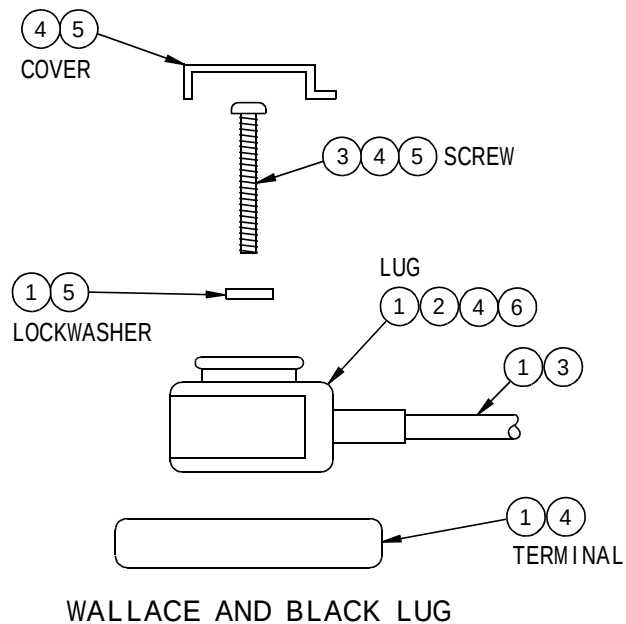
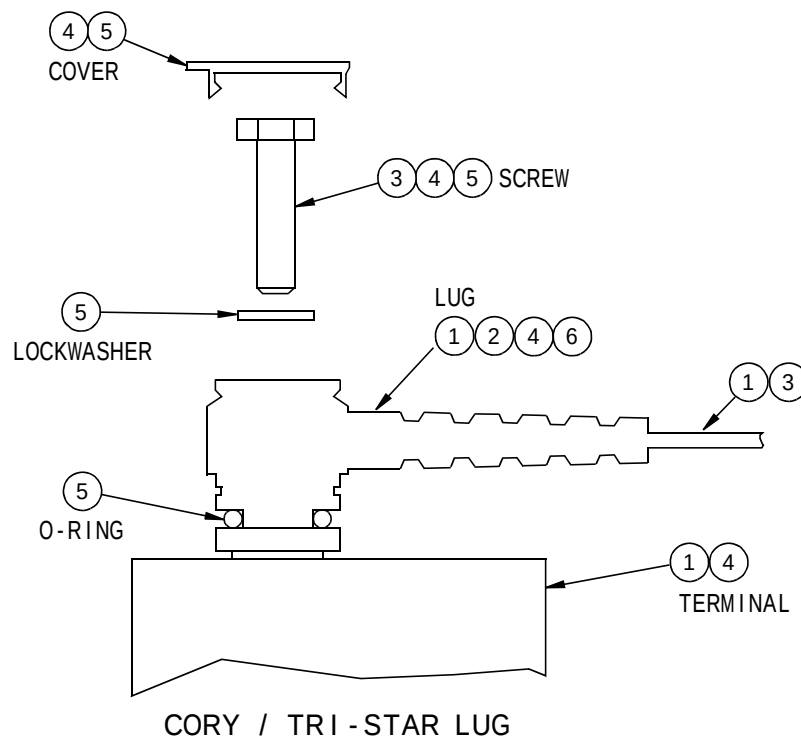
**FIGURE 2: INSPECTION OF THE RIGHT WINDSHIELD  
(SHEET 3 OF 5)**

| STEP | TASK | NAME | IDENTIFICATION | QTY | MORE DATA |
|---|---|---|---|---|---|
| | <b>NOTE:</b> If the terminal lug or cap has melted, replace the shipside terminal lug and windshield. | | | | |
| <b>NOTE:</b> If the terminal block has melted, distorted or cracked, replace the windshield. | | | | | |
| <b>NOTE:</b> If the shipside wire insulation is melted or discolored, then repair or replace shipside wiring as necessary. Refer to Standard Wiring Practices Manual SWPM 20-10-13 as an accepted procedure. | | | | | |

| STEP | TASK | NAME | IDENTIFICATION | QTY | MORE DATA |
|---|---|---|---|---|---|
| | <b>NOTE:</b> If the terminal block mating surface has contamination, clean surface. Refer to SWPM 20-20-00 Cleaning Method 5 as an accepted procedure. If the terminal shows signs of arcing, blueing or overheating, the window must be replaced. | | | | |
| | <b>NOTE:</b> If the mating surface on the terminal lug has contamination, clean surface. Refer to SWPM 20-20-00 Cleaning Method 5 as an accepted procedure. If the lug cannot be cleaned or shows signs of arcing, blueing or overheating, the lug must be replaced. | | | | |
| | <b>NOTE:</b> If the lug moves with light manual pressure, replace the windshield. | | | | |

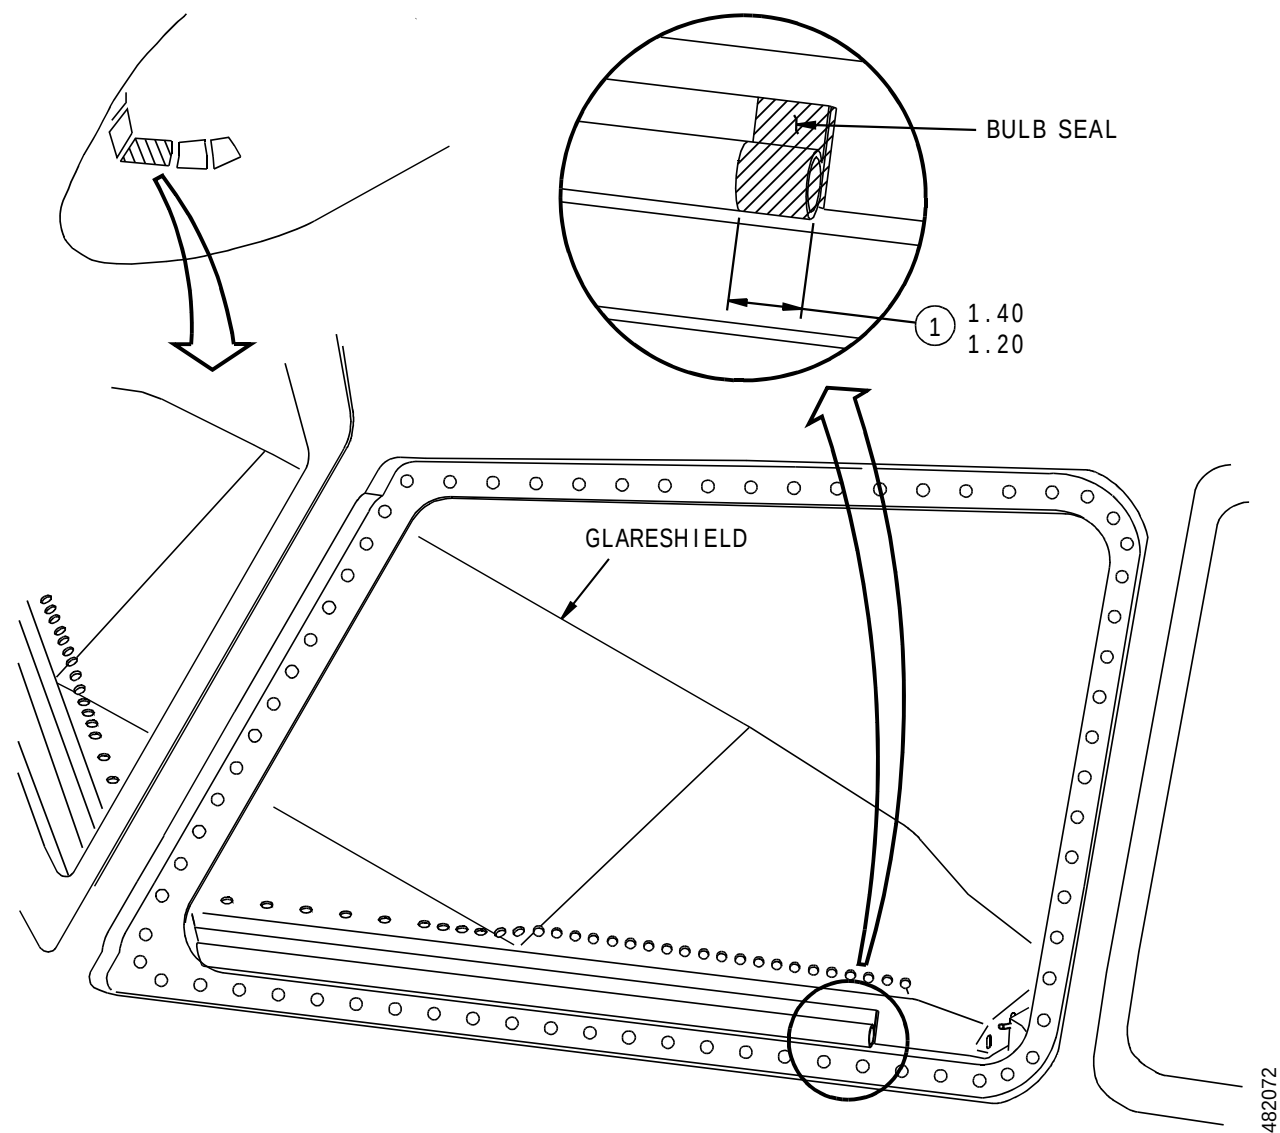
FIGURE 3: CUT THE BULB SEAL FOR THE LEFT WINDSHIELD  
(SHEET 1 OF 1)

| STEP | TASK | NAME | IDENTIFICATION | QTY | MORE DATA |
|---|---|---|---|---|---|
| <b>CAUTION:</b> DO NOT CUT THE STRUCTURE BELOW THE BULB SEAL. THE WINDOW SILL IS A HIGH MOISTURE AREA AND MOISTURE CAN CAUSE CORROSION IF THE FINISH IS DAMAGED. DAMAGE TO THE FINISH MUST BE REPAIRED. | | | | | |

| STEP | TASK | NAME | IDENTIFICATION | QTY | MORE DATA |
|---|---|---|---|---|---|
| | <b>NOTE:</b> If the finish below the bulb seal is damaged, it will need to be sealed with chemical treatment and primer. Refer to Standard Overhaul Practices Manual SOPM 20-41-02 and SOPM 20-43-03 as accepted procedures. | | | | |

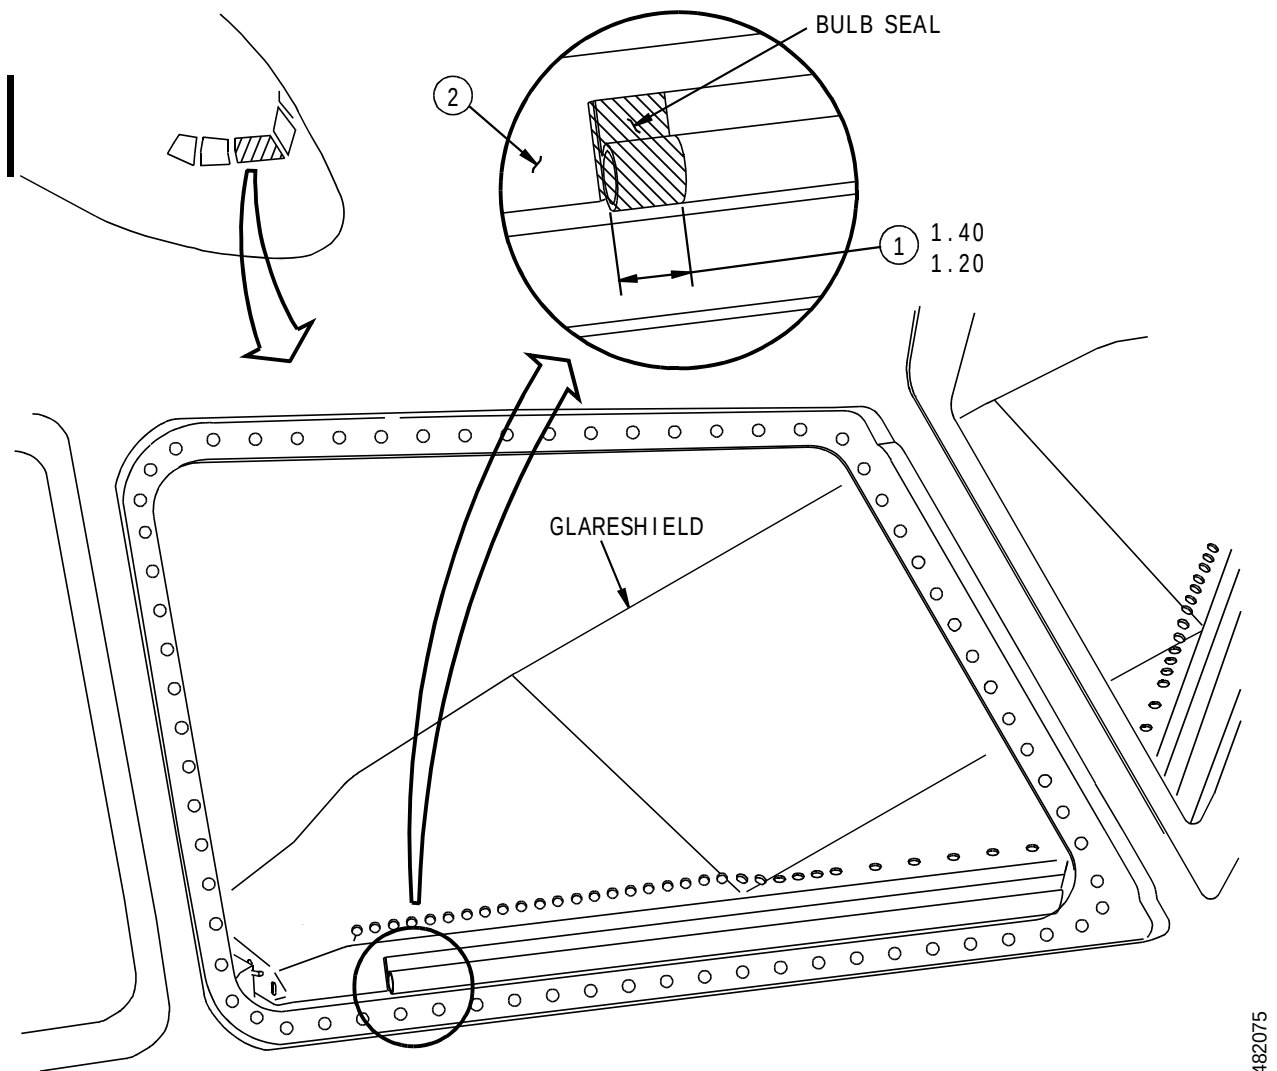
**FIGURE 6: CUT THE BULB SEAL FOR THE RIGHT WINDSHIELD**  
(SHEET 1 OF 1)

| STEP | TASK | NAME | IDENTIFICATION | QTY | MORE DATA |
|---|---|---|---|---|---|
| <b>CAUTION:</b> DO NOT CUT THE STRUCTURE BELOW THE BULB SEAL. THE WINDOW SILL IS A HIGH MOISTURE AREA AND MOISTURE CAN CAUSE CORROSION IF THE FINISH IS DAMAGED. DAMAGE TO THE FINISH MUST BE REPAIRED. | | | | | |

| STEP | TASK | NAME | IDENTIFICATION | QTY | MORE DATA |
|---|---|---|---|---|---|
| | <b>NOTE:</b> If the finish below the bulb seal is damaged, it will need to be sealed with chemical treatment and primer. Refer to Standard Overhaul Practices Manual SOPM 20-41-02 and 20-43-03 as accepted procedures. | | | | |
