777

**Number:** 777-29-0032

**SUBJECT:** HYDRAULIC POWER - Main Hydraulic Systems - Nose Landing Gear Alternate  
Extension Hydraulic Tube - Change

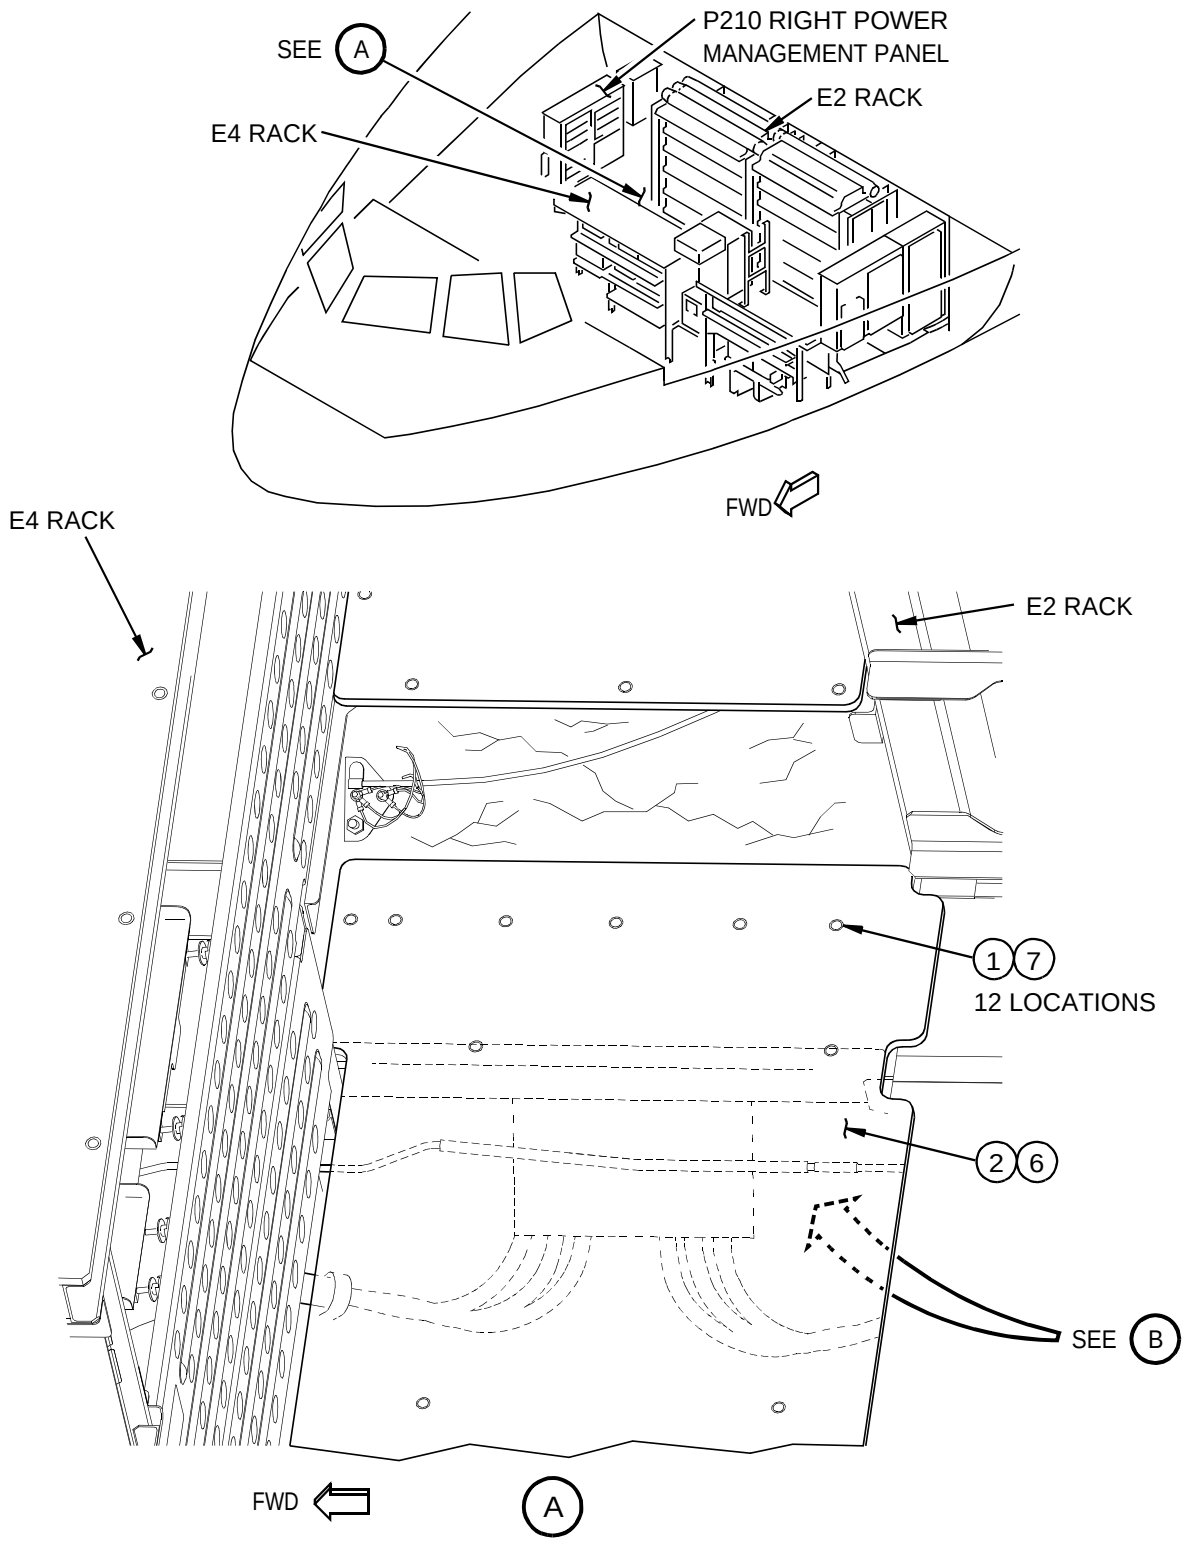
FIGURE 1: Main Equipment Center - Hydraulic Tube - Access and Change  
(SHEET 1 OF 3)

An operator reported a fire in the main equipment center after the maintenance crew connected external power. The cause of the fire was traced to a failure of an external power connector in the P30 panel, which caused high-temperature arcing and splatter of molten copper on an adjacent hydraulic tube. The molten copper splatter created a hole in the tube, and hydraulic fluid sprayed into the power connector and caught on fire.

In the main equipment center, wrap self-fusing fire resistant silicone tape around the section of the nose landing gear alternate extension hydraulic tube that is adjacent to the P30 panel.

1. Remove primary and secondary external power from the airplane. Refer to 777 AMM 24-22-00 as an accepted procedure.
2. Get access to and change the hydraulic tube as given in Figure 1.
3. Put the airplane back to a serviceable condition.
