***BAe AIRCRAFT***  
BULLETIN FOR DE HAVILLAND MOTH AIRCRAFT

DOCUMENT TYPE AND REF No TECHNICAL NEWS SHEET CT (MOTH) No 29 Issue 3

| TITLE: FUSELAGE: LATERAL TIE RODS - FRACTURE<br>AT WING JOINT FITTINGS. | CLASSIFICATION<br>MANDATORY |

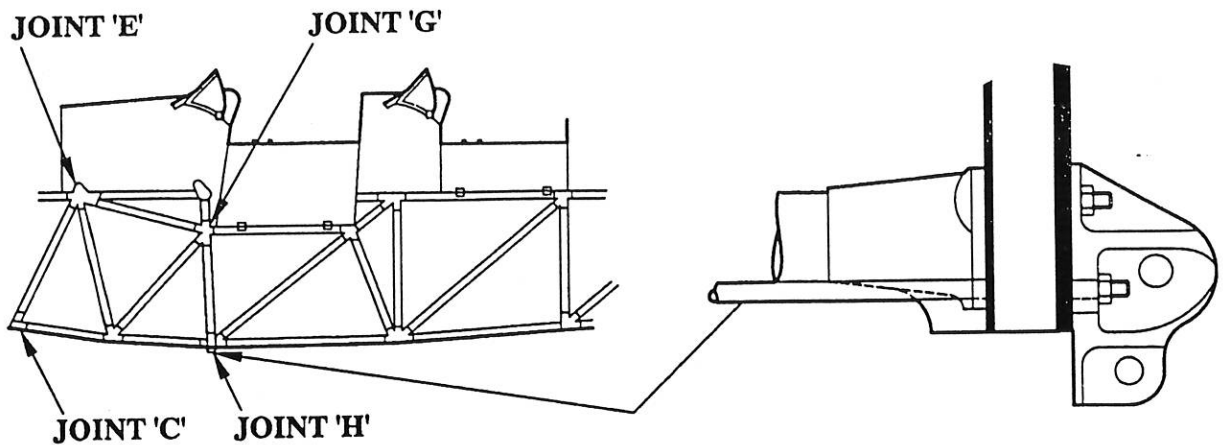
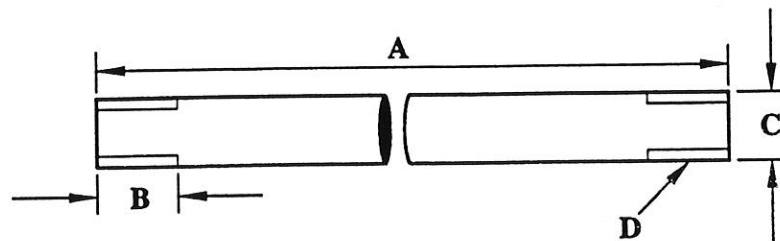
**FIGURE 1**

- (1) Remove or stow the wings in accordance with the Maintenance and Repair Manual.
- (2) Refer to Figure 1 attached and locate the Spar Joint Fittings applicable to type at fuselage joint indicated, on both the Port and Starboard sides of the aircraft.
- (3) Remove the securing nuts and withdraw the two lateral Fuselage Tie Rods.
- (4) Using cleaning fluid and a lint free cloth remove all grease and dirt from the surface of the Spar Joint Fittings particularly around the periphery of the Tie Rod location holes.
- (5) Examine the Tie Rod location holes using a strong light source and 10 X magnifier for signs of ovality. Where these holes are found to be elongated the fitting should be declared scrap and replaced with an appropriate new item.

**JOINT FITTING (Pt No H34640/1)**  
Examine holes for signs of elongation

NOTE: All Rods to be manufactured as shown in Figure 1. Operators with queries regarding applicability of parts should contact BAe in accordance with Paragraph 4 (REPORTING).

- (1) Install new tie rods and run up the securing nuts by hand "finger tight". Tighten and torque load the nuts to 2 - 2.5 lbf ft (2.71 - 3.39 Nm) on wood constructed aircraft and 7.5 - 8.5 lbf ft (10.17 - 11.52 Nm) on metal constructed aircraft. A little further tightening may be necessary so that the next slot aligns with the split pin hole. Secure with a split pin and apply protective treatment.
- (2) Refit wings and re-rig the aircraft in accordance with the Maintenance and Repair Manual.
