## BOLLETTINO TECNICO

N° **109SP-087**

**SUBJECT:** TAIL ROTOR PITCH CONTROL LINK ASSY P/N 109-0130-05-117.

**REASON:** Perform an inspection of the subject link assy for excessive friction of the spherical bearing.

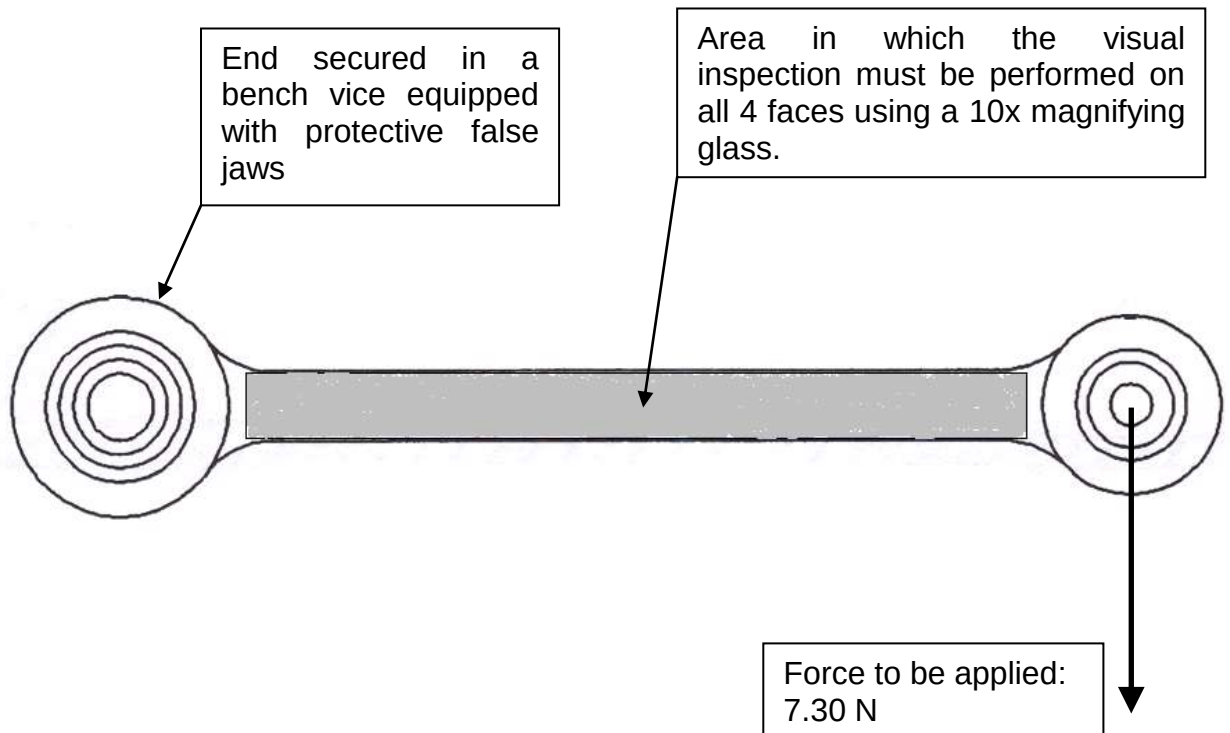
**FIGURE 1**

3. Secure the larger spherical bearing of the link in a bench vice equipped with protective false jaws.
  - 3.1. At the other end apply a dynamometer on the spherical bearing and perform the check of the torsion value force for the spherical bearing rotation as shown in figure 1.

- 3.2. In the same manner perform the check of the necessary torsion value force for the smaller link spherical bearing rotation as shown in figure 1.

- 3.3. Check that the force torsion value is lower than 7.30 N for both the spherical bearings. In case a force torsion value above the limits is detected, even if in only one of the spherical bearings, it is necessary to replace the link with a serviceable one with the same P/N. Proceed with point 7.

5. Perform a visual inspection of the stem for cracks using a 10x magnifying glass (see figure 1 for the affected area).

Indicative picture.  
The force value must be verified on both  
spherical bearings.

**LINK ASSY P/N 109-0130-05-117**

6. If no cracks are found, reinstall the links on the helicopter in accordance with the procedures given in the AW109SP Air Vehicle Maintenance Publication n. 0B-A-AMP-00-X. Otherwise, replace the link with a serviceable one with the same P/N.
7. Return the helicopter in a ready to flight condition.
8. Record compliance with PART II^ of this Bollettino in the helicopter log book.
