**DATE:** April 02, 2015

**SUBJECT:** Stabilizer Support Tube Inspection and Repair

**REVISION:** A

**HUSKY MODELS:** A-1, A-1A, S/N 1468 & BELOW  
A-1B, S/N 2397 & BELOW  
A-1B-WF, S/N 0002 & BELOW  
A-1B-NF, S/N 0008 & BELOW  
A-1C, S/N 3198 & BELOW

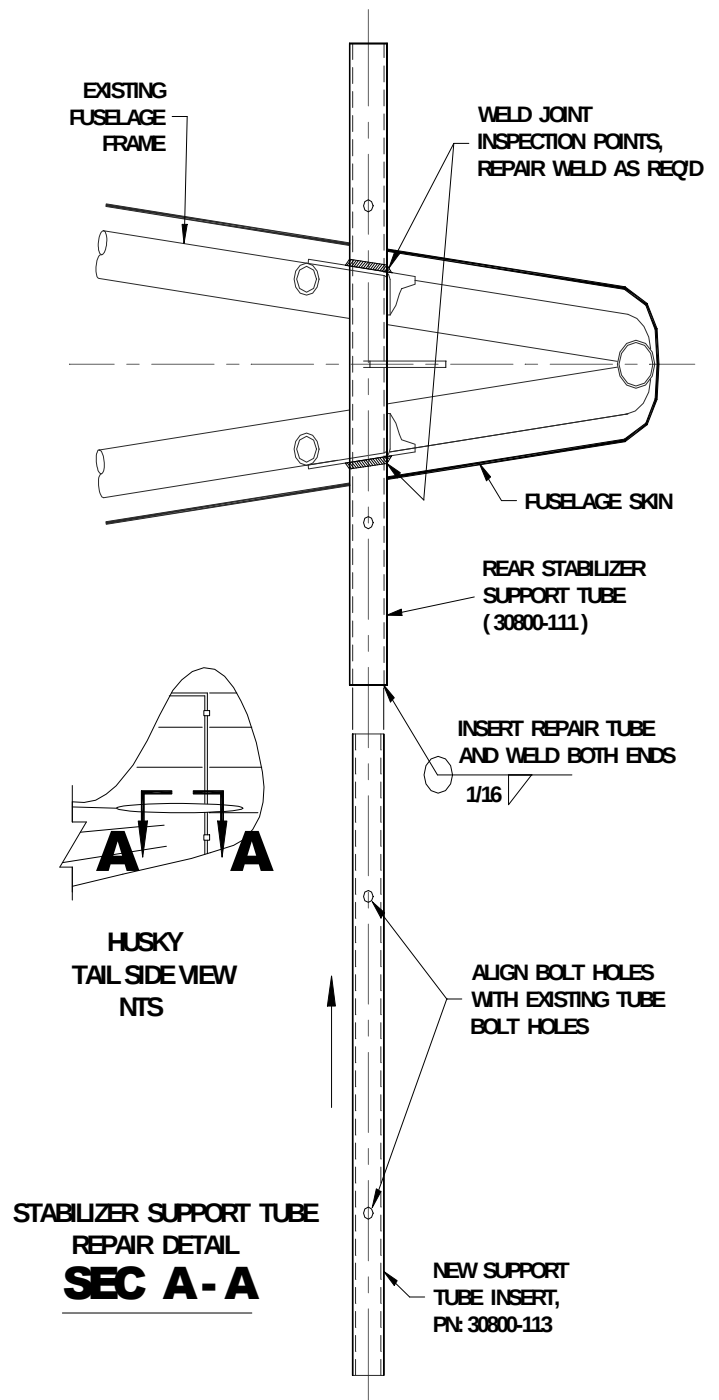
1. Mandatory Inspection:
  - a. Begin by removing inspection access covers located above and below rear support tube.
  - b. Visually inspect entire circumference of support tube at weld joint between fuselage frame and fabric for corrosion or damage.

- c. If damage is verified or suspected, proceed to Recommended Repair instructions.
2. Recommended Repair:
  - a. Mark and record adjustments of tail rigging and controls as necessary.

- e. Insert repair tube inside existing stabilizer support tube, align bolt holes, and weld both ends using AWS ER70S-2 welding rod in accordance with AC 43.13-1B, Chapter 5.

- g. Reinstall stabilizers, elevators and controls.
  - h. It is recommended to replace all stabilizer mounting bolts & nuts. Any questions on rigging, refer to Instructions for Continued Airworthiness Doc: Model A-1, A-1A; see 70192-002 section 1, 3.10, Model A-1B; see 70192-004 section 1, 3.10, Model A-1C; see 70192-006 section III, 5.2d.
