# S-92<sup>®</sup> HELICOPTER

ASB 92-25-026

**SUBJECT:** EQUIPMENT FURNISHINGS – Side Facing Utility Seat – One Time Inspection of Side Facing Utility Seat (MBCS12410AA001) and Observer Seat (MBCS12200, and MBCS7301-2) and Repair with New Tube Assembly if Necessary

## **SPECIAL INFORMATION LEAFLET No. 831**

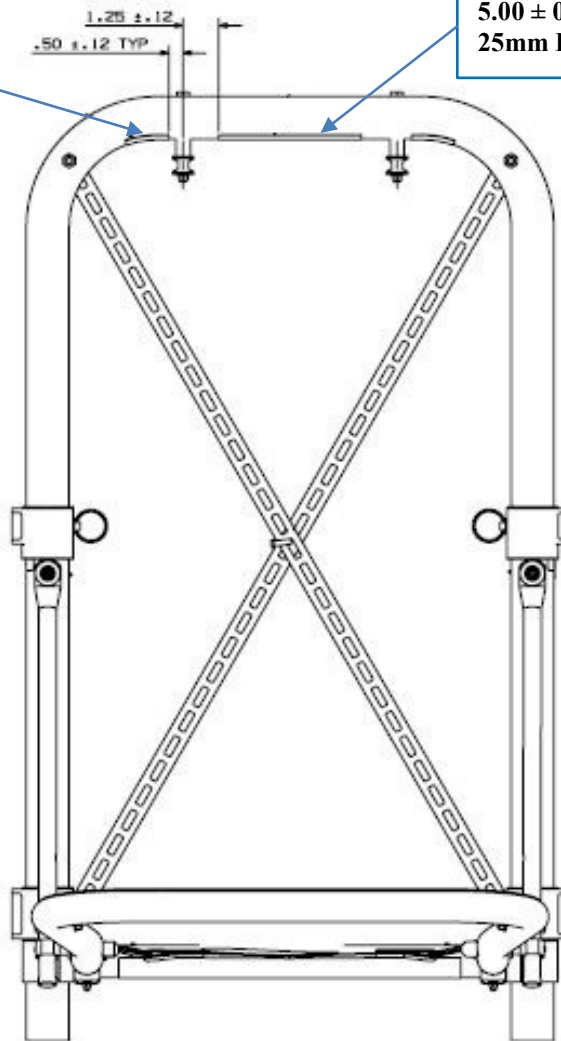
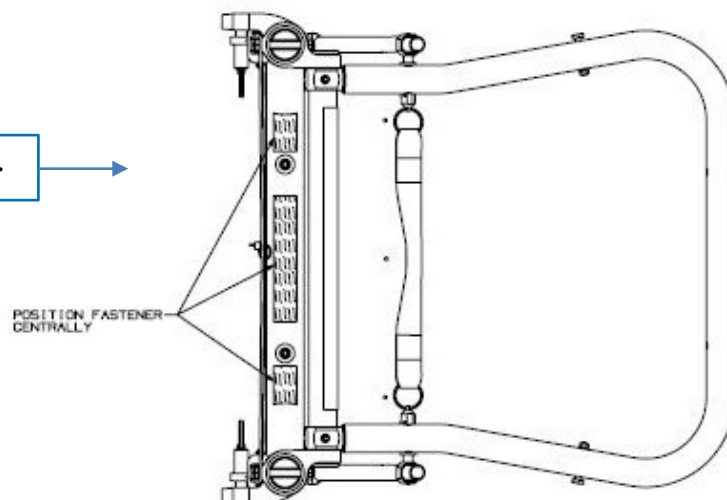
**Figure 1 – Position of Fastener, 25mm Hook P37689 on Tube Assembly, Back Main MBCS12834**

1.50 ± 0.12 long  
Fastener, 25mm  
Hook (P37689) 2  
places.

**D2.6.1** With reference to Figure 1 below, attach fastener, 25mm hook P37689 to underside of the top of the main back tube assembly.

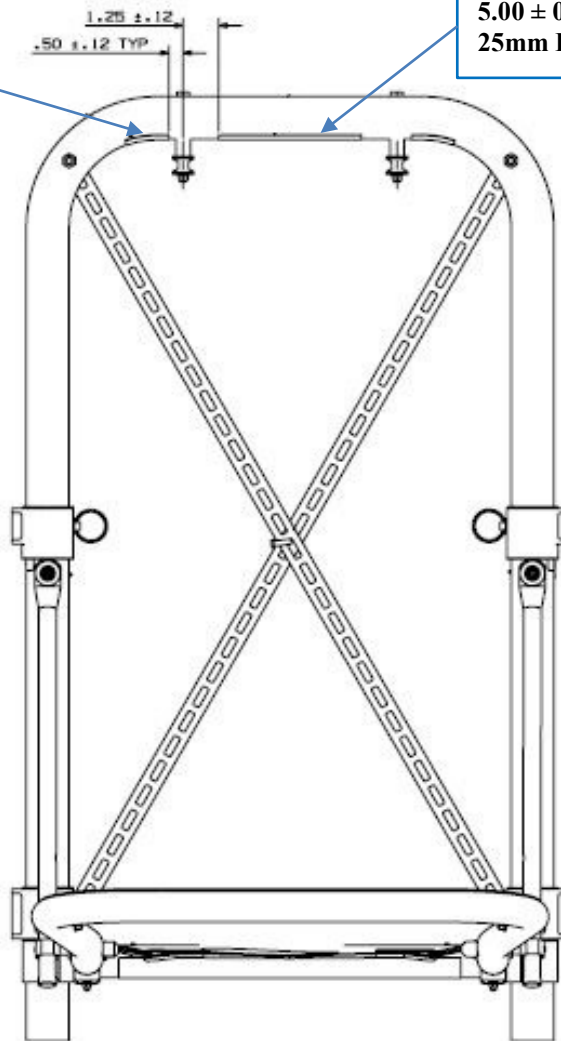
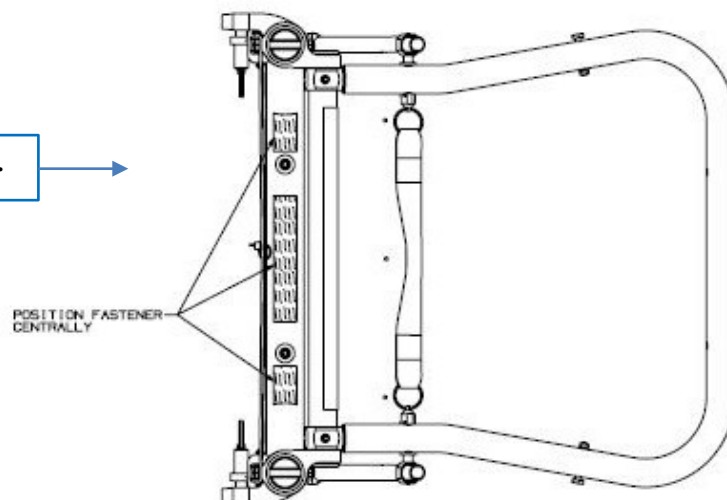
**Figure 1 – Position of Fastener, 25mm Hook P37689 on Tube Assembly, Back Main MBCS12834**

1.50 ± 0.12 long  
Fastener, 25mm  
Hook (P37689) 2  
places.

5.00 ± 0.12 long Fastener,  
25mm Hook (P37689).
