**MU-2**

# SERVICE BULLETIN

| No. 243 | DATE: June 30, 2015 |
| Subject: | Main Landing Gear Oleo Attach Fitting – Inspection of |

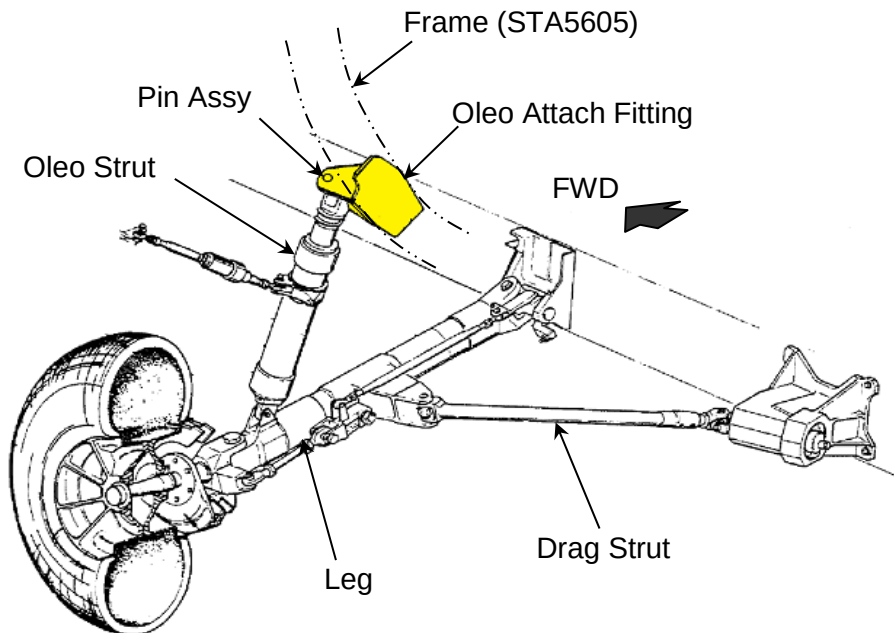
| Background: | Cracks were found in the fittings of the main landing gear oleo strut on several long body airplanes. Since the fitting is very important structure for safe landing, a one-time inspection is required to ensure continued airworthiness. |

Figure 1: LOCATION OF FITTING LUG INSPECTION  
(Typically shown for L/H side)

- (1) Visually inspect the lugs of the oleo attach fittings on both sides for visible cracks. (Figure 1 & 2) Use a mirror and flashlight to check the entire surface of lugs of the fitting. If any cracks are found in the lug, replace with a new fitting in accordance with the applicable Maintenance Manual and discard the discrepant fitting.

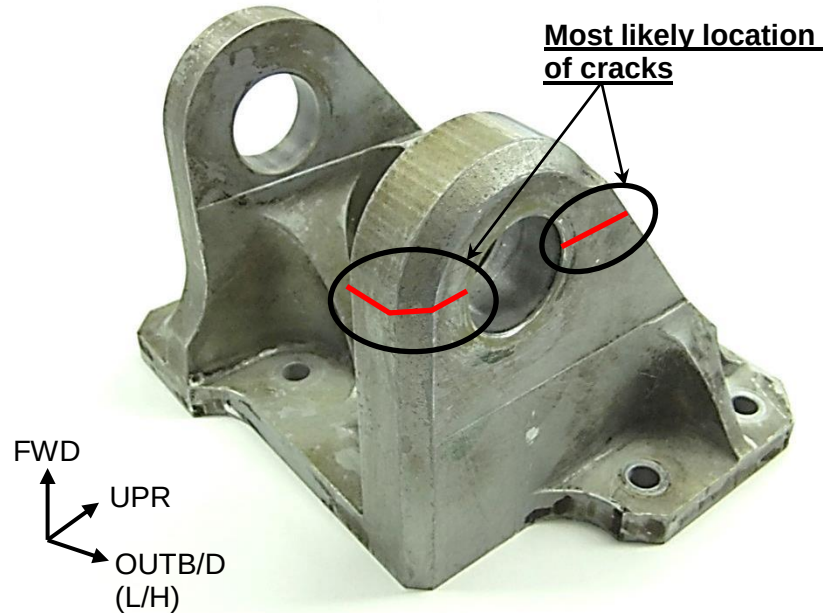
Figure 2: MOST LIKELY LOCATION OF CRACKS ON FITTING  
(Typically shown for L/H side)
