**SERVICE BULLETIN****N° 139-783****EMERGENCY ALERT****DATE:** April 10, 2024**REV. :** A November 6, 2024

**TITLE****ATA 32 – MLG SHOCK ABSORBER INSPECTION****REVISION LOG**

**INSPECTION OF SHOCK ABSORBER PISTON ROD EYE END**

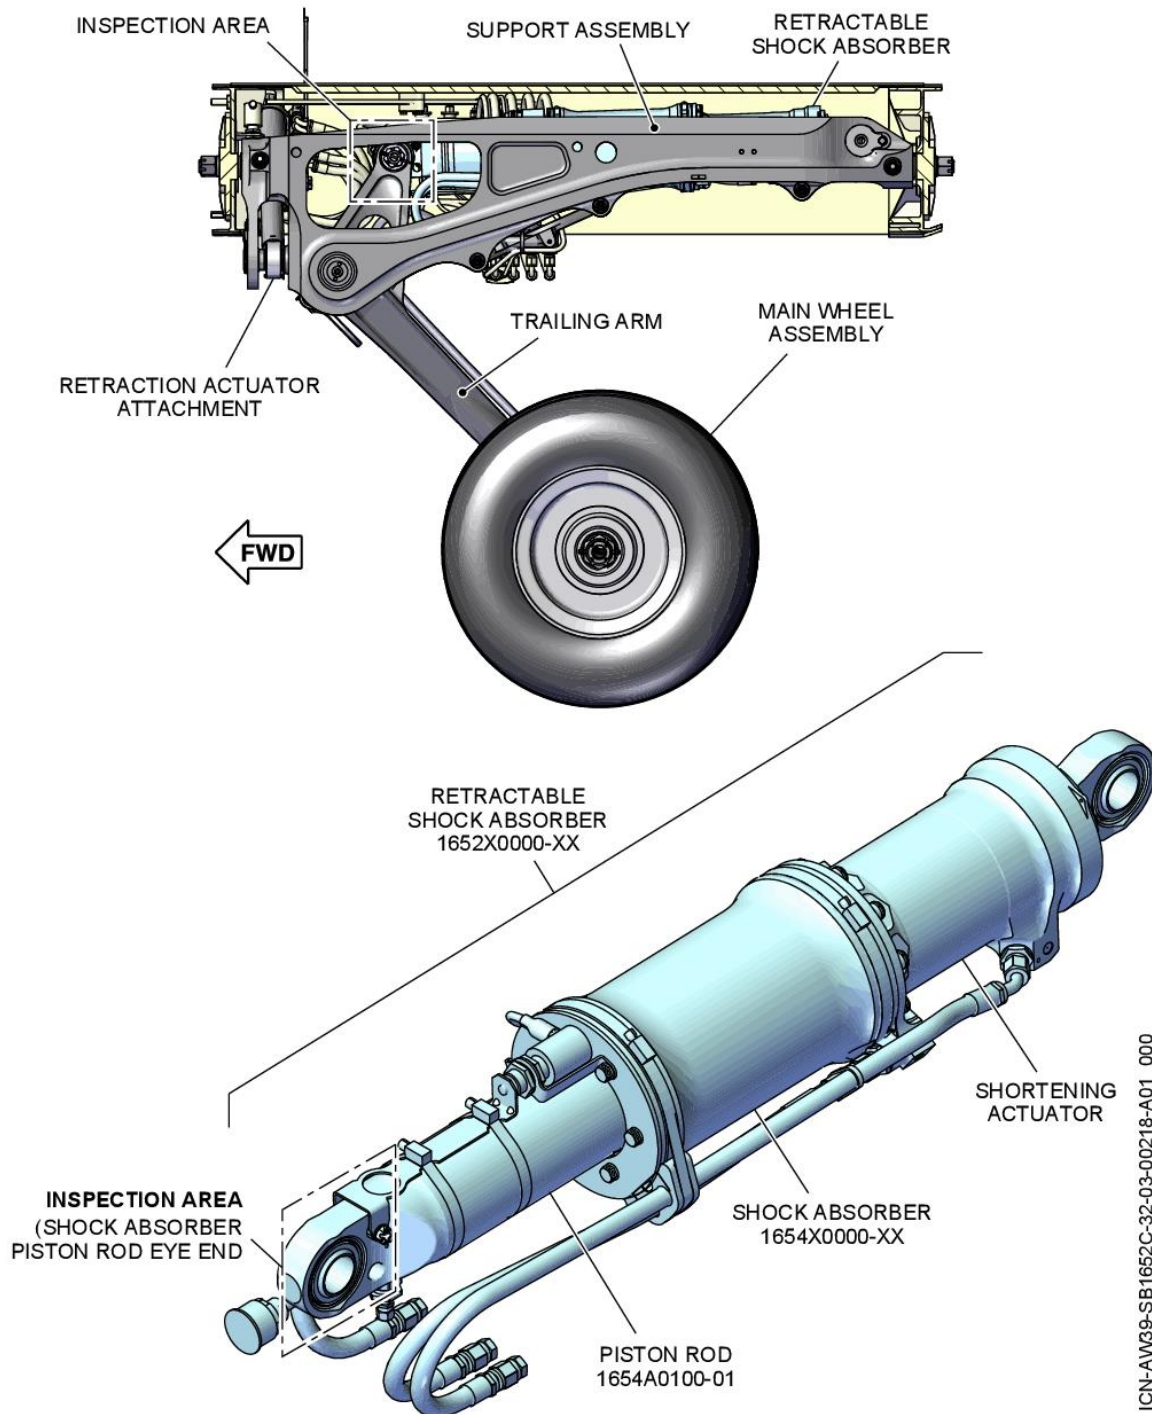
Ultrasonic Inspection of Shock Absorber Piston Rod Eye End  
Figure 1

The inspection is performed using the UT technique and focusing on the SA piston rod eye end to detect cracks development in two specific areas (refer to Figure 2 of LLI SB 1652C-32-03 in Annex A). In case of findings, it is needed to replace the SA with

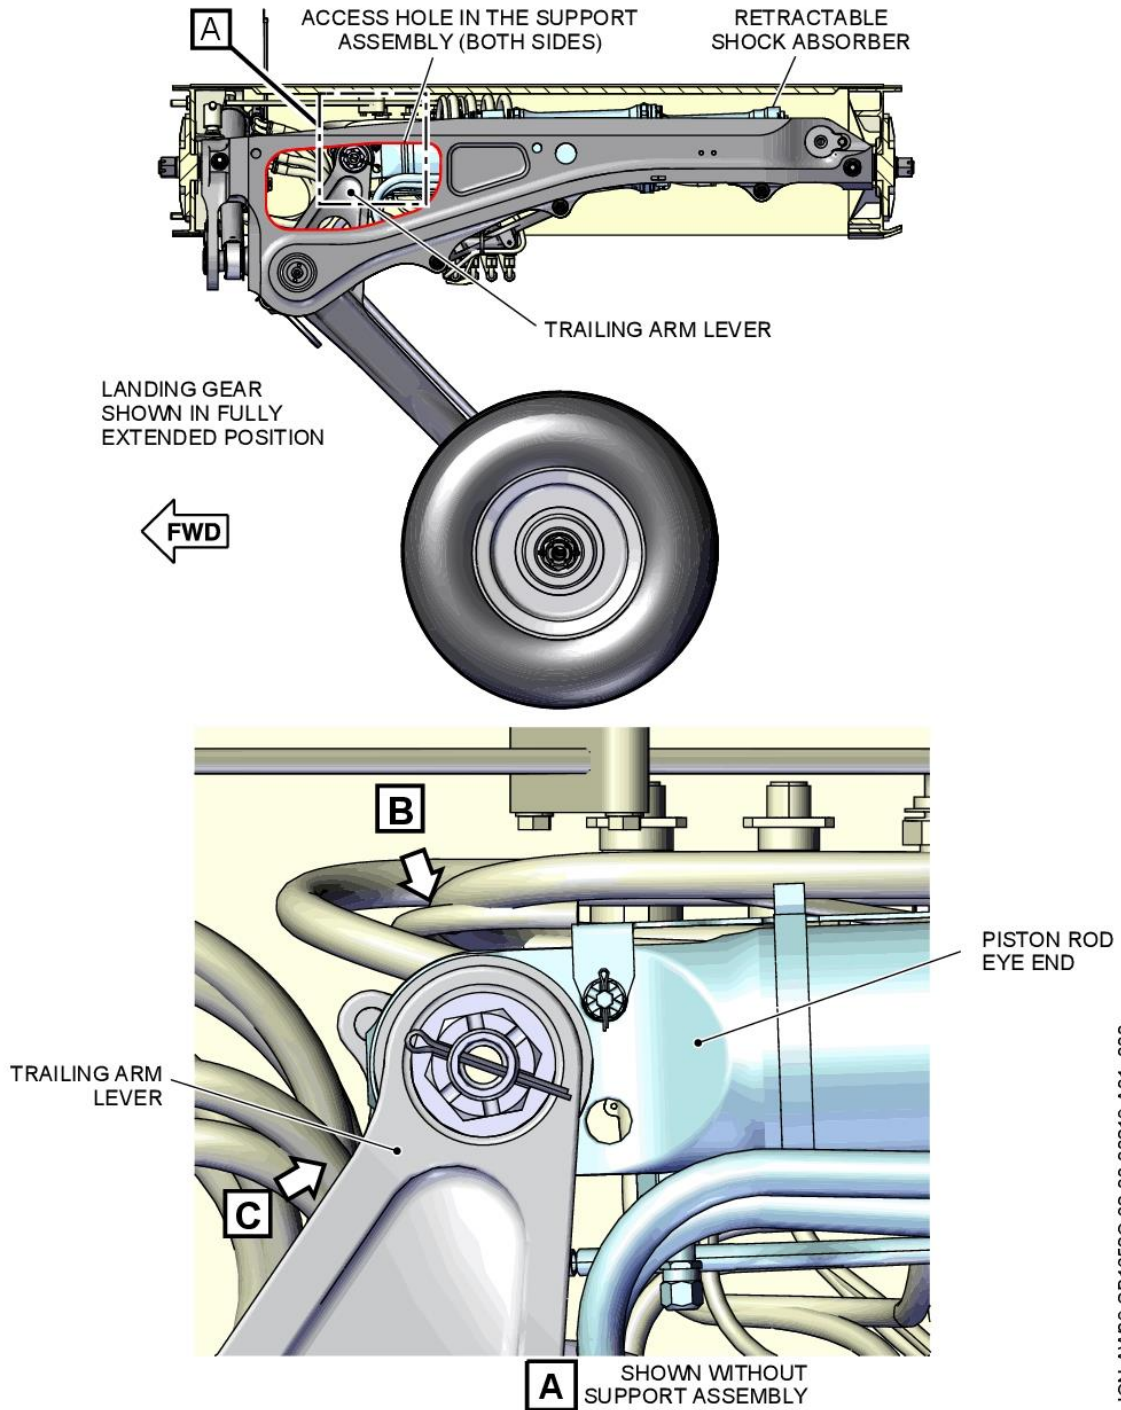
Inspection Area  
(Sheet 1 of 2)  
Figure 2

- (a) The Inspection Area is defined in [Figure 2](#) and [Figure 3](#). Two separate Inspection Areas are to be observed, one at the UPPER side and one at the LOWER side of the piston rod eye end. With the landing gear installed on the helicopter the Inspection Area is partially obstructed by surrounding structure. An inspection mirror and an inspection flashlight is inevitable to gain visibility access to the Inspection Area.

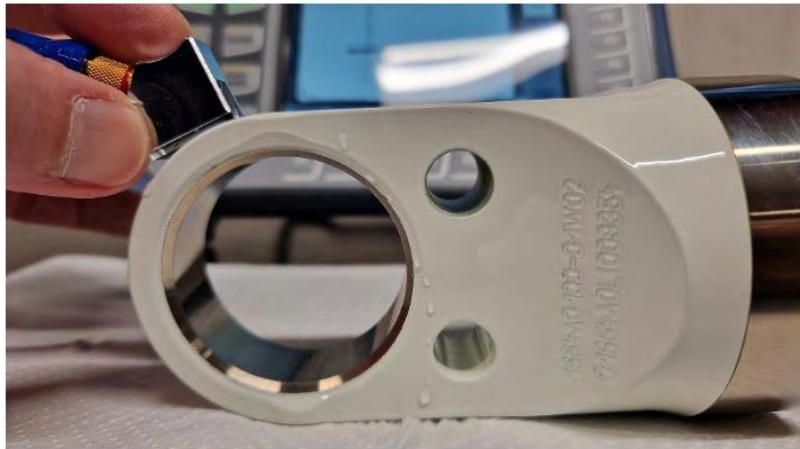
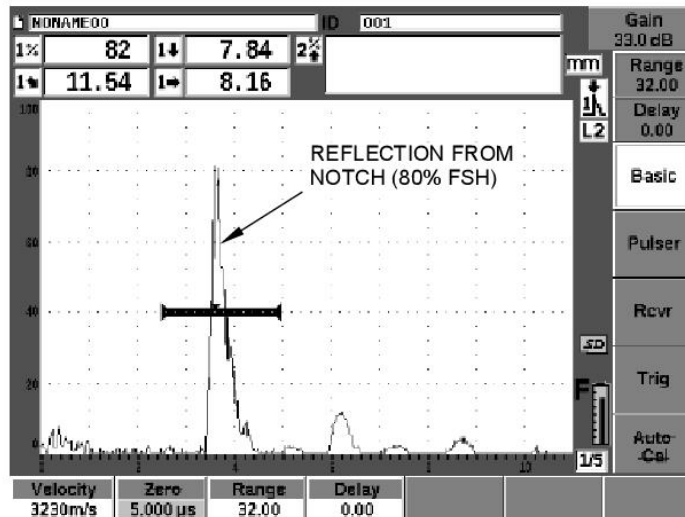
Calibration on the notch of Reference Specimen  
Figure 4

The Reference Specimen has two notches inside the main bore, one at the UPPER side and one at the LOWER side of the eye end. Each notch simulates a potential crack at the expected location. However, only one of the two notches is required for UT calibration purposes. The other notch is for back-up purposes only. The UT inspection of the Reference Specimen leads to an ultrasonic echo indication as shown in [Figure 4](#).

13 Check the calibration on the Reference Specimen PN 1654A0100-01W02 to verify that the amplitude of the notch indication is 80% FSH. If the check fails, repeat the sequence of operations in para. 3.C.(3) (a) and 3.C.(3) (b).

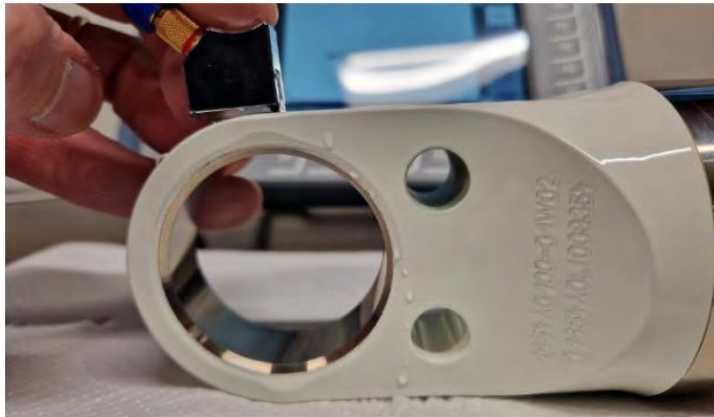
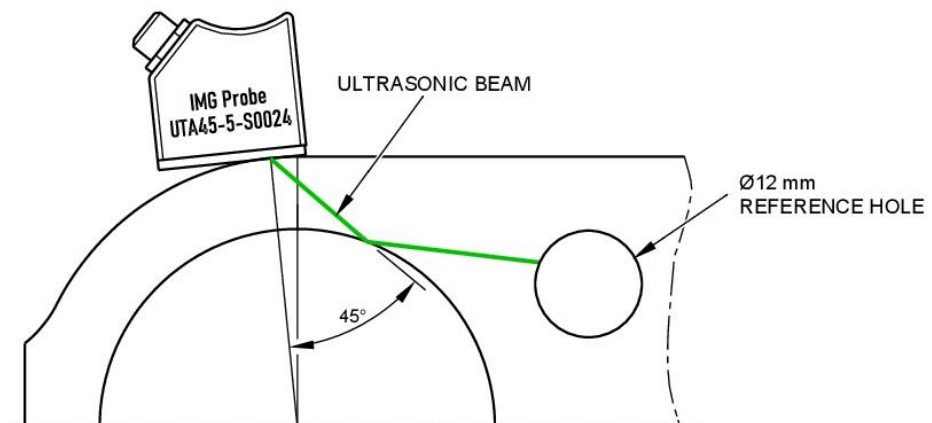
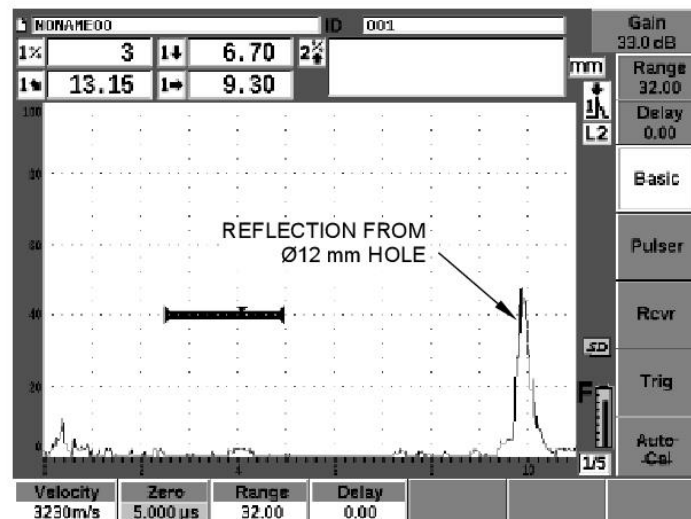
Ultrasonic indication from the 12 mm hole (starting point)  
Figure 5

11 Do the UT Inspection moving the sensor back and forth from the 12-mm hole indication (starting point) ([Figure 5](#)) to the end nose of the piston rod eye end ([Figure 7](#)) to detect a potential crack at the expected location (within the recording gate) on the Piston Rod PN 1654A0100-01. Observe the display of the Flaw Detector for indications within and above the Recording Gate.

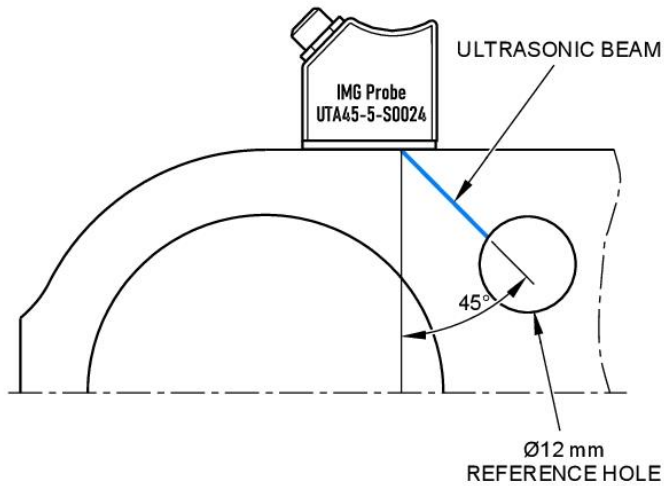
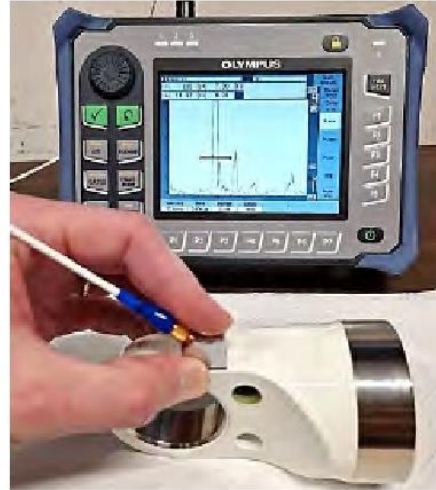
Example of wrong signal  
Figure 6

**WARNING:**  
PROBE BEYOND SCANNING AREA  
(FLAT AREA)

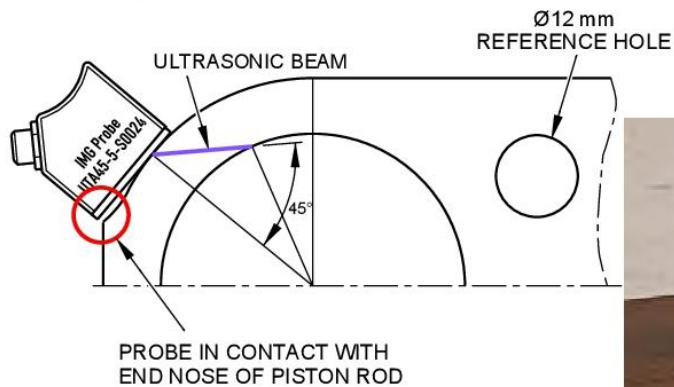
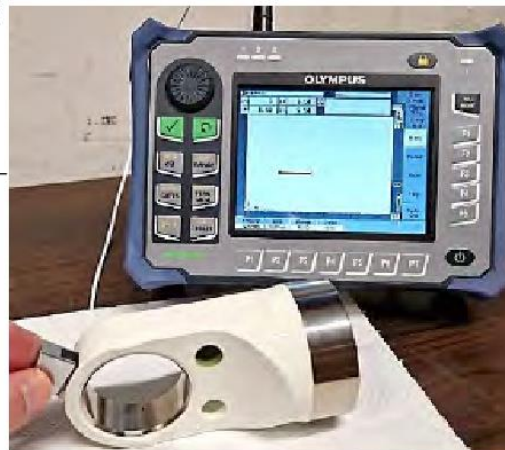
Probe in contact with the nose (End point)  
Figure 7

END POINT OF SCANNING AREA  
(NOSE END)
