**No. EC130-32A013**

# ALERT SERVICE BULLETIN

### LANDING GEAR - Skid type Landing Gear Inspection for corrosion on the landing gear

### No. EC130-32A013

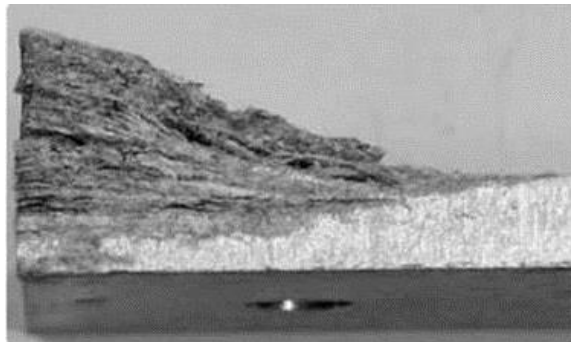
Figure 1

- . If you find at least one crack or leafing corrosion or exfoliant corrosion (Figures 1 and 2):

- .. Contact Airbus Helicopters at the address that follows to get a technical solution:

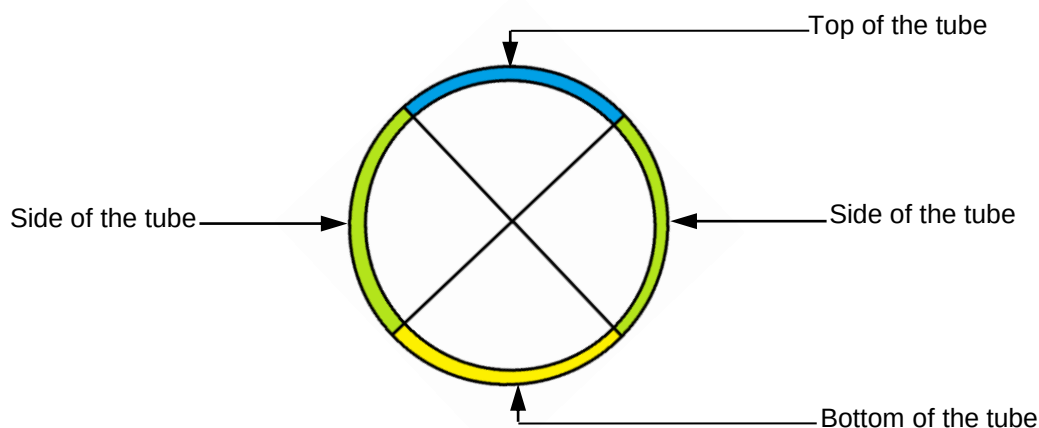
Figure 3

| Table 3 | | |
|---|---|---|
| M | Below the two half-bearings of the rear crossbeam (a). | Make sure that there is a minimum thickness of:<br>- 7.4 mm (.275 in.) on the top of the tube (Figure 3).<br>- 8.1 mm (.318 in.) on the sides of the tube (Figure 1).<br>- 8.4 mm (.330 in.) on the bottom of the tube (Figure 3). |

- If the corrosion is **not more than** the criteria in [Table 3](#):
  - . Comply with paragraphs [3.B.2.d.](#)
- If the corrosion is **more than** the criteria in [Table 3](#):
  - . Contact Airbus Helicopters at the address that follows to get a technical solution:
    - .. Airbus World: Technical Request Management <https://airbusworld.helicopters.airbus.com>
    - .. E-mail: [support.technical-airframe.ah@airbus.com](mailto:support.technical-airframe.ah@airbus.com)
    - .. Fax: + 33 (0) 4 42 85 99 66

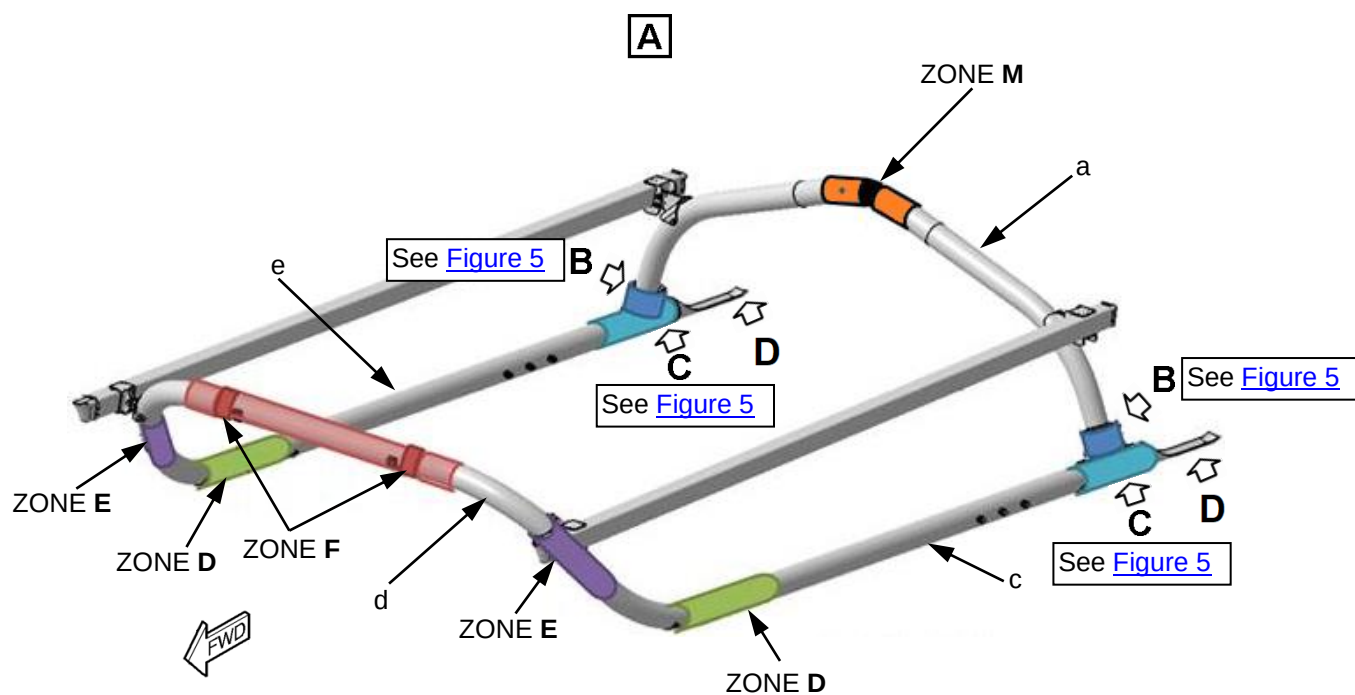
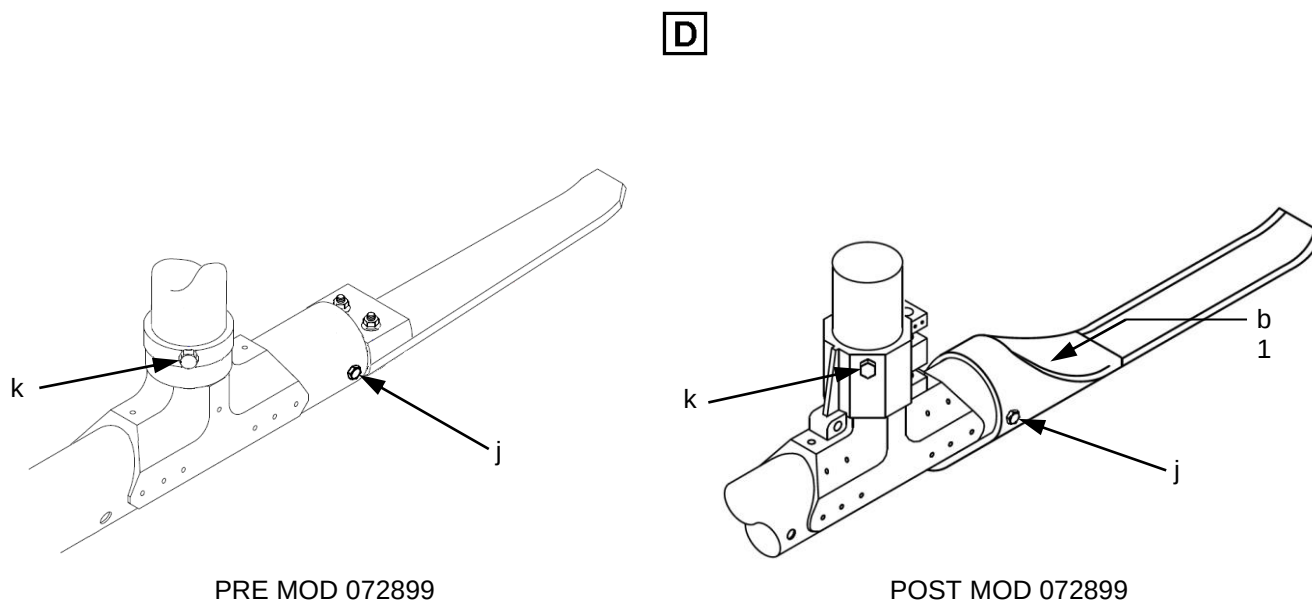
Figure 4

- With the borescope (zz), examine the inner side of the landing gear tubes (a), (c), (d) and (e) for corrosion and cracks. Refer to Detail A, [Figure 4](#), and to the criteria of [Table 3](#).

*To do the borescope inspection of the landing gear tubes (a), (c), (d) and (e), you can remove the screws (j) or the blanking cap assembly (b) (Detail D, [Figure 4](#)). Refer to the principle of Task 32-11-00, 4-2 (AMM).*

- .. Disassemble the landing gear. Refer to Task 32-11-00, 4-2 (AMM).
- .. Remove the corrosion from all the zones. Refer to Work Card 20-90-04-101 (MTC).
- .. Comply with paragraph [3.B.2.c.](#)

- .. Remove the corrosion from the zone. Refer to Work Card 20-90-04-101 (MTC).
- .. Comply with paragraph [3.B.2.c.](#)

- .. Install the screws (j) or the blanking cap assembly (b) or (1) and the screw (k). Refer to Task 32-11-00, 4-2 (AMM) (Detail D, [Figure 4](#)).
- .. Comply with paragraph [3.B.2.d.](#)

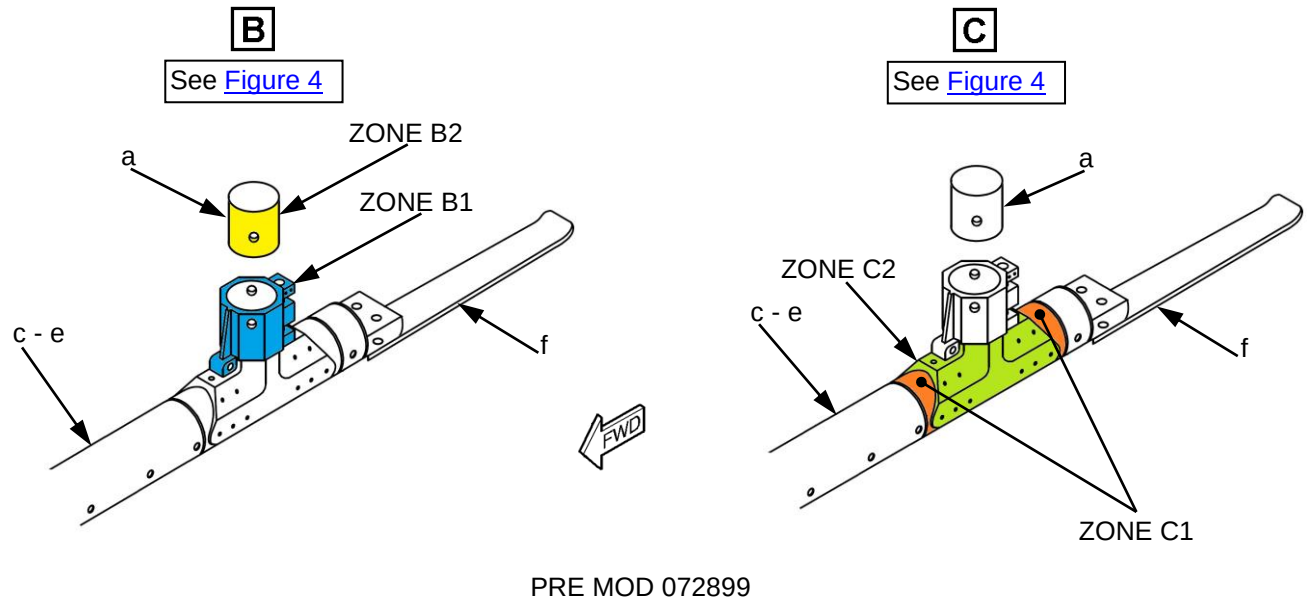
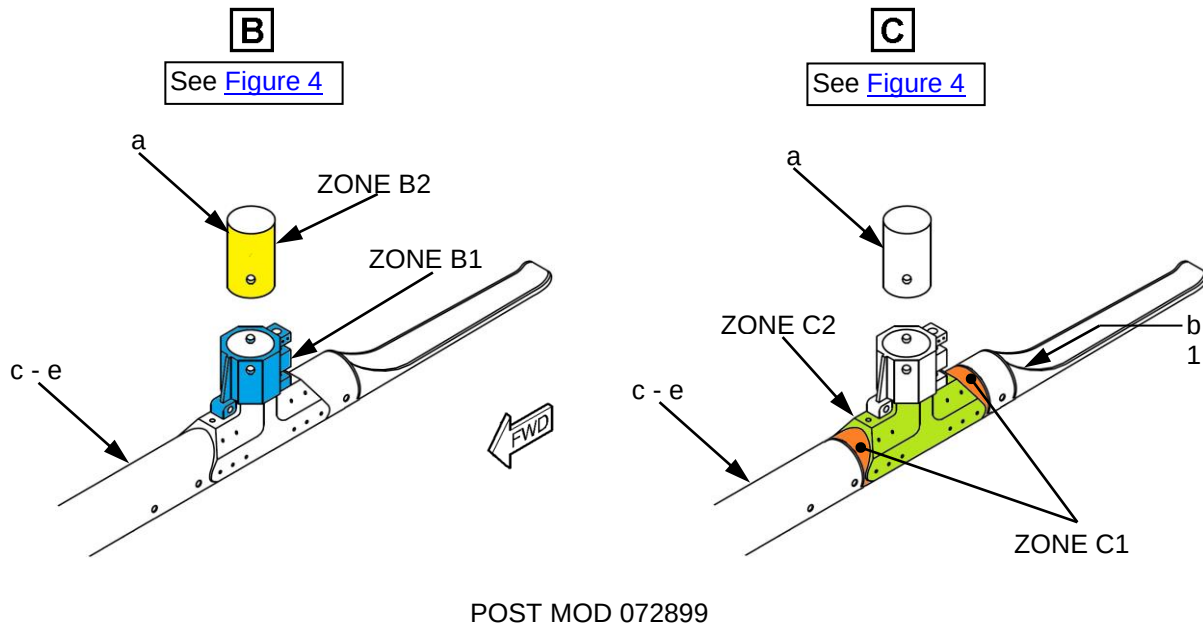
Figure 5

| Table 3 | | |
|---|---|---|
| B1 | On the LH/RH fitting, in the rear crossbeam (a) fitting zone (Detail B, <a href="#">Figure 5</a> ). | Make sure that there is a minimum thickness of 8.0 mm (.314 in.). |
| B2 | On the LH/RH rear crossbeam (a), in the fitting zone (Detail B, <a href="#">Figure 5</a> ). | Make sure that there is a minimum thickness of 7.3 mm (.287 in.). |
