# ALERT SERVICE BULLETIN

**TITLE:** Tail Rotor Drive - Shaft - Improved geometry of the tail boom rear drive shaft

| Model: | EC130 |
| Version: | T2 |

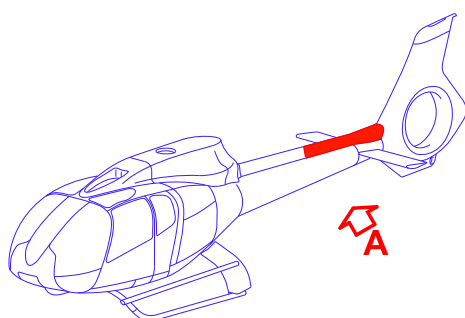
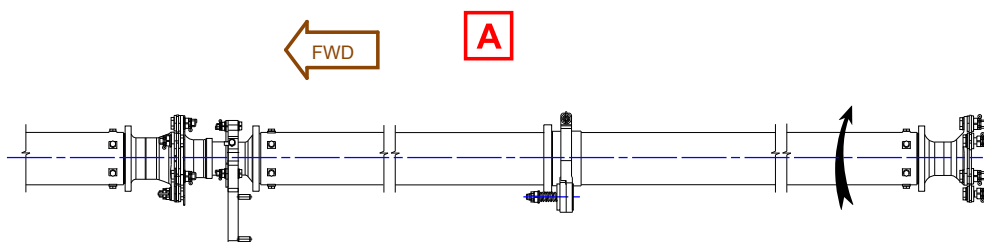
#### GENERAL ILLUSTRATION

Several in-service incidents were reported to AH concerning degradation of the intermediate tail drive shafts support on the H130 equipped with a new tail boom post ECP 079809 featuring a new tail drive shaft assembly with a single bearing. The damage consists of loose/failed rivets on the bearing support, in some limited cases occurrence of cracks in the supporting structure and occasional wear of the splines in the connection between the two drive shafts. AH had initiated extensive investigations and identified the root cause of these events. As a corrective measure, the main objective of this ALERT SERVICE BULLETIN is to replace the current tail boom rear drive shaft by a new rear drive shaft with an improved geometry.

This ALERT SERVICE BULLETIN provides the instruction to the replacement of the tail boom rear drive shaft.
