**Gegenstand:** Lager der Handsteuerung

| Scheibe- Flugzeugbau GmbH<br>August- Pfaltz- Str. 23<br>85221 Dachau<br><br>LBA- Anerkennung I- EB 2 | <b>Technische Mitteilung 653-47/ 2</b><br><br> | <b>SF 25C:</b> Änd. 86, 109<br><b>SF 25 E:</b> Änd. 38, 42<br><b>SF 25 K:</b> Änd. 1<br>Gerätenr.: 653<br>Blatt 2 von 2 |

| Scheibe- Flugzeugbau GmbH<br>August- Pfaltz- Str. 23<br>85221 Dachau<br><br>LBA- Anerkennung I- EB 2 | <p style="text-align: center;"><b>Service Bulletin 653-47/ 2</b></p> <p style="text-align: center;"></p> | <p><b>SF 25C:</b> Modification 86, 109<br/> <b>SF 25 E:</b> Modification 38, 42<br/> <b>SF 25 K:</b> Modification 1<br/> TCDS-N° 653<br/> Page 1 of 2</p> |

**Subject:** Bearings in the control stick

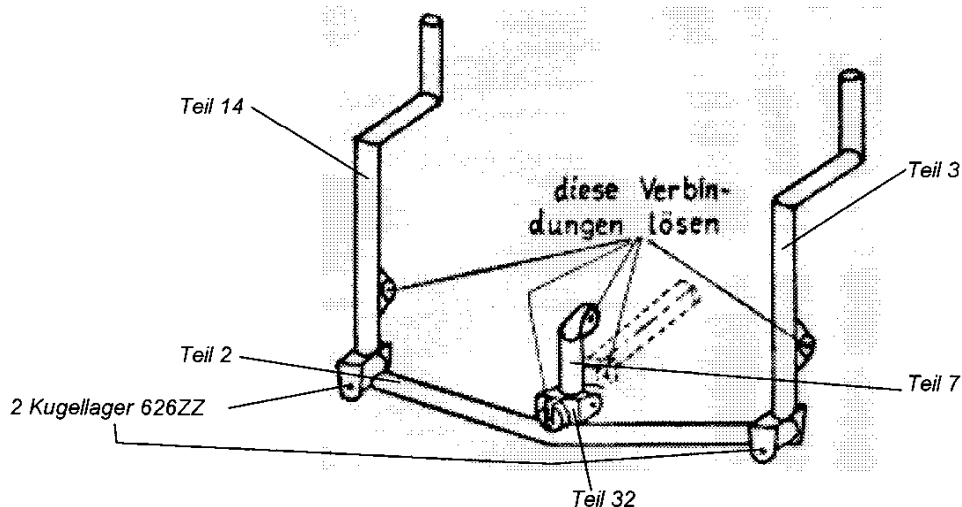
**Dringlichkeit:** a) Sofort, wenn an einer Lagerstelle der Handsteuerung nach bei liegender  
Skizze noch 2-reihige Pendelkugellager 14C6 eingebaut sind oder  
b) wenn die mit TM 653-47 vorgeschriebenen Lager GE8E im Schadensfall  
ersetzt werden müssen.

**Vorgang:** Die mit TM 653-47 eingerüsteten Lager GE8E verschleifen sehr schnell.  
Außerdem sind diese Lager nicht mehr erhältlich.  
Sollen diese Lager erneuert werden, ist daher die gesamte Handsteuerung  
(Teil 2, 3, 7, und 14 aus 653E-41-S10) auf den neuen Musterstand nach  
653E-41-S10 Änd. d in Verbindung mit Teil 32 nach 653E-41-S10 E1 zu  
ändern.

**Maßnahmen:** An den Teilen 2, 3, 7 und 14 (siehe nachfolgende Abbildung) aus Zeichnung  
653E-41-S10 sind neue Lagerringe entsprechend den Zeichnungen  
653E-41-S10 Änd. d und 653E-41-S10E1 anzuschweißen.  
Anstelle des bisherigen Teil 33 aus 653E-41-S10 ist zwischen Teil 2 und  
Teil 7 das Teil 32 aus Zeichnung 653C-41-S10E1 einzubauen  
Bis auf das Lager 14C8 auf Teil 2 sind alle anderen Lager als Gleitlager  
ausgeführt (1x SSCP 8 IH und 2x SSCP 6 IH). Alle Gleitlager sind mit  
Loctite 270 eingeklebt und mit jeweils 2 Seegerringen gesichert.  
Zusätzlich sind die 4 Lager 626 ZZ in Teil 2 aus 653E-41-S10 zu erneuern.

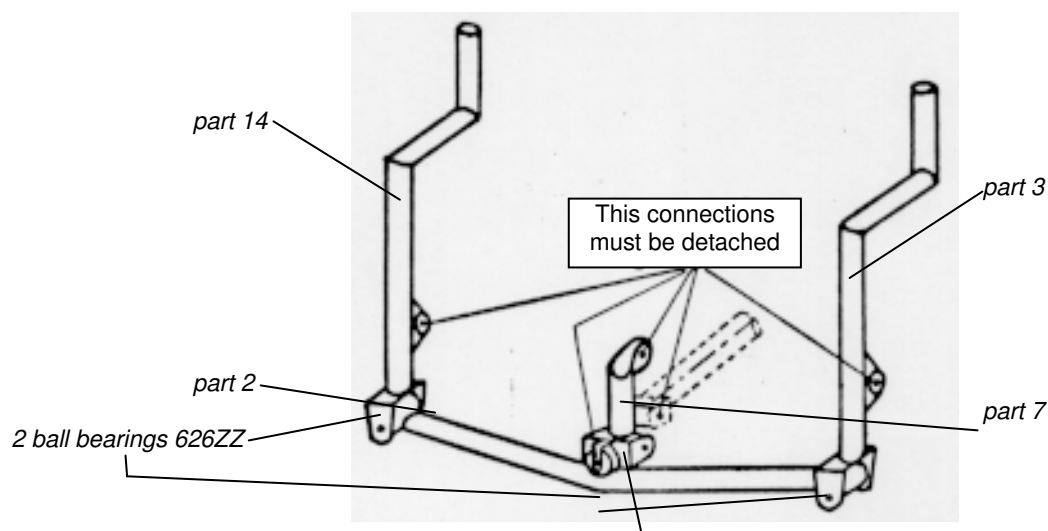
**Urgency:** a) Before the next flight, if a double-row self aligning ball bearing 14 C 6 is to be found in the control column parts 2, 3, 7 and/or 14 (see below sketch) or  
 b) when the spheric slide bearings GE 8 E installed in accordance with TM 653-47 are worn out and must be replaced.

**Reason:** The spheric slide bearings GE 8 E according to TM 653-47 wear out very soon and are no longer obtainable.  
 If these spheric slide bearings must be replaced, the complete control column (Parts 2, 3, 7 and 14 according to 653E-41-S10 and part 32 according to 653E-41-S10E1) must be modified according to 653E-41-S10 change d.

**Actions:** New slide bearing supports must be welded to the parts 2, 3, 7 und 14 (see below sketch) according to 653E-41-S10 change d and 653E-41-S10E1.  
 The old Part 33 of 653E-41-S10 located between part 2 and 7 is to be replaced by the new part 32 according to 653E-41-S10E1.  
 With the exception of the spheric ball bearing 14 C 8 at part 2 of 653-41-S10E1 all the other bearings are spheric slide bearings (1x SSCP 8 IH und 2x SSCP 6 IH). All the slide bearings are fixed with Loctite 270. Apply 2 new chime rings at each bearing.  
 Replace the additional 4 ball bearings 626 ZZ at part 2 of 653E-41-S10.
