# REPAIR INSTRUCTION NO. RI-1078-95/1

G 115E / EG all as affected

Repair of hinge bracket attachment points – ELEVATOR and HORIZONTAL STABILIZER

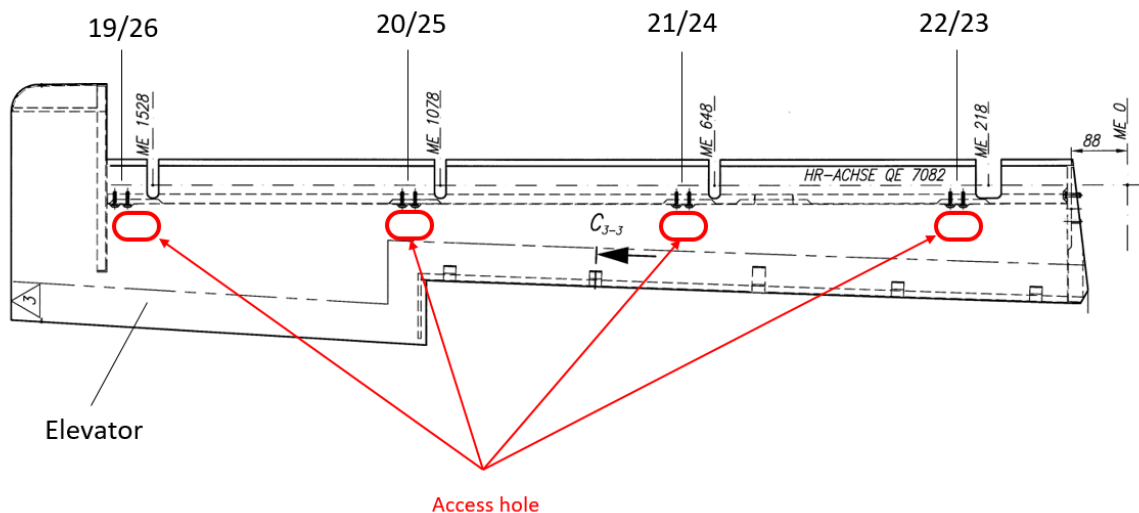
**Figure 1: Elevator Access Holes and Hinge Bracket Locations (LH shown, RH mirrored)**

- 7.1.1 Make the aircraft safe for parking, refer to AMM Chapter 10-10.
- 7.1.2 Remove the elevator, refer to AMM Chapter 55-20.
- 7.1.3 Remove the affected hinge bracket from the elevator. Discard the lock nuts.
- 7.1.4 Cut an access hole into the elevator surface as small as practical, refer to Figure 1. Grob recommends to cut the access holes into the lower elevator surface.

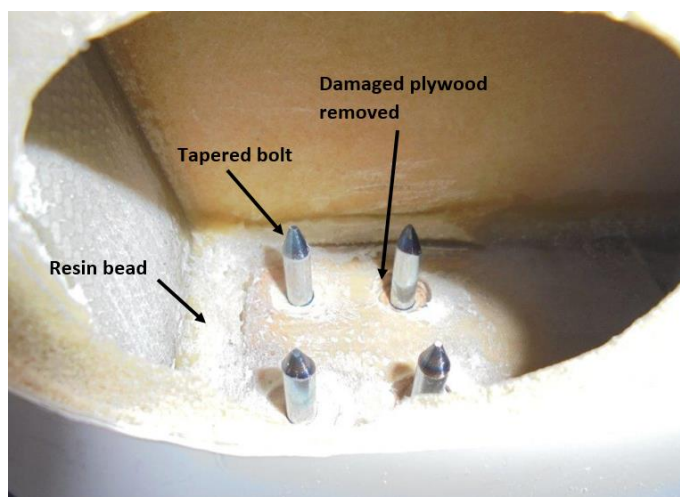
**Figure 2: Insert damage removed and tapered bolts installed**

- 7.1.9 Remove the grinding dust with a vacuum cleaner.
- 7.1.10 Install four tapered bolts through holes in the spar. Wax the tapered bolts with release agent e.g. QZ5111 before installation. The tapered end must point to the inside of the elevator, refer to Figure 2. Verify that the repair plate fits in the repair area properly. If required, trim the repair plate to fit. Refer to Figure 1 and Table 1 for the P/N of the Repair Plate.
- 7.1.11 If required, fill-out the holes where the damaged insert material was removed with thickened resin. Use GS510020-13 with 15-20% cotton flocks GS510060 and 2-3% Aerosil GS510063.
- 7.1.12 Remove the part number label from the respective repair plate. Make sure to remove any remaining adhesive of the part number label from the repair plate.
- 7.1.13 Apply thickened resin to the repair plate and to bonding area, refer to Figure 3.

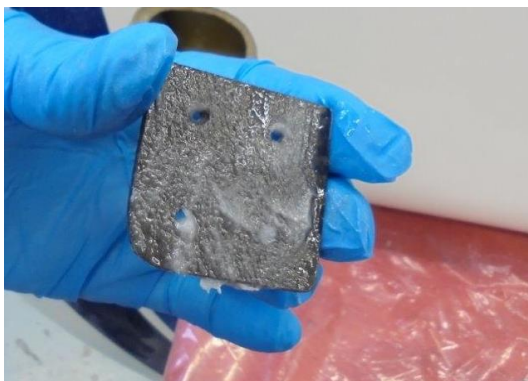
**Figure 3: Thickened resin applied to CFRP repair plate**

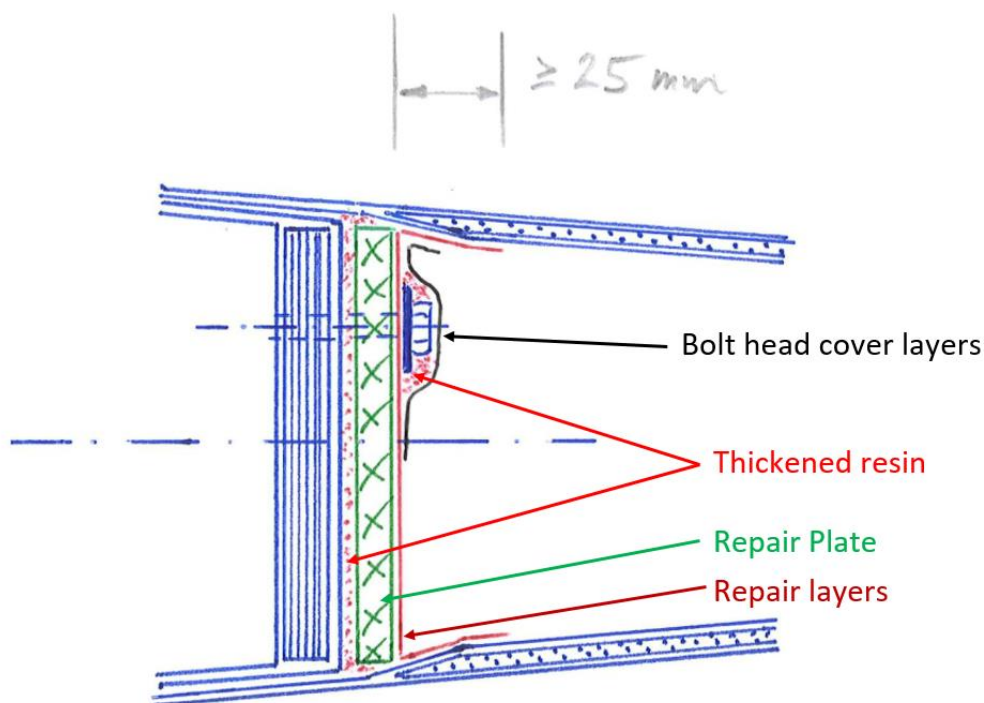
**Figure 4: Repair schematic elevator**

- 7.1.14 Bond the repair plate with the non-chamfered side through the tapered bolts on top of the repair. If required, smoothen out the excessive resin at the edges of the repair plate to gain a transition to the spar.
- 7.1.15 Cover the insert along the spar with two layers of glass fabric GS510031  $\pm 45^\circ$ , refer to repair schematic in Figure 4.

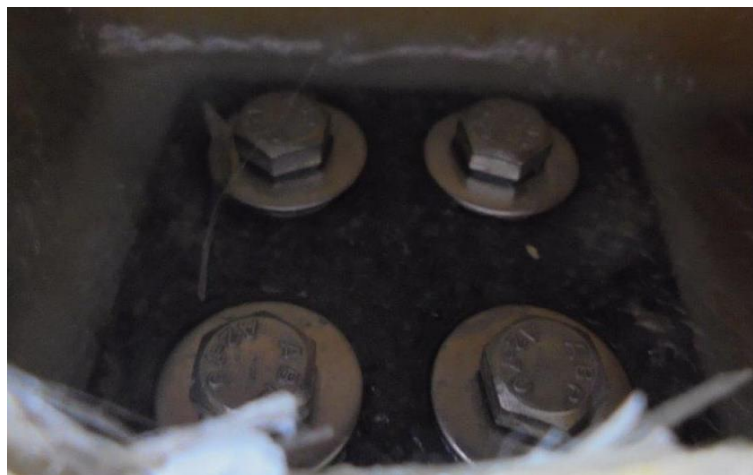
**Figure 5: Bolts and washers installed**

- 7.1.16 Remove the tapered bolts.
- 7.1.17 Install four washers (item 9 of List 9) and four bolts (refer to Table 1 for the P/N of the bolts), refer to Figure 5. If required, clean the thread of the bolts from resin.

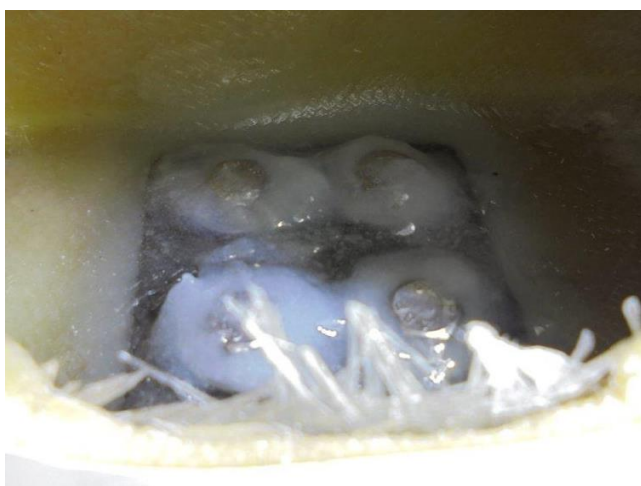
**Figure 6: Thickened resin around bolt heads and washers with covering layers of glass fabric**

- 7.1.18 Re-install the removed hinge bracket to the leading edge rib with the previously removed washers and standard M5 nuts. Tighten the nuts by hand just to keep the bolts heads and washers in position. If required, the length of the bolts shall be adjusted by additional washers under the nut, refer to IPC.
- 7.1.19 Apply thickened resin around the bolt heads and washers and cover the repair with two layers of glass fabric GS510031  $\pm 45^\circ$ , refer to Figure 6.

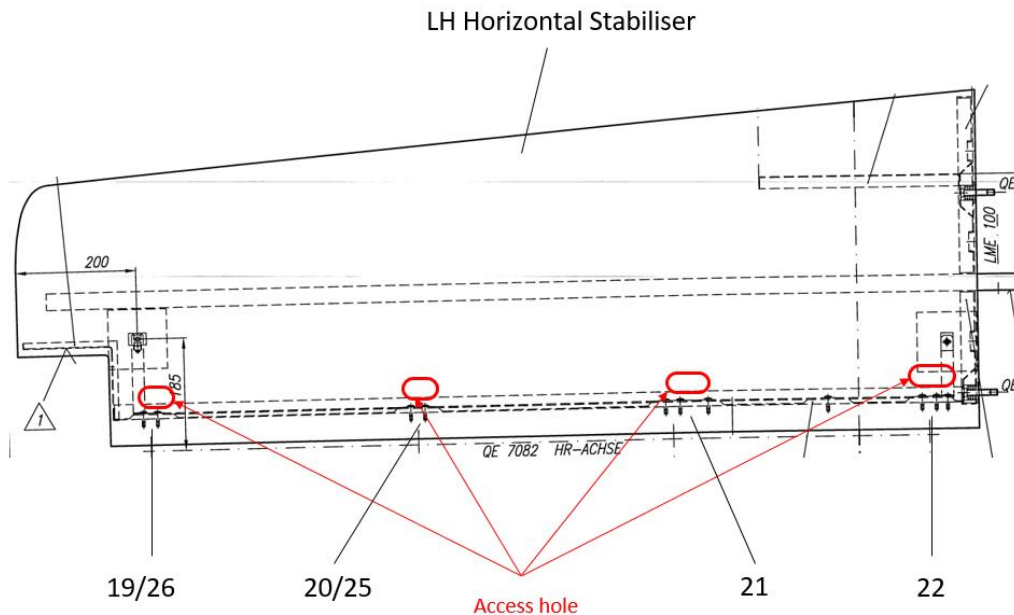
**Figure 7: LH Horizontal Stabiliser Access Holes and Hinge Bracket Locations**

- 7.2.1 If required, make the aircraft safe for parking, refer to AMM Chapter 10-10.
- 7.2.2 If required, remove the elevator, refer to AMM Chapter 55-20.
- 7.2.3 Remove the affected hinge bracket from the horizontal stabiliser. Discard the lock nuts.
- 7.2.4 If required, cut an access hole into the horizontal stabiliser surface as small as practical, refer to Figure 7. Grob recommends to cut the access holes into the lower stabiliser surface.

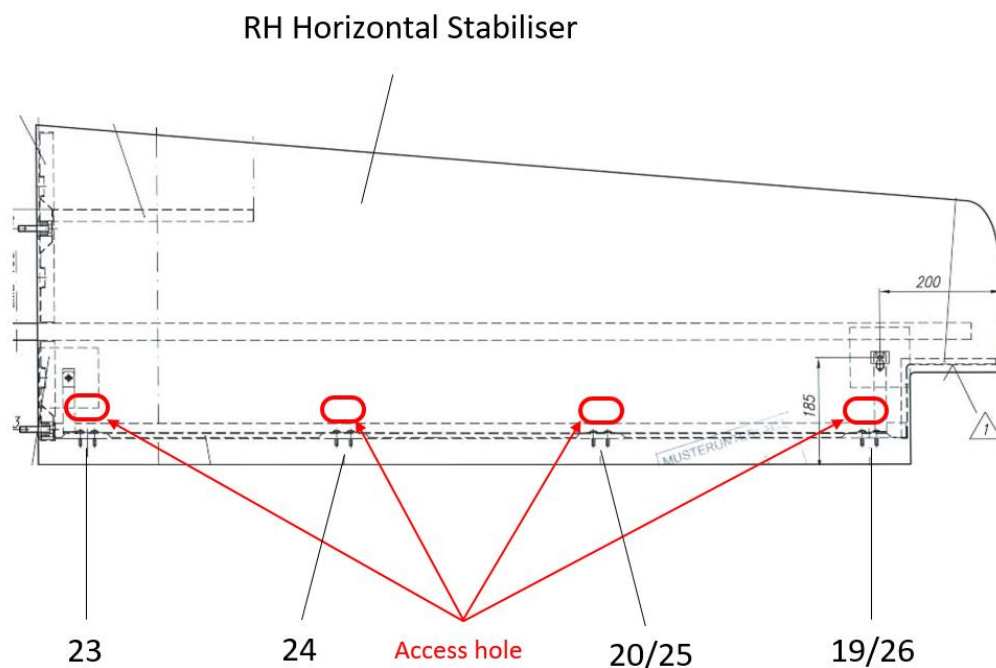
**Figure 8: RH Horizontal Stabiliser Access Holes and Hinge Bracket Locations**

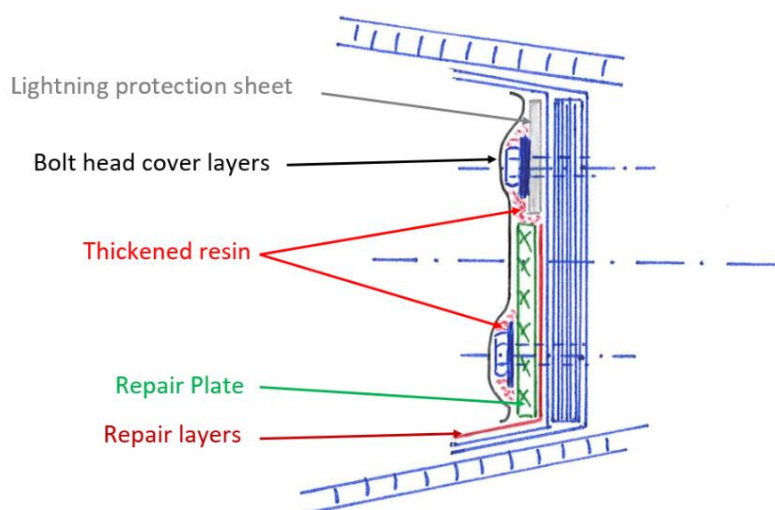
**Figure 9: Repair schematic horizontal stabiliser**

- 7.2.12 Cover the insert along the spar with four layers of carbon fabric GS510040  $\pm 45^\circ$  (stagger the layers in span wise direction), refer to Figure 9.

- 7.2.14 Apply thickened resin to the repair plate and to bonding area, refer to Figure 3.
- 7.2.15 Bond the repair plate with the non-chamfered side through the tapered bolts on top of repair, refer to Figure 9. Smoothen out the excessive resin at the edges of the repair plate to gain a transition/chamfer to the spar.

- 7.2.19 Do a bonding check, refer to AMM 51-80.
- 7.2.20 Apply thickened resin around the bolt heads and washers and cover the repair with two layer of glass fabric GS510031  $\pm 45^\circ$ , refer to Figure 9.
