# SERVICE BULLETIN

DATE: 24 MARCH 2021

## INSPECTION OF THE PILOT-TO-COPILOT TAIL ROTOR TORQUE TUBE

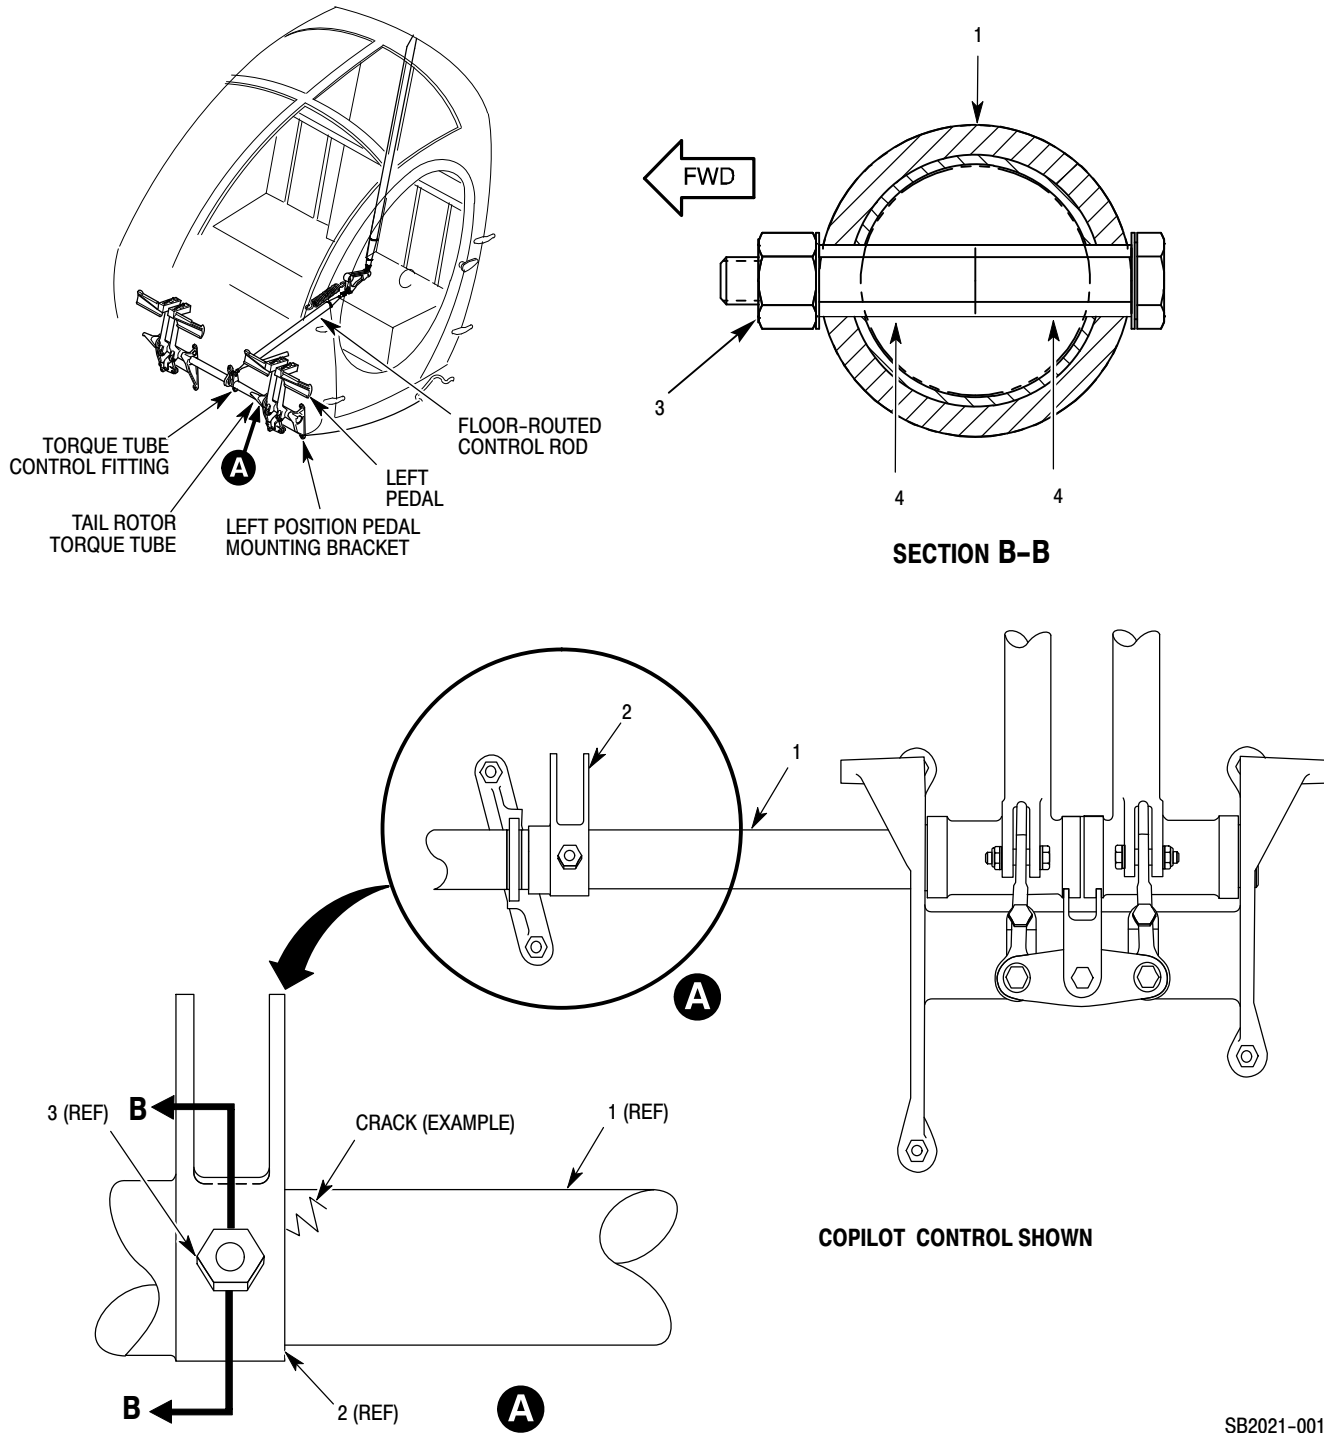
**Figure 1. Borescope Inspection of the Torque Tube**

MDHI has received a 369H7531 pilot-to-copilot tail rotor torque tube with a significant spiral crack that seems to have originated from a hole where the tail rotor torque tube control fitting attaches to the torque tube. The crack caused reduced directional control pedal authority.

- (1). Get access to the inspection area, as necessary.
- (2). Examine the exterior of torque tube (1) with a bright light and a mirror for cracks, elongation, and other damage.

- (3). Examine the interior of torque tube (1) with a borescope for cracks, elongation, and other damage.
  - (a). Fully examine the area around the interface of torque tube (1) and bushing segments (4).
  - (b). Replace a torque tube with cracks, elongation, or damage. (Ref. CSP-HMI-2, 67-20-10, Removal / Installation, procedures 5. or 6.)
- (4). Examine the tail rotor torque tube interior with a borescope at every 300-hour inspection.
