**SERVICE BULLETIN****REVISION NOTICE****FLIGHT CONTROLS - NON-DESTRUCTIVE INSPECTION (NDI) OF 374461-5, -7, AND -11 ELEVATOR BOOSTER FOR ACTUATOR CRACKS**

**SERVICE BULLETIN****FLIGHT CONTROLS - NON-DESTRUCTIVE INSPECTION (NDI) OF 374461-5, -7, AND -11 ELEVATOR BOOSTER FOR ACTUATOR CRACKS**

**382-27-51**

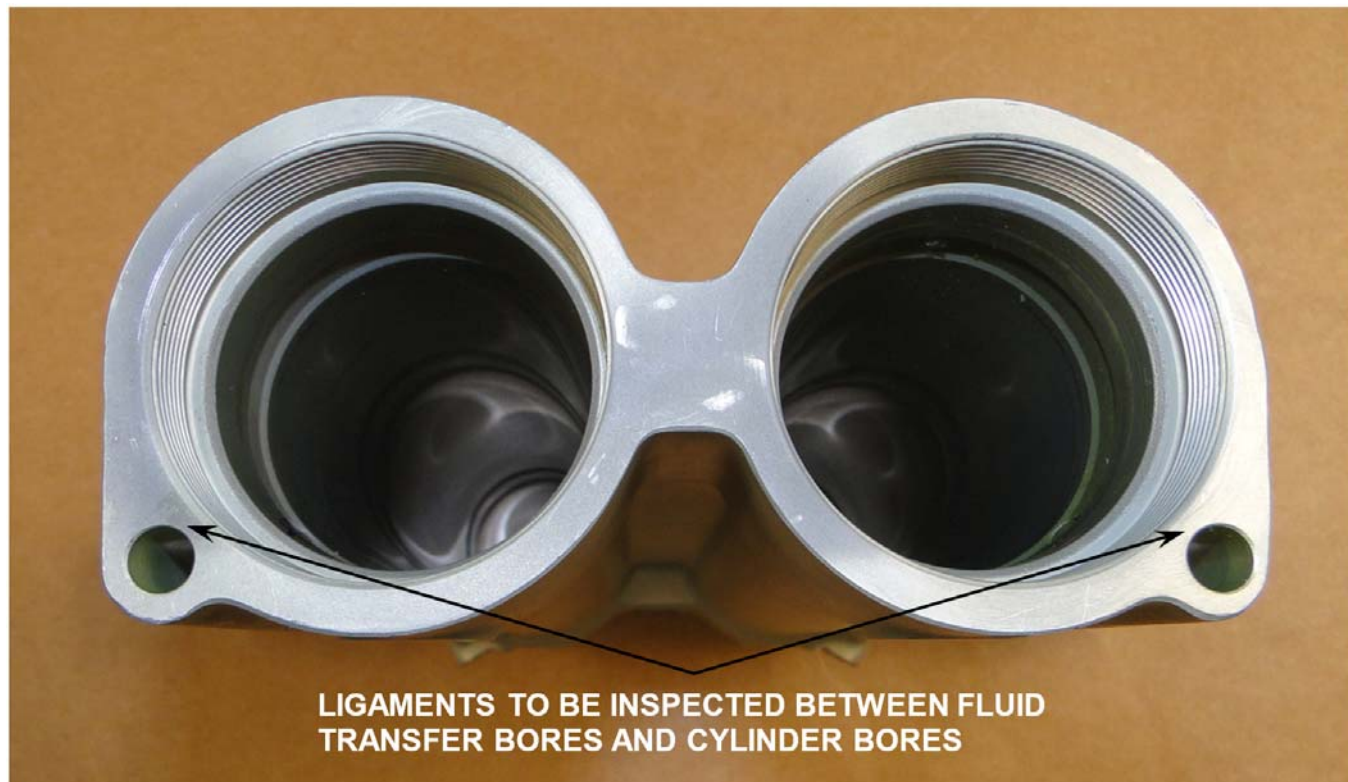
Disassembled Elevator Booster Assembly with Ligaments of Interest Noted  
Figure 2

2. **DESCRIPTION:** The elevator booster actuator contains small diameter fluid passageways connected to the main piston bores by small diameter diagonal bores drilled at 45-degree angles to the noted piston bores. These angled passageways are susceptible to fatigue cracking which initiates at the corners of the diagonal bore and propagates through the cylinder wall.

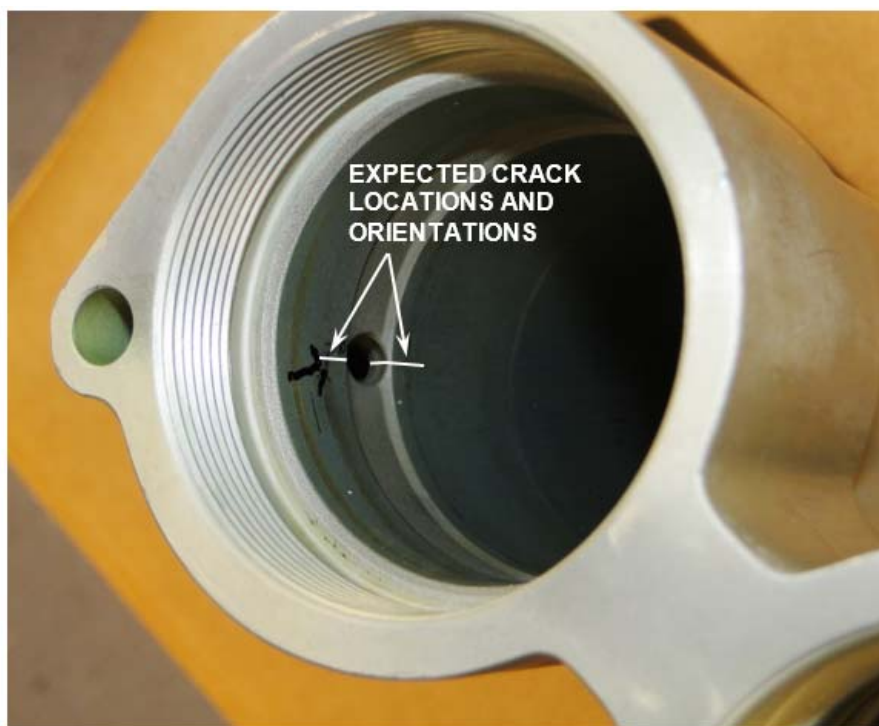
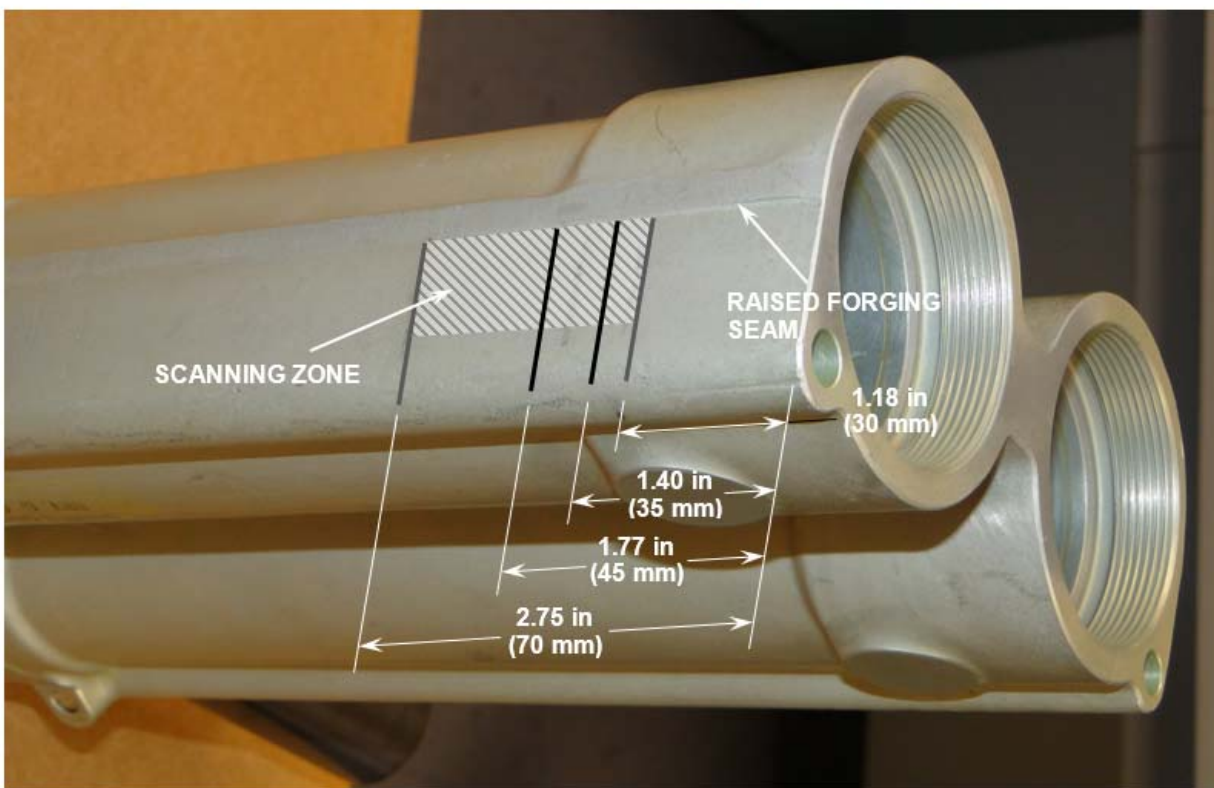
Expected Crack Location and Orientation, Common to Main Cylinder Bore and Diagonal Bore, and Measurements Identifying Diagonal Bore Location and Scanning Zone  
Figure 3

3. **DEFECTS:** Cyclic loading may result in fatigue cracks initiating at the corners of the diagonal bore, located between the fluid transfer bore and main cylinder bore, and propagate in an approximate fore-aft direction along the ligament between the noted bores. See Figure 3 for the expected location and orientation of fatigue cracking in the elevator booster assembly.

- (a) Measuring from the forward-most end of the cylinder, mark two lines at 1.40 and 1.77 inches (35 and 45 mm) on the outside of the cylinder. These markings identify the location for transducer placement when establishing the signal response from the diagonal bore. See Figure 3. The location of the diagonal bore, measured at the interior cylinder bore, is located from approximately 1.20 to 1.53 inches (30.5 to 38.8 mm) from the forward-most end of the cylinder.

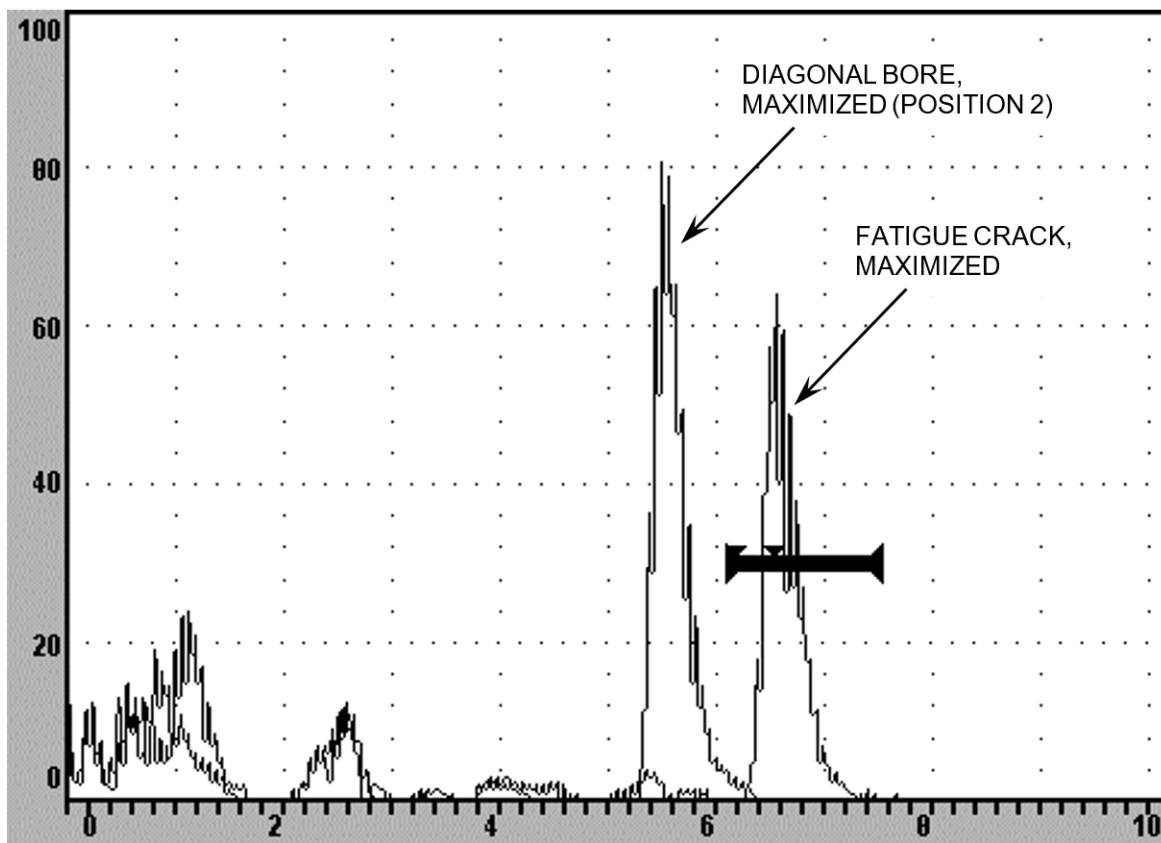
Ultrasonic Signal Responses During Calibration and Inspection  
Figure 5, Sheet 2

- (c) A simultaneous reduction in the diagonal bore signal response at approximately 55 percent FSW (5.5 TB) and an increase in the fatigue crack response at approximately 65 to 70 percent FSW (6.5 to 7 TB) will indicate a fatigue crack in the cylinder. See Screen Display 2 in Figure 5, Sheet 2 for a typical signal response from fatigue cracking.

- (1) Fatigue crack indications will be observed as a simultaneous reduction in the diagonal bore signal response at approximately 55 percent FSW (5.5 TB) and an increase in the fatigue crack response at approximately 65 to 70 percent FSW (6.5 to 7 TB). See Screen Display 2 in Figure 5, Sheet 2 for the expected signal responses from the diagonal bore and typical fatigue cracking.

- (3) Reject Criteria: Any fatigue crack response, located at approximately 65 to 70 percent FSW (6.5 to 7 TB), and greater than 30 percent FSH will be considered a rejectable defect and shall be further reported. A confirmed rejectable defect will require replacement of the elevator booster assembly.

Screen Display 2: Maximized Signal Response from Diagonal Bore and Typical Maximized Crack Response Exceeding 30 Percent Gate.

- G. RC - If a crack is detected on either actuator cylinder, proceed as follows:
  - (1) Prior to next flight, replace elevator booster. Refer to appropriate Hercules Maintenance Manual.

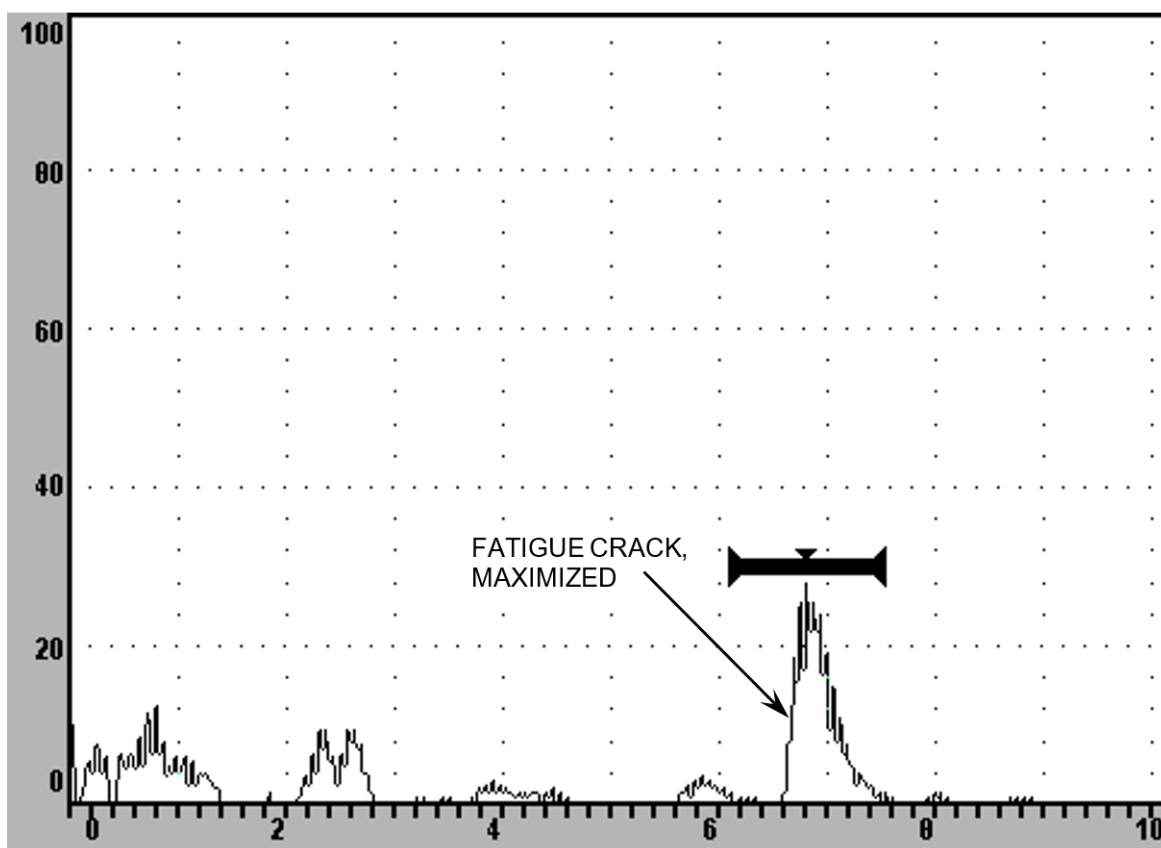
Ultrasonic Signal Responses During Calibration and Inspection  
Figure 5, Sheet 3

- (2) Accept Criteria: Any fatigue crack response, located at approximately 65 to 70 percent FSW (6.5 to 7 TB), and less than 30 percent FSH will be considered an acceptable defect and shall be further reported. See Screen Display 3 in Figure 5, Sheet 3 for the maximum allowable signal response for fatigue cracking. A confirmed acceptable defect will allow for continued use of the elevator booster assembly.

Screen Display 3: Maximum Allowable Crack Response Below 30 Percent Gate.
