## Service Bulletin

**EPB.02.B**

### Inspection of the propeller hub

Variant: ELPROP 3-1-1P

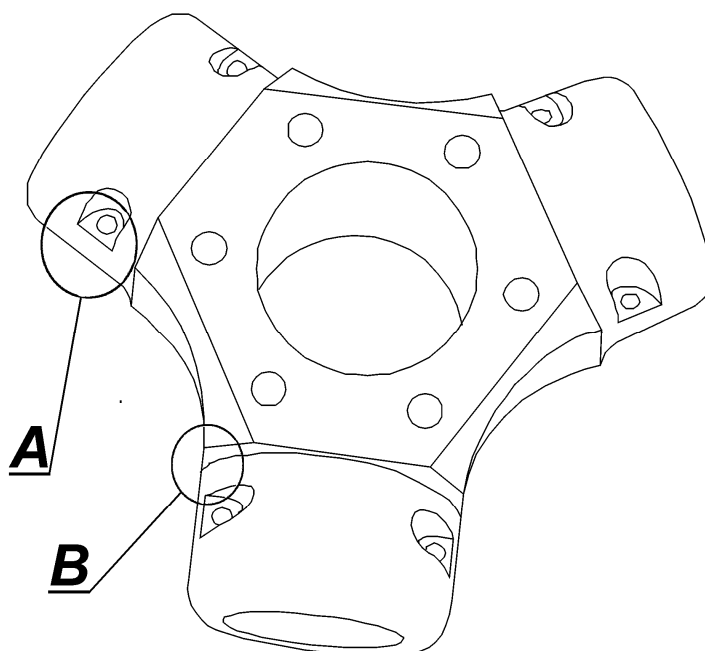
**Fig.1. Places where cracks occur.**

Cracks occurred at bolts securing the blades, see area A Fig.1 and on blade area, see area B Fig.1. Cracks occurred after several hundred operating hours of the propeller.

Following factors contribute to hub crack occurrence:

- exceeding the maximum value of torque applied to bolts that secure the propeller and bolts that secure propeller blades.
- uneven tightening of propeller bolts.
- operation with high level of vibration, unbalanced or damaged propeller, non-linear tracking, etc.

- Remove the spinner as per Airplane Maintenance Manual.
  - Check the condition of the blades.
  - With the use of 5x magnifying glass visually inspect the condition of the front and the back part of the hub, look for possible cracks. Pay special attention to areas A and B as shown on Fig.1; inspect areas next to each blade.
  - Check the condition of the blade bolts and nuts.
  - Check the position of the washers under the nuts and bolt heads, Fig. 2.
- Correctly positioned washers point with their rounded edge towards the hub. If any of the washers is incorrectly positioned, carry out the activities according to point 5.2 of this bulletin.

- Take the propeller out of service.
- Immediately inform the propeller manufacturer and provide required information as per point 5.6 of this bulletin.

- Remove the spinner as per Airplane Maintenance Manual.
- Check the condition of the blades.
- With the use of 5x magnifying glass visually inspect the condition of the front and the back part of the hub, look for possible cracks. Pay special attention to areas A and B as shown on Fig.1; inspect areas next to each blade.

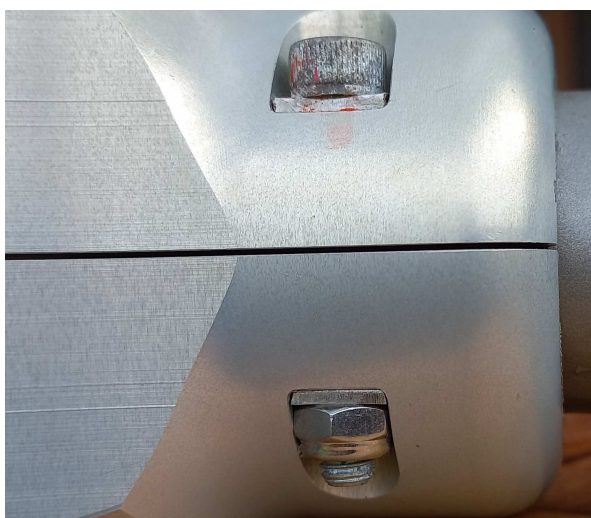
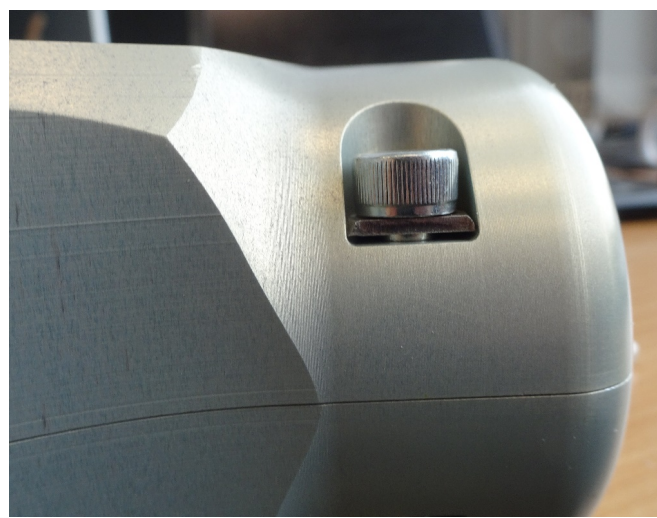
**Fig.2. Washers positioned under the bolt head and the nut: a) correct, b) incorrect**

- Check the condition of the blade bolts and nuts.
- Check the position of the washers under the nuts and bolt heads, Fig. 2.  
Correctly positioned washers point with their rounded edge towards the hub. If any of the washers is incorrectly positioned, carry out the activities according to point 5.2 of this bulletin.

- Dismantle the propeller from the airplane.
- Dismantle the propeller blades according to point 3.6 of the Elprop Propeller Maintenance Manual. Before dismantling, mark the position of the blades in relation to the propeller hub with a thin, indelible marker pen. The marking will allow the blade angle to be maintained when reassembling the propeller.
- Check carefully the propeller hub for cracks.
- Check the condition of the hub surface under improperly mounted washers, damage of the surface is unacceptable. In the event of damage being found, proceed in accordance with point 5.3. of this bulletin.
- If no cracks were found, install the propeller blades in the hub with correctly fitted washers, according to point 3.6. Elprop Propeller Maintenance Manual.
- Set the blades angle according to the marking.
- Tighten the bolts according to point 3.4 Elprop Propeller Maintenance Manual.
