REVO, INC.  
SERVICE BULLETIN B-78

SUBJECT: Horizontal Tail Attachment Fittings

Airplanes Affected: All Colonial C-2, Lake LA-4 & LA-4-200 Models

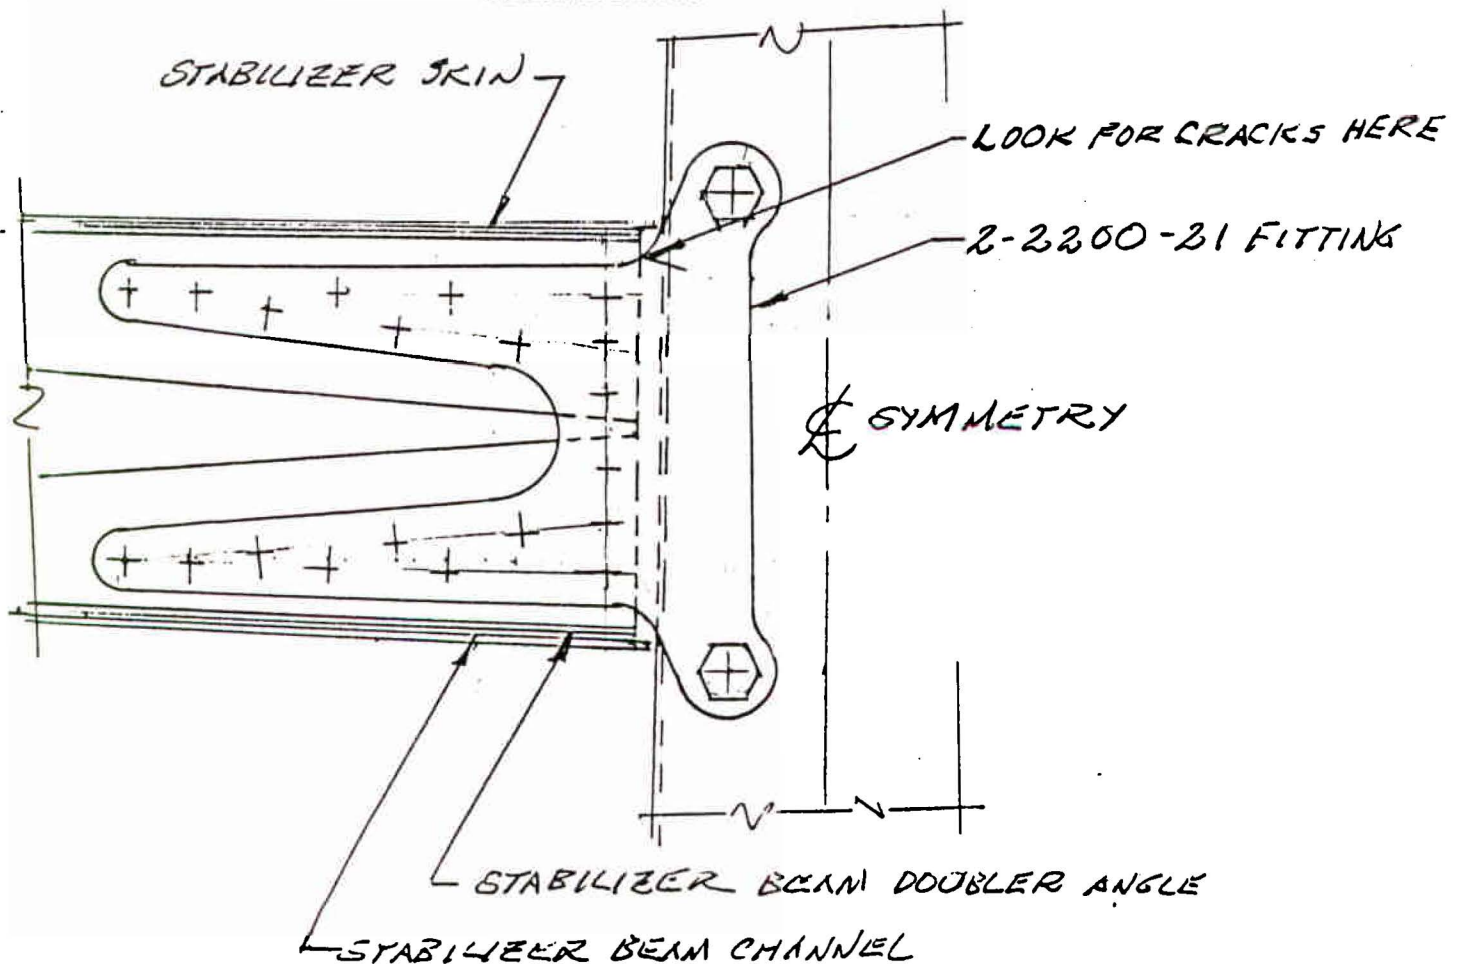
VIEW IS OF LEFT SIDE, LOOKING FORWARD

Description: A recent incident involving failure of the attachment fitting of the left-hand horizontal stabilizer to the vertical fin has shown that a cause for initiation of a crack in the fitting can exist. The area in questions is shown below.

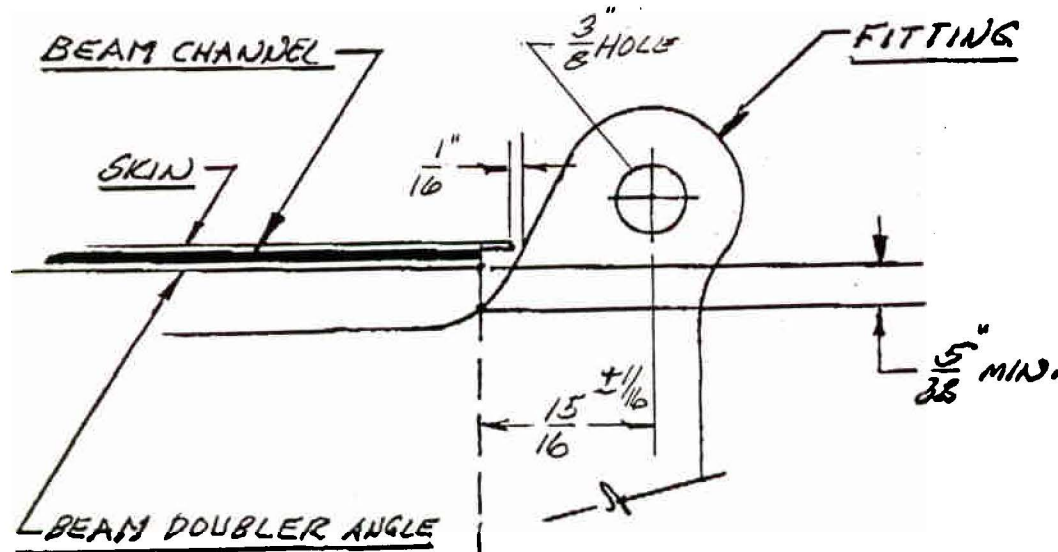
The fitting in the area of its attachment to the horizontal stabilizer rear beam may be initially inspected by raising the elevator and determining the distance between the fitting and the flanges of the beam doubler angle, and any contact of the fitting with the skin. (See below). Both left and right stabilizer halves, top and bottom, must be checked.

The shank of a 5/32 drill bit may be used to check the gap.

1. If the gap is at least 5/32", and the stabilizer skin is not contacting the fitting, no further action is necessary.
2. If the gap is at least 5/32", but the skin has less than 1/16" clearance, simply trim off the skin edge to provide at least 1/16" clearance.
3. If the gap is less than 5/32", at any fitting, it will be necessary to remove the fitting in order to properly inspect it. This entails removal of the horizontal tail half from the airplane. (A guide to this procedure is in the appendix to this Bulletin.)
