| | | <b>SERVICE BULLETIN</b> | | <b>SB 25-006 B</b> |
| <b>Subject</b> | | <b>ELT Antenna Relocation</b> | | |
| <b>Associated Airworthiness Directive</b> | | EASA AD 2025-0282 | | |

Cabri G2 from S/N **1003** to S/N **1389** except **1383** and **1388**.

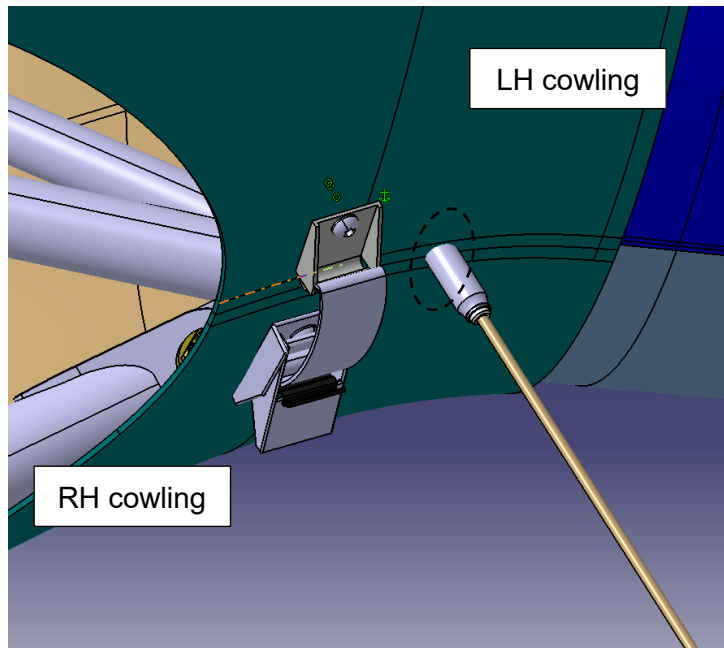
- u) Identify the interference area between VHF2 antenna and both lateral cowlings as shown below,

- v) Using a carbide router, trim the cowlings, make sure there is at least a **5 mm** gap between the antenna and the composite,
- w) If necessary, proceed to paint touch-up using paint listed in MM Supplement **J70-013**,
- x) Install a plug **HG22-2692** in the former VHF2 antenna hole, bond it in place using cyanoacrylate glue.
