| | | <b>SERVICE BULLETIN</b> | | <b>SB 24-001 C</b> |
| <b>Subject</b> | | <b>Swashplate Inspection</b> | | |

Cabri G2 fitted with swashplate P/N **G41-00-000** (all S/N).

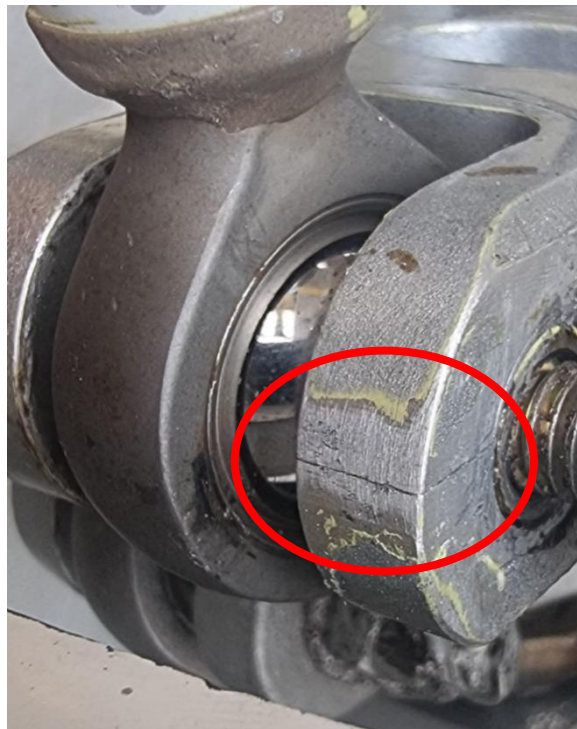
HG has had reports of cracks on swashplate **G41-00-000**, likely to be related to ageing and corrosion:

The present Service Bulletin prescribes the inspection of the swashplate arms for cracks.

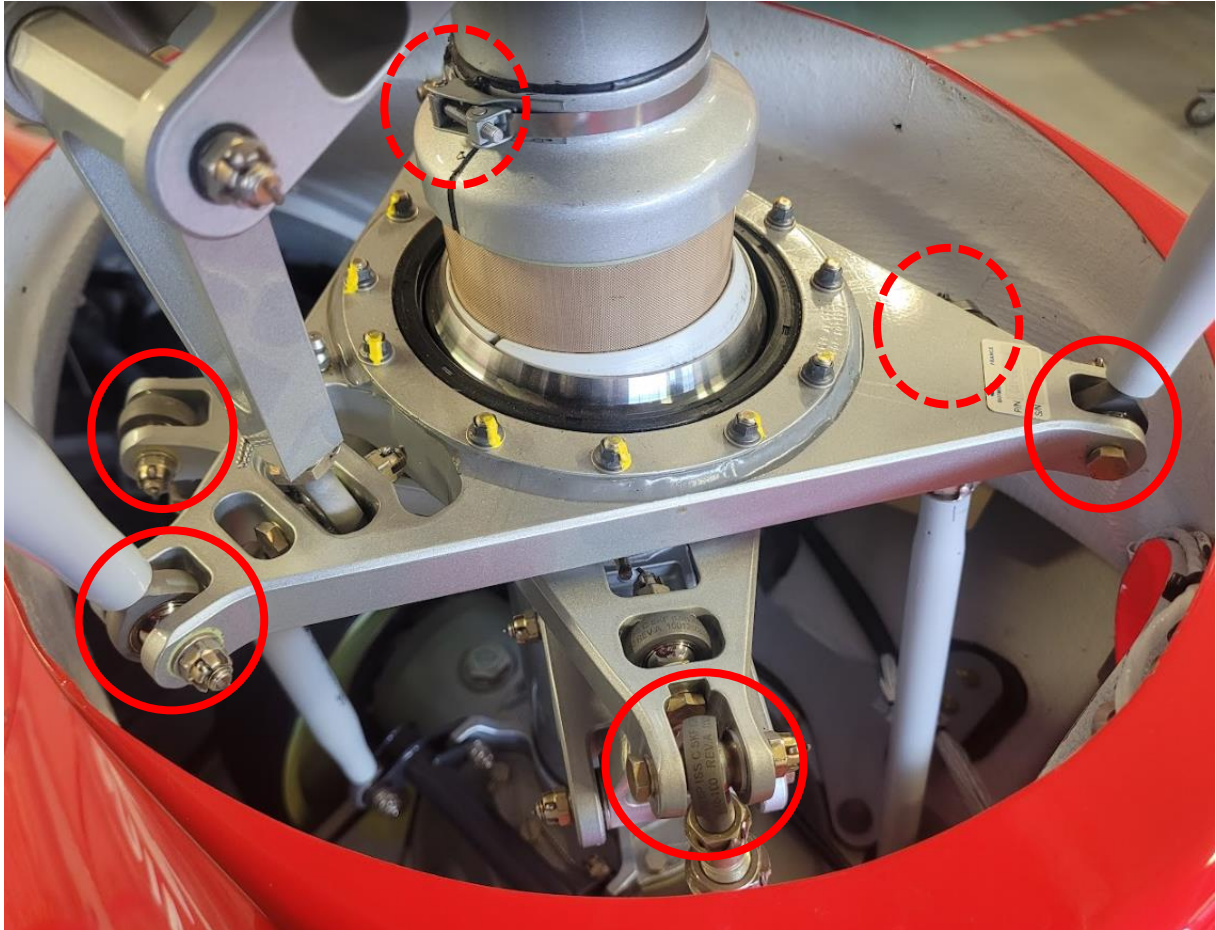
- a) Use a flashlight and inspect the six arms from both the rotating and non-rotating swashplates for cracks:

**Caution:** Pay attention to each face of each clevis arm.

- b) In case of doubt and/or paint damage, particularly paint peeling off, remove the paint using P600-GRIT abrasive for further crack inspection.
- c) If a crack is found, replace the swashplate with a serviceable one before further flight and contact HG support.
- d) If no crack is found, paint touch up the areas where paint has been removed:
- degrease the area using MEK,
  - apply Alodine,
  - apply anti-corrosion chromate primer: **HG31-0031** primer mixed with **HG31-1471** hardener, see **SB 18-030** for mixing ratio,
  - apply paint: **HG31-0033** paint mixed with **HG31-1304** hardener and **HG31-2704** thinner, see **SB 18-030** for mixing ratio.

Swashplate must NOT be released to service until paint touch up has been completed on every area where paint has been removed.
