**Wings – Missed rivets on flap arm 2 R/H and L/H**

## SB-328-57-239

### Title: Wings – Missed rivets on flap arm 2 R/H and L/H

No.: SB-328-57-239

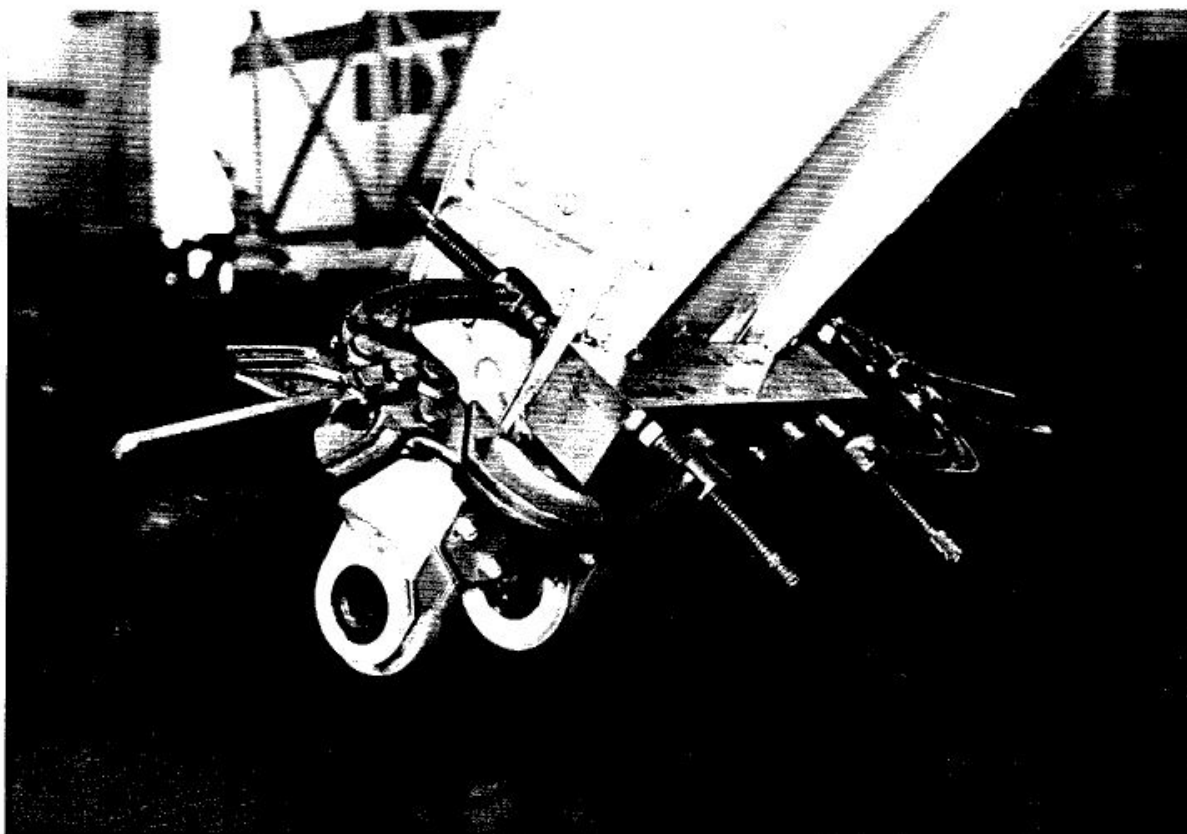
**Fig. 2**

Missed rivets on flap arm 2 R/H and L/H must be incorporated to maintain the fatigue requirements

- 1) Position drilling jig P/N 001U575A0600 on bottom side of flap arm 2, refer to fig.1 and fig. 2.
- 2) Drill fastener holes dia 3,1mm (0.125 in.) and then enlarge to 4,1mm (0.1633 in.).
- 3) Remove drilling jig.
- 4) Install the Hi-Lok fasteners (item no. 1 and 2) according to the SRM.
- 5) Renew surface protection according to the SRM.
