# SERVICE NO. 1204 LETTER

## MAINTENANCE ALERT

**HEATED WINDSHIELD TEST PROCEDURE**

PA-46-350P Mirage/M350  
PA-46R-350T Matrix  
PA-46-500TP Meridian/M500  
PA-46-600TP M600

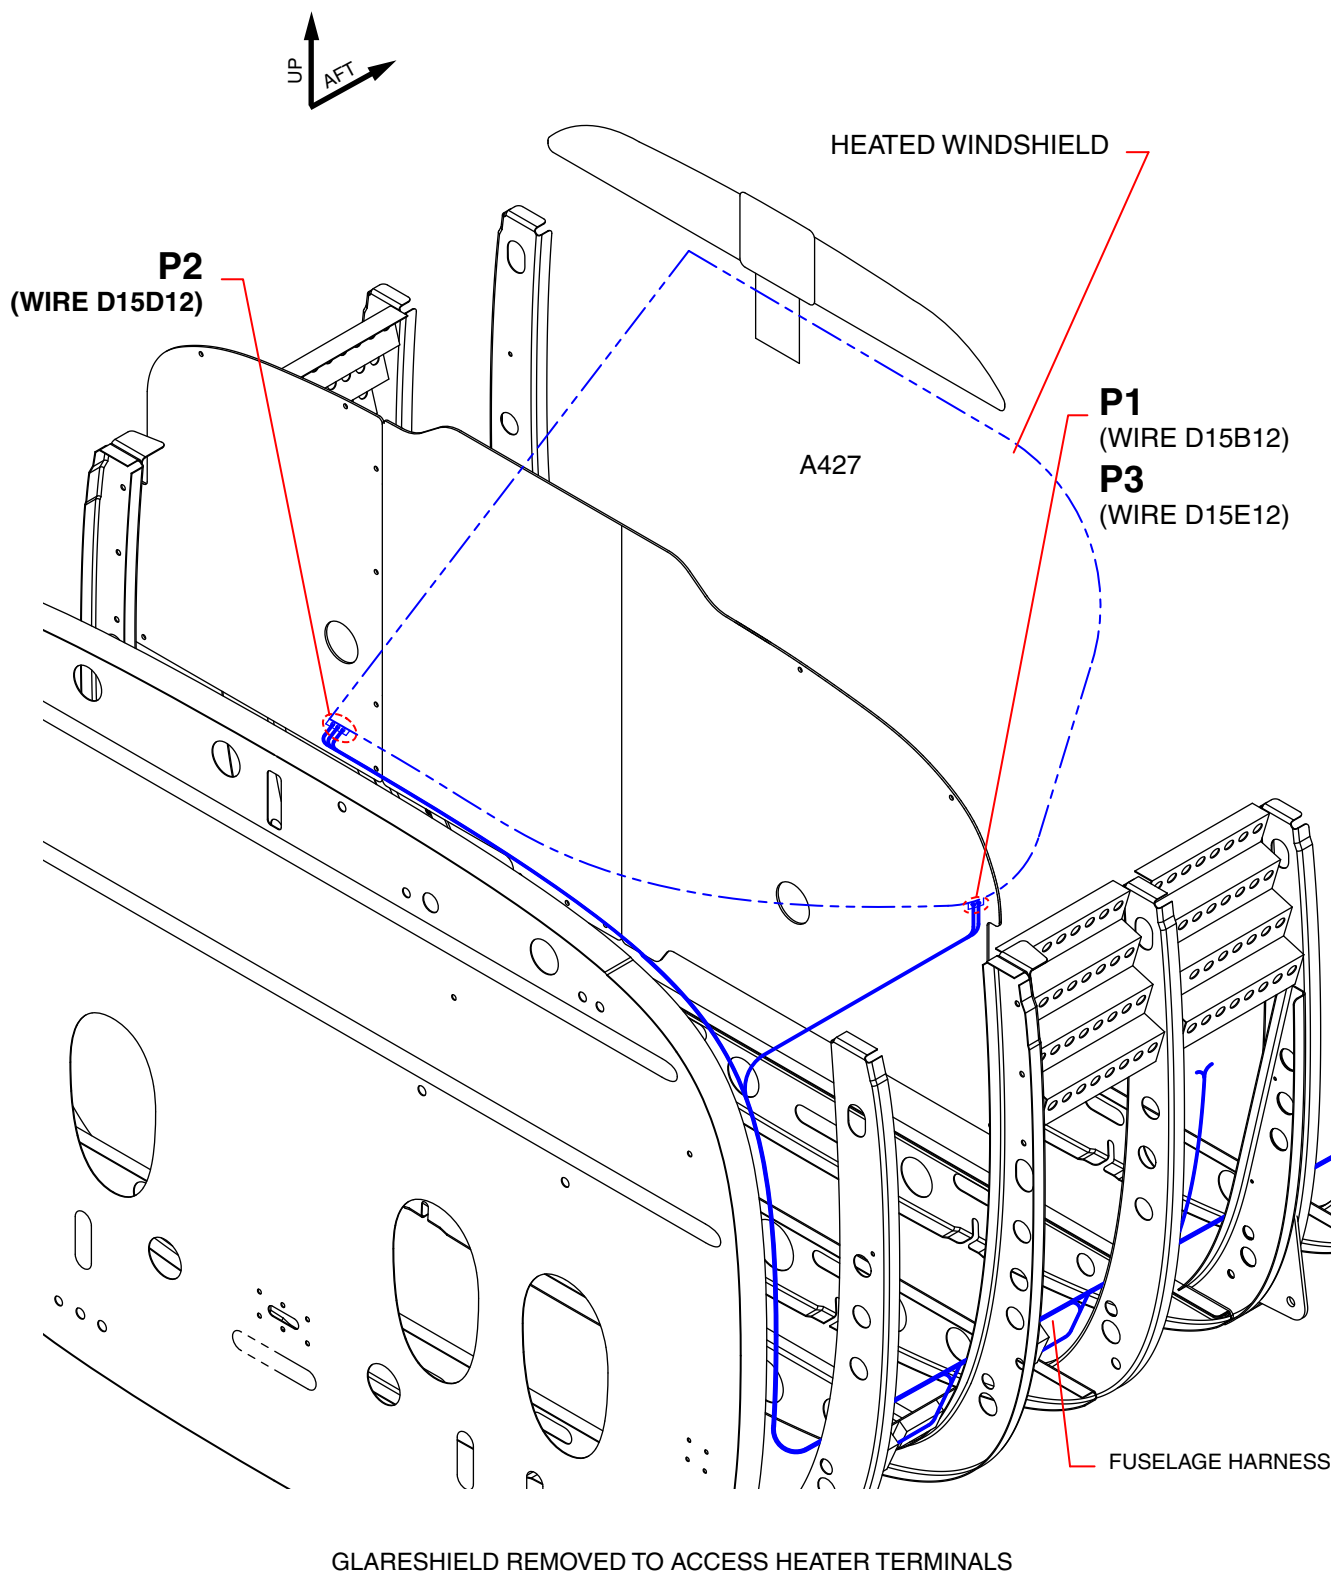
**Figure 1**  
Heated Windshield Terminal Block Locations

In-cockpit ammeter readings are erroneously being used to assess the serviceability of heated windshields installed in the affected airplanes. This service letter provides an approved method of determining heated windshield serviceability.

- a. Remove the glareshield to access the heated windshield terminal blocks. See Figure 1 for terminal block locations.
- b. Resistance is to be tested with power removed from the heated windshield. When the windshield terminal blocks are exposed:

- 1) For all affected PA-46R-350T Matrix, PA-46-500TP Meridian/M500, and PA-46-600TP M600; PA-46-350P Mirage/M350 models 4622172 and up only:
    - a) Measure resistance between terminal P1 and P2. Resistance must be 1.15 ohms +/- 10%.

- b) Measure resistance between terminal P1 and P3. Resistance must be 1.58 ohms +/- 10%.
  - 2) For PA-46-350P Mirage models 4622003 through 4622171 only:

- a) Measure resistance between terminal P1 and P2. Resistance must be 1.11 ohms +/- 10%.
    - b) Measure resistance between terminal P1 and P3. Resistance must be 1.70 ohms +/- 10%.

- 3) If the measurements fail to meet specified values in either step 1) or 2) above, for the applicable aircraft, then the windshield must be replaced.
