**Piper Aircraft, Inc.**  
2926 Piper Drive  
Vero Beach, FL, U.S.A. 32960

# SERVICE NO. 1280A BULLETIN

Date: April 29, 2016

### H3R FIRE EXTINGUISHER REPLACEMENT

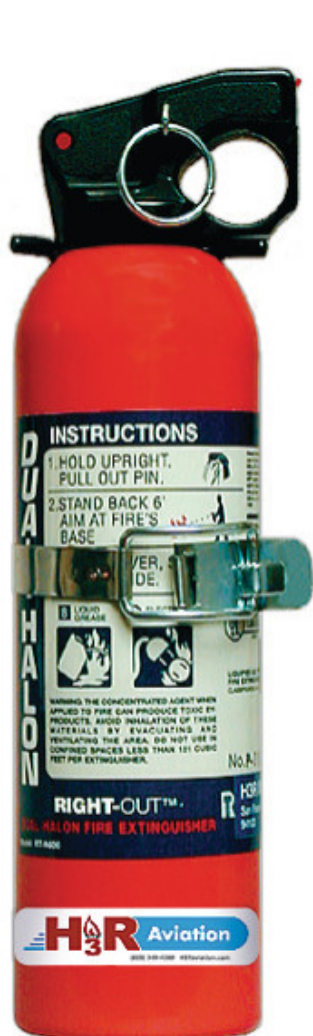
**Figure 1**  
 Fire Extinguisher –  
 Piper P/N 459-887

1. Locate the fire extinguisher, and compare it to Figure 1. The fire extinguisher in Figure 1 is Piper P/N 459-887, and will have the manufacturer's marking "RT-A600."
  - If the onboard fire extinguisher matches the one shown in Figure 1, then further action is required. Proceed to Step 2.
  - If the onboard fire extinguisher is NOT a match to the one shown in Figure 1, no further action is required. Proceed to Part IV, Documentation of Compliance.

2. Examine the date code label, which is found on the UL nameplate or on the underside of the cylinder.
  - If the date code is 2012 or newer or no date code is found, then further action is required. Proceed to Step 3.
  - If the date code is 2011 or older, no further action is required. Proceed to Part IV, Documentation of Compliance.
3. Examine the fire extinguisher for a placard, as shown in Figure 2, with the following text:
