# SERVICE NO. 1318B BULLETIN

**FUSELAGE STATION 144.25 RIVET REPLACEMENT**

PA-46-600TP M600

4698004 through 4698041

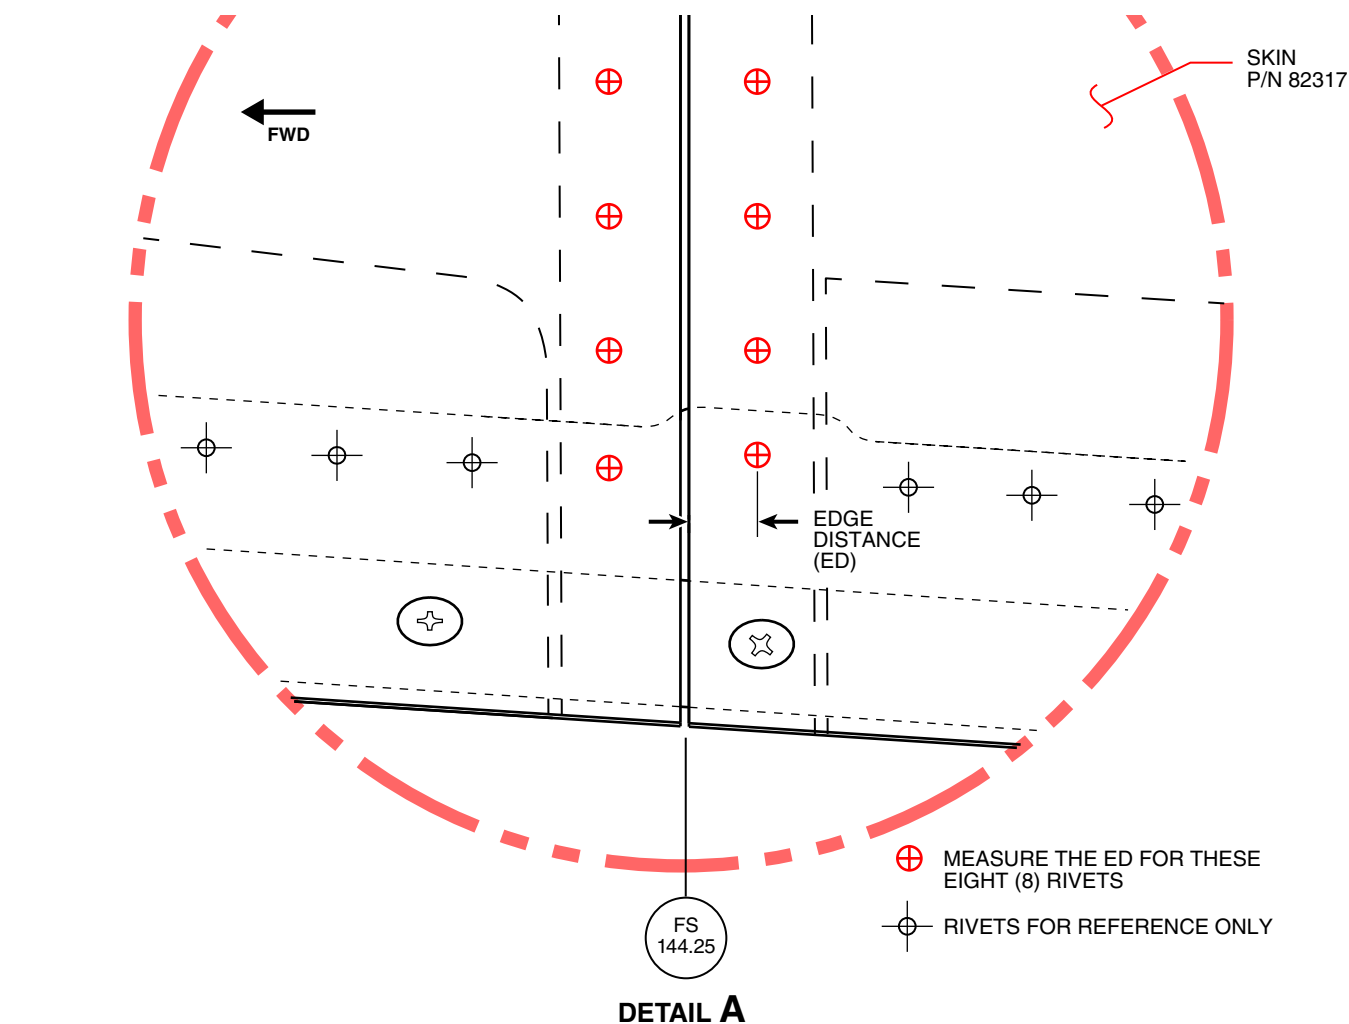
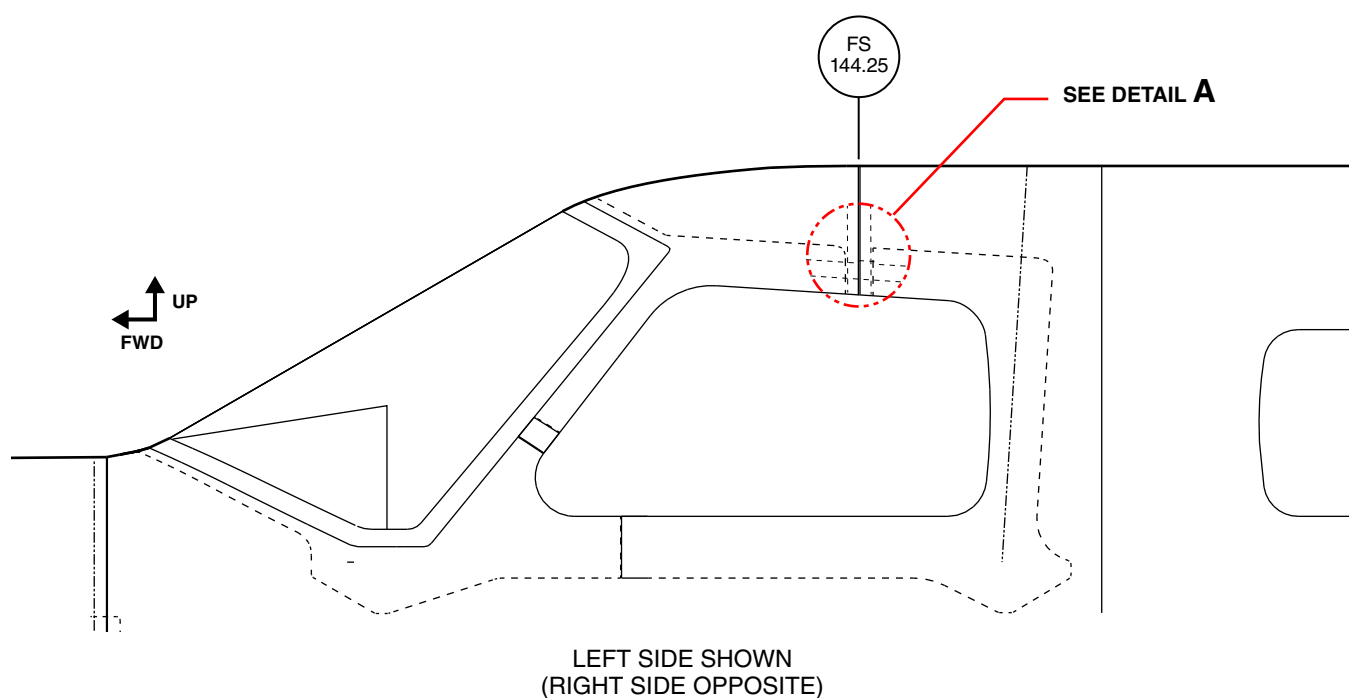
**Figure 4**  
Canopy Rivet Inspection

A specific area of the cockpit canopy on affected aircraft may include rivets that were not installed in conformance to type design. If aircraft with this condition are operated at the limitations stated in the current revision of the pilot's operating handbook, it could result in an understrength condition. Additionally, aircraft operated in this condition may not have the fatigue strength required to achieve the published structural life limit of the fuselage.

At a minimum, 16 rivets (eight per side) shall be replaced on each aircraft to comply with this service bulletin. A modification may be required as well as the rivet replacements. Two kits are available, one for either condition. One of either kit shall be required, per side, as determined by the results of the inspection included in the following steps.

1. RC – Locate the canopy area above both cockpit side windows, which is shown in Figure 4, Detail A.
2. RC – The topcoat of paint will likely obscure the rivet pattern shown. If necessary, locally remove paint to the depth required to gain visual access to the rivet heads. The removal of paint to the bare metal is not required.
3. RC – At each of the eight (8) rivets specified, per side: measure the edge distance (ED) from the center of the rivet to the edge of the skin, as shown in Figure 4, Detail A.

- **If the ED for each rivet** meets or exceeds 0.30 inches, only the replacement of the rivets is required. Order and install Rivet Replacement Kit, Piper Part Number (P/N) 88623-701, Revision A.
- **If the ED for any of the rivets** is less than 0.30 inches, modification to the airframe and rivet replacement is required. Order and install Canopy Modification Kit, Piper P/N 88624-701, Revision A.
