# SERVICE BULLETIN

No. 547

Piper Aircraft Corporation

Inspection of Stabilator Tip Rib

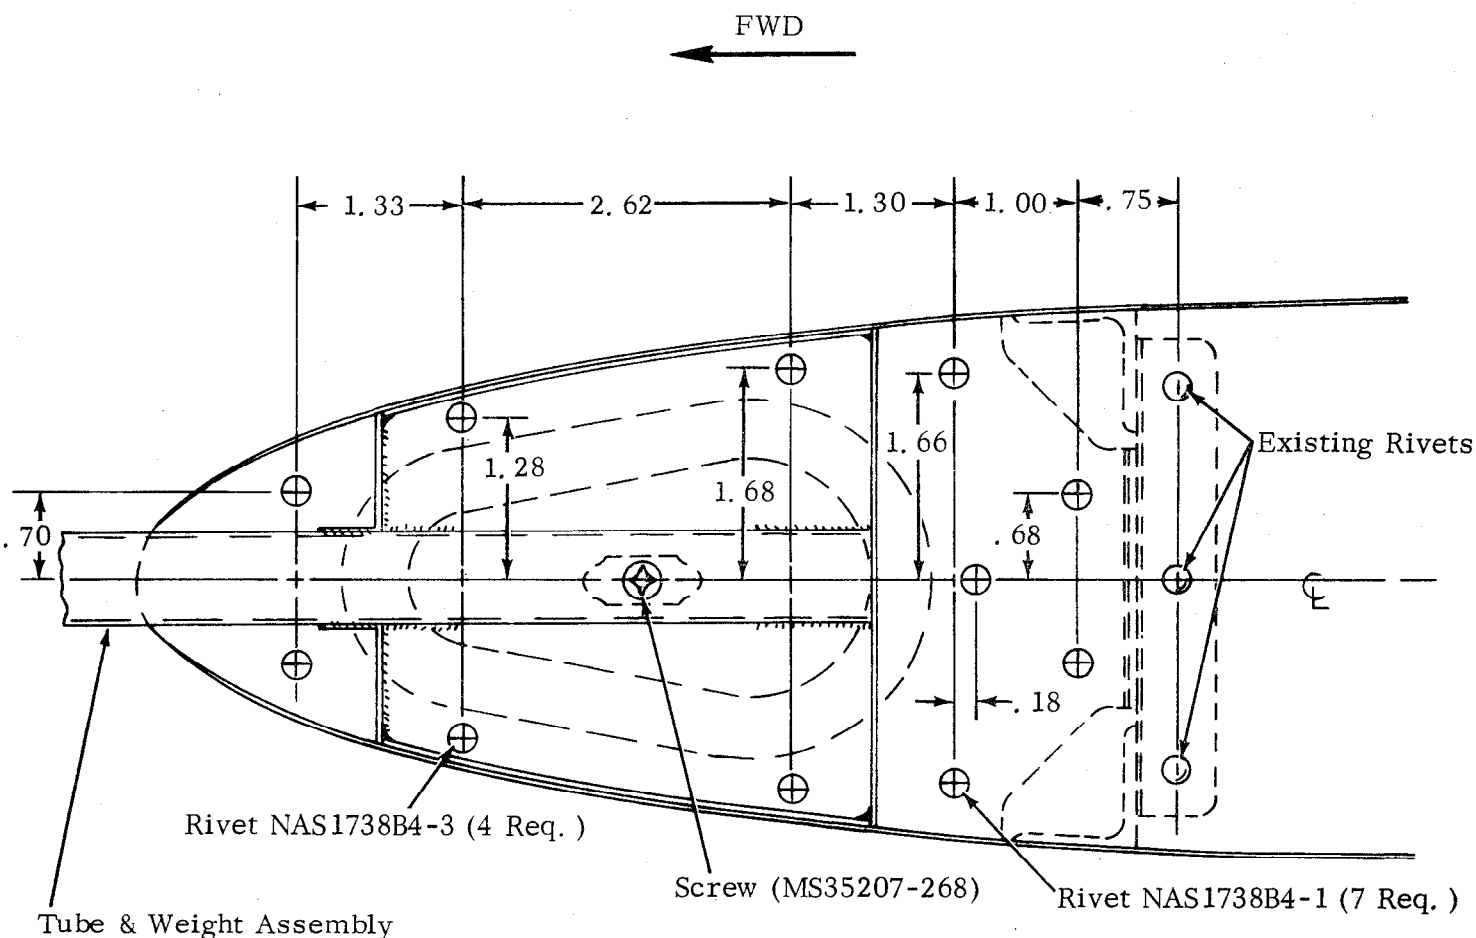
END VIEW OF STABILATOR TIP RIB (Left Shown - Right Opposite)

Purpose: Resulting from the inspection specified in Piper Service Bulletin No. 540 dated January 4, 1977, it was found that certain stabilator tip rib rivets and/or the stabilator tip tube and weight assembly attachment screw may be missing. Although no failures have been reported as a result of this condition, inattention to this matter could lead to cracking in the stabilator tip rib area.

1. Remove tip assembly from left and right stabilators.
2. Inspect forward end of stabilator ribs to determine if five rivets are installed aft of the tube & weight assembly attachment plate, two rivets installed forward of the attachment plate and a screw installed thru the square tube welded to the attachment plate.

4. If screw and rivets are missing from either stabilator, install new hardware as follows:
  - a. Install MS35207-268 screw (P/N 411 537) thru the square tube and into the anchor nut as shown.

- b. Locate and drill eleven .144 holes as shown above.
  - c. Install four NAS1738B4-3 blind rivets (P/N 522 883) at the attachment plate and seven NAS1738B4-1 blind rivets (P/N 522 881) aft and forward of the attachment plate.

- d. Reinstall tip assembly and make proper logbook entry of stabilator rivet and screw installation per Service Bulletin 547.
