**Number: SB2X-76-05****Issued: 29 Oct 2024**

**SNS SUBJECT: 76-10 POWER CONTROL - Upper Power Lever Inspection and Replacement**

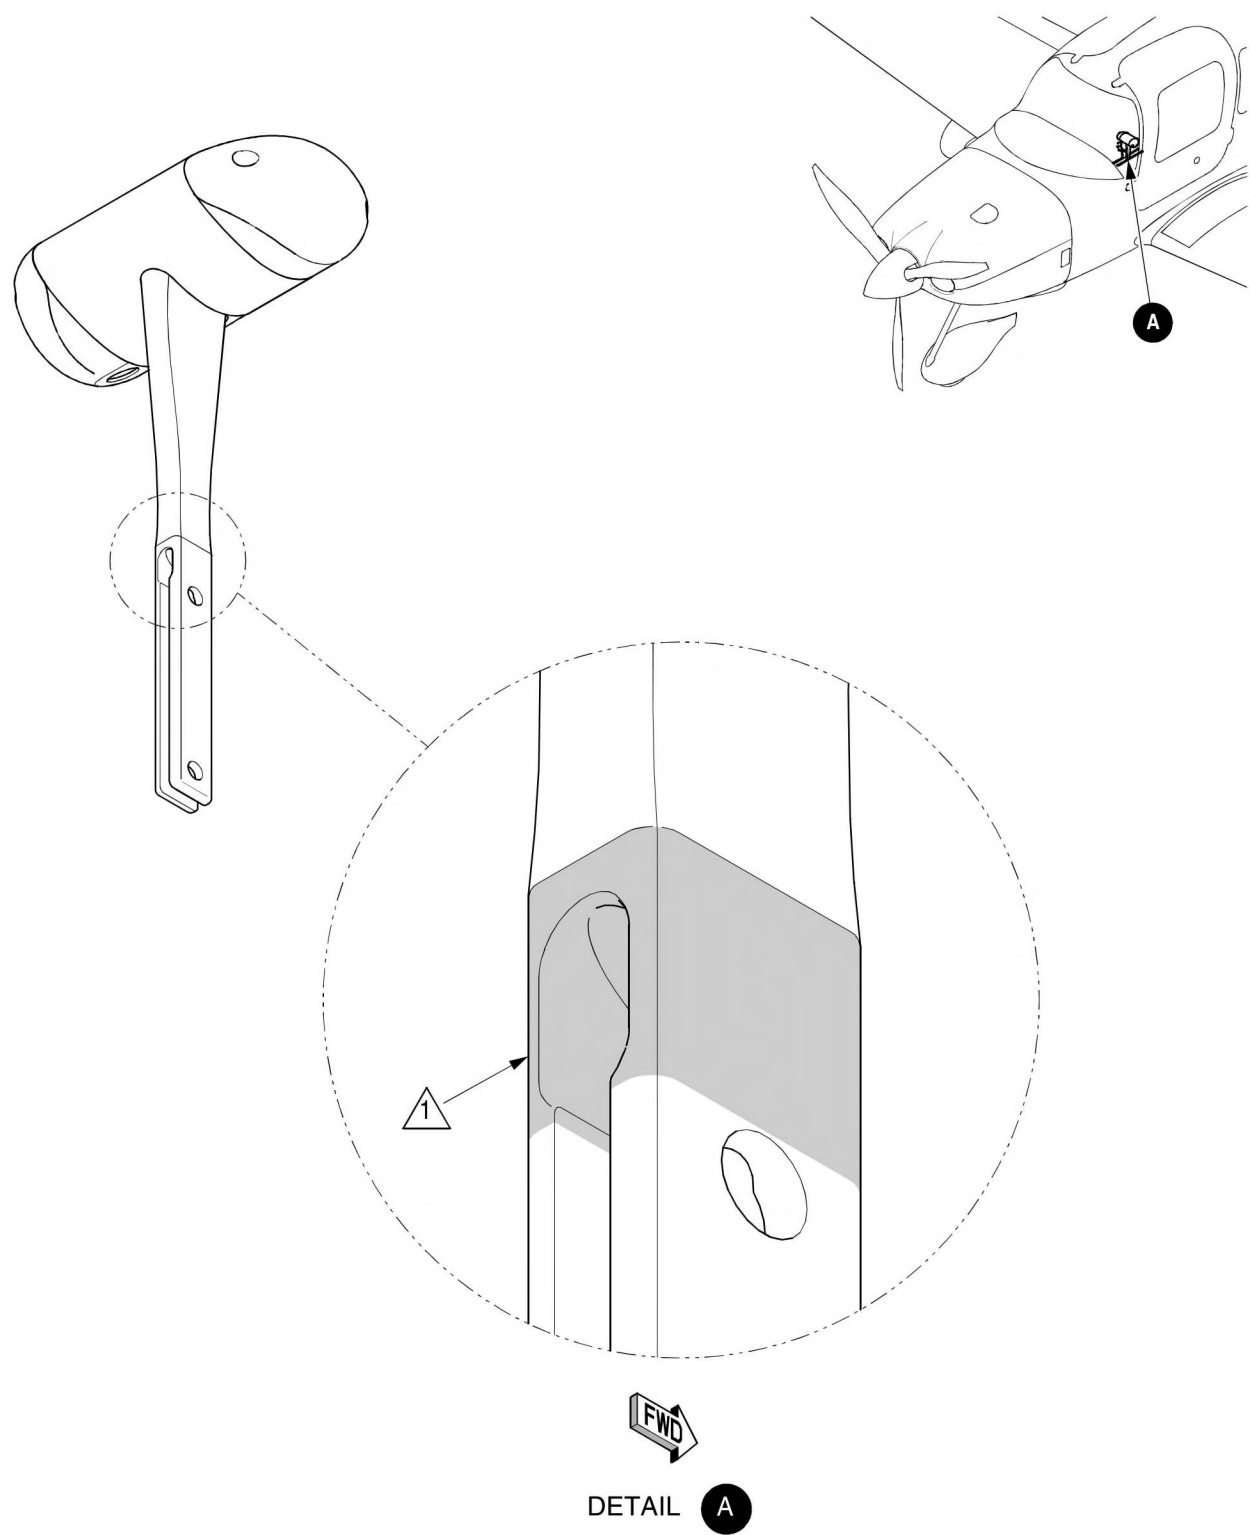
Figure 01  
Upper Power Lever Inspection Area

F. Use magnifier to visually inspect upper power lever for damage. (See Figure 01)

NOTE  
1 Inspect shaded area for damage. Minor scratching/scuffing is acceptable.

(1) If cracks are detected, no further inspection is required. Return damaged component to Cirrus for analysis. Install new upper power lever (item 1). (Refer to AMM 76-10)

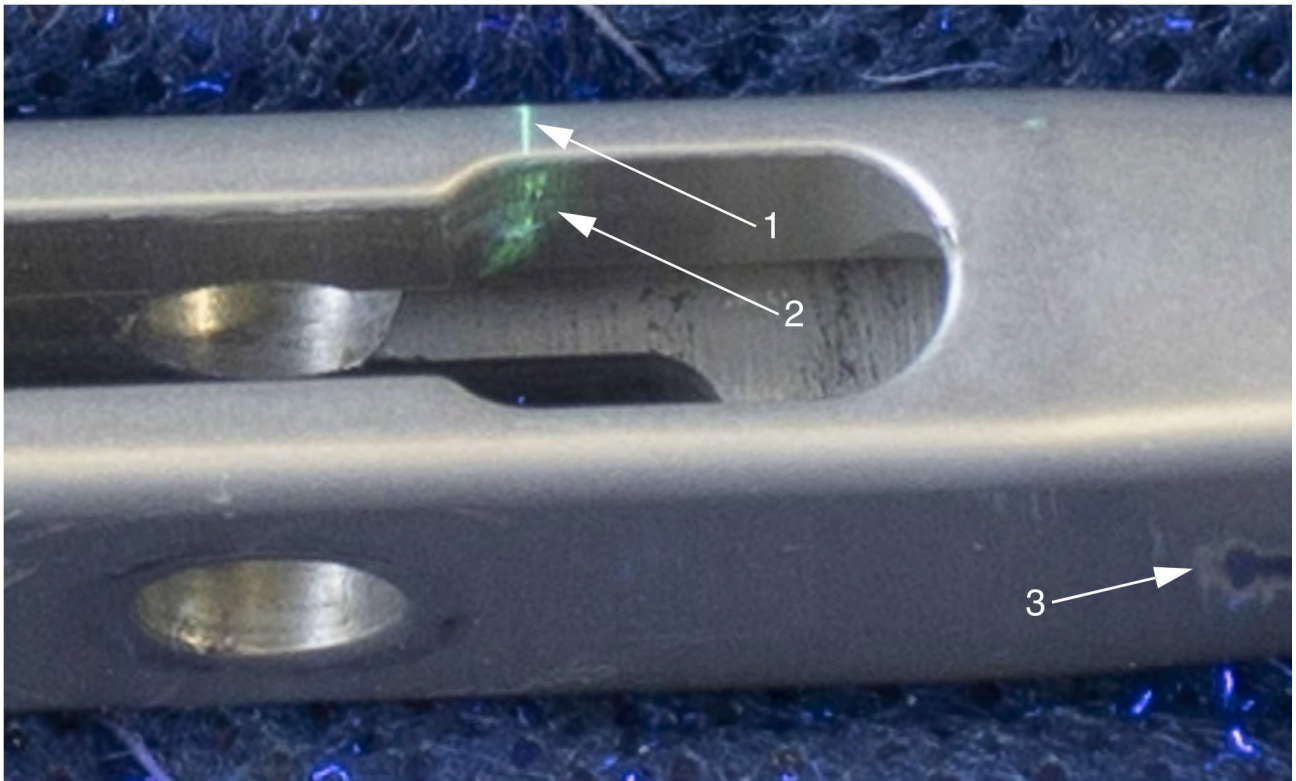
**Figure 02**  
**Dye Penetrant Inspection Example**

- J. Allow developer to dwell for 10 minutes minimum. (See Figure 02)
- (1) If cracks are detected, return damaged component to Cirrus for analysis. Install new upper power lever (item 1). (Refer to AMM 76-10)

1. Positive identification of surface crack.
2. Positive identification of interior crack.
3. Sample of minor scuffing, not applicable.
