**Service Bulletin**

June 18, 2007

SEB07-2  
Revision 2**TITLE****ENGINE MOUNT BRACKET INSPECTION****EFFECTIVITY**

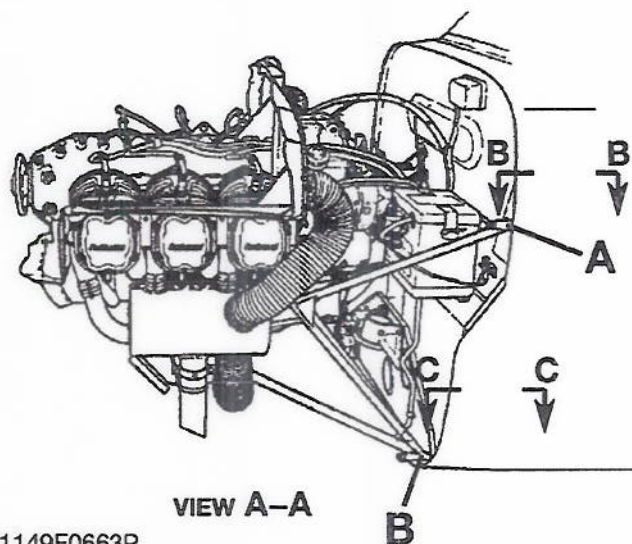
**VIEW A-A**

5. Do an inspection of the left 0513132-11 Upper Mounting Bracket:
  - A. (Refer to Figure 1, View A-A and Detail A.) From a position under the instrument panel, move the wires and the insulation away from the bolt that attaches the upper left engine truss to the left 0513132-11 Upper Mounting Bracket.

- D. (Refer to Figure 1, View D-D.) Look carefully for a deformed or cracked left 0513132-11 Upper Mounting Bracket.
  - (1) If you do find deformities or cracks, go to Step 5E.
