**Rev.: # 2**

**PURPOSE: CHECKING THE STRUCTURAL INTEGRITY OF THE FRONT LONGITUDINAL SPARS OF THE WINGS OF THE PIPER PA-25 Series, IN ORDER TO PREVENT CATASTROPHIC FAILURES**

THIS PUBLICATION of SB # 25-57-11 R2 (Revision # 2) REPLACES THE PREVIOUS "Original and R1"

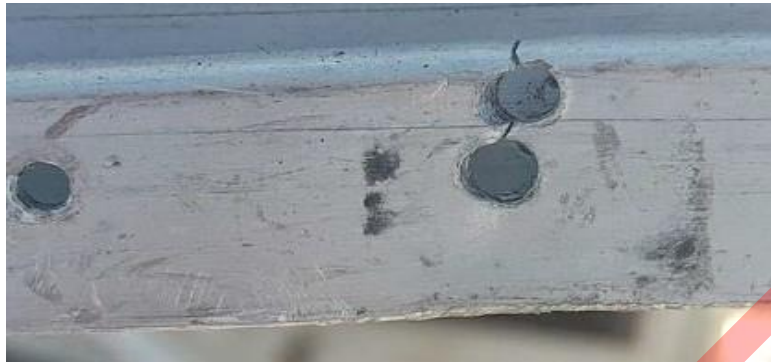
**PHOTOS OF FAILURES FOUND**

**BACKGROUND:** Due to service difficulties (DES) with PA-25 aircraft, where WING DETACHMENTS have been observed, studies and observations carried out on the recovered material concluded that the main spars collapsed due to fatigue.

The failures were structural (cracks), starting at holes or screw threads. This was interpreted as poor maintenance practices during metal leading edge changes or during the replacement of metal leading edges with composite leading edges that are not original equipment from the manufacture and certification of the PA-25 Series.

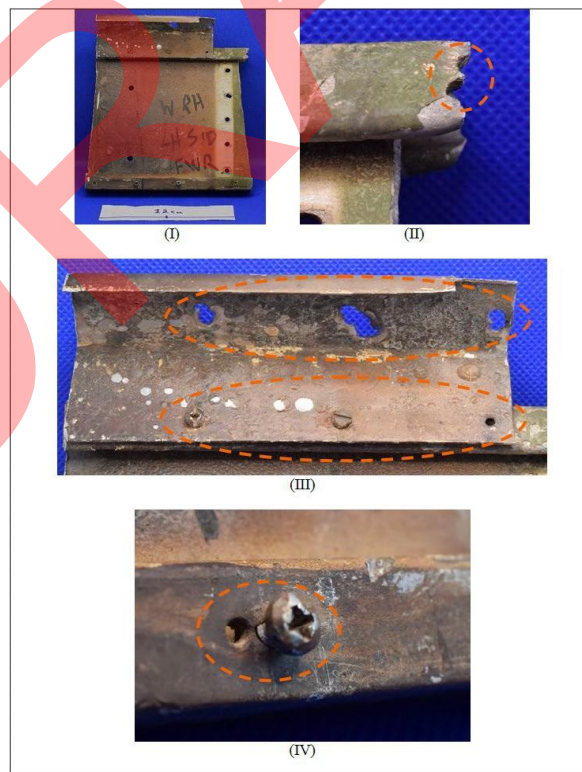
The evidence of poor maintenance practices is based on the observation of parts recovered from the three aircraft that crashed in Argentina, which, taken as a reference, reveal holes that were superimposed and misaligned with the originals (see photos above), significantly displaced from the centerline of the flange, or even holes drilled in the upper flange. (See image below, photos I to IV)

NOTE: Users or workshops that have made leading edge changes, whether or not they have recorded the action, must pay special attention during the execution of this visual END by borescopy in order to ensure that there are no cracks in the main spar flanges.

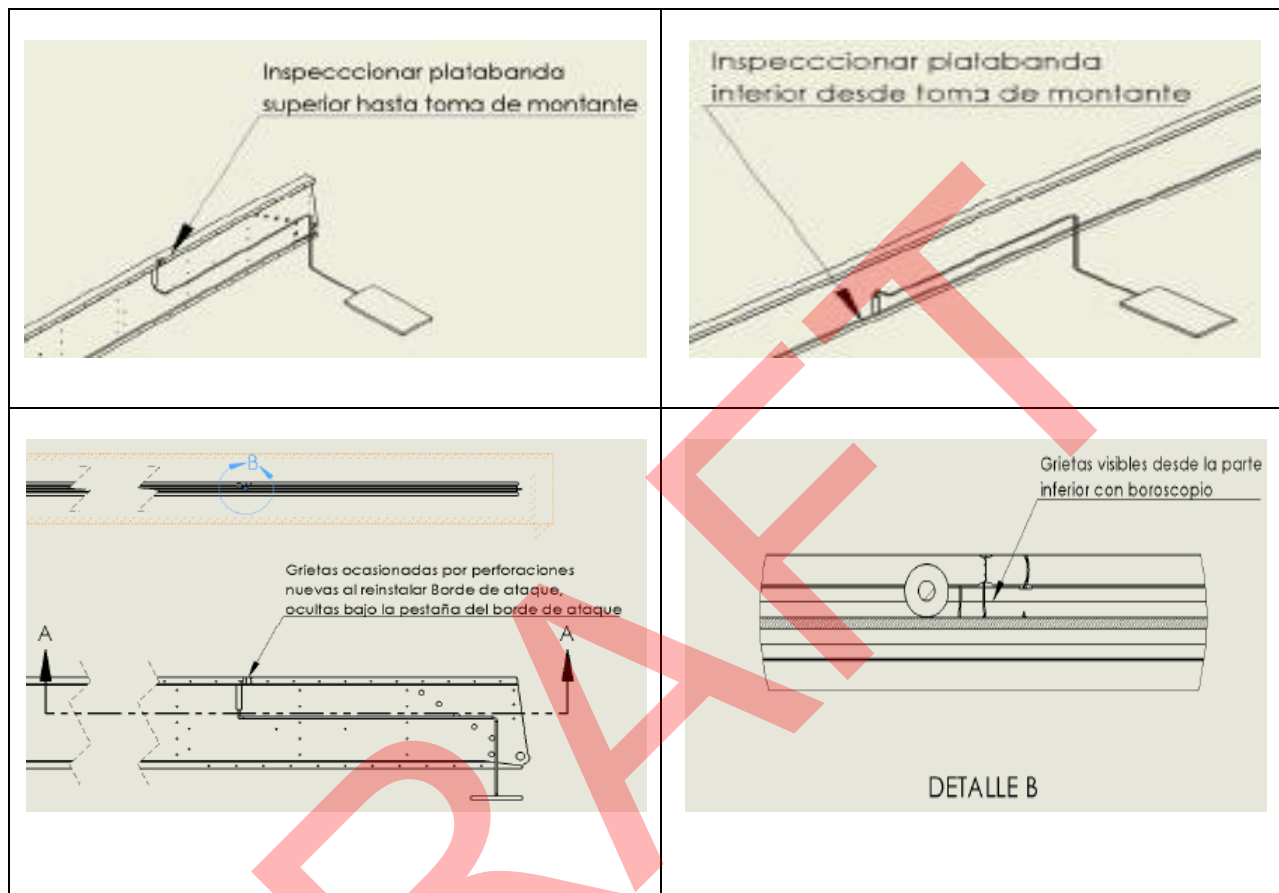
**Figure 1 – Inspection areas, reference to faults to be detected, and camera positioning**

- 6 Visually check that there are no cracks near the drill holes.
- 7 Perform a visual inspection using a borescope as indicated below in points a) to c).
- a). Insert the borescope and advance it, grazing the core of the spar while keeping the camera vertically upward in areas #1 to #5. **Visually inspect the lower area of the upper flange for signs of cracks such as those shown in Figure 1 Detail B.**

b) Similarly, insert the borescope and advance it, grazing the core of the spar while keeping the camera vertically downward in the area of Cover #6. **Visually inspect the upper area of the lower flange for signs of cracks such as those shown in Figure 1 Detail B.**

- If you find more holes than in the original design, the spar must be replaced. Alternatively, an AMOC should be proposed.
- If there are screws with diameters greater than those stipulated in drawing P/N 15086, the spar may be compromised and must be replaced. Alternatively, an AMOC should be proposed.
- If there are holes very close to the round tip of the flange or very close to the upper side of the flange, according to Verification of Vertical Location of Screws holes in Spar Flange, the spar must be replaced. Otherwise, an AMOC should be proposed.
- If you find drill bit marks on the core of the doble T main spar, as shown in photo #1, you must follow up on them at each ANNUAL scheduled inspection by means of a visual END inspection with the aid of a borescope to check their condition.
- If you find cracks, the Spar must be replaced.

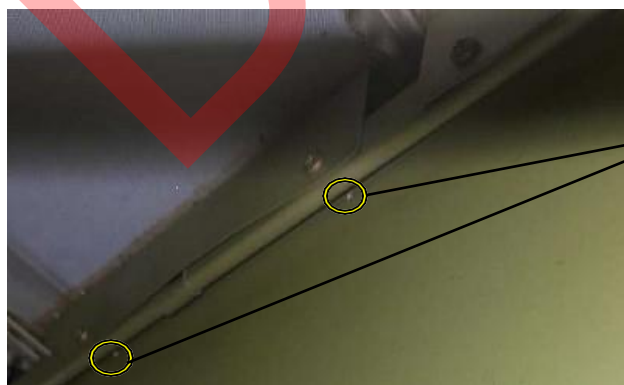
**Pothograph # 1**

c) Check for drill marks such as those shown in the following photograph.

**NOTE:** If drill bit marks are detected, mark them, sketch them on a diagram, include them in the maintenance log, and **emphasize the obligation to check their condition during each inspection stipulated in RECURRENCE of the item COMPLIANCE**

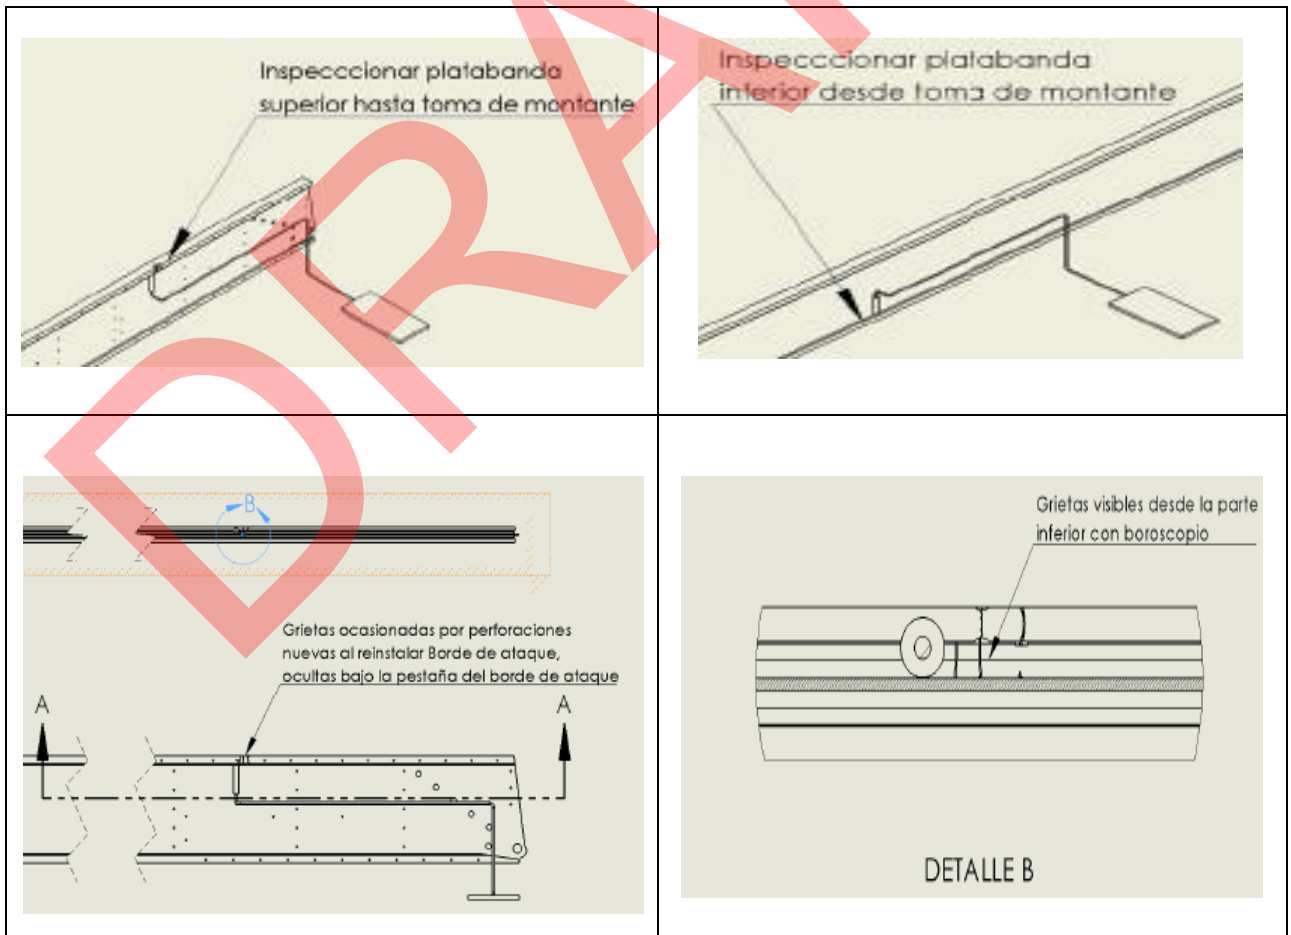
**Figure 1 – Inspection areas, reference to faults to be detected, and camera positioning**

4. Insert the borescope and advance it, grazing the core of the spar while keeping the camera vertical and pointing upward in areas #1 to #5. **Visually inspect the underside of the upper flange for signs of cracks such as those shown in Figure 1 Detail B.**

5. Similarly, insert the borescope and advance it, grazing the core of the spar while keeping the camera vertically downward in the area of Cover #6. **Visually inspect the upper area of the lower flange for signs of cracks such as those shown in Figure 1 Detail B.**

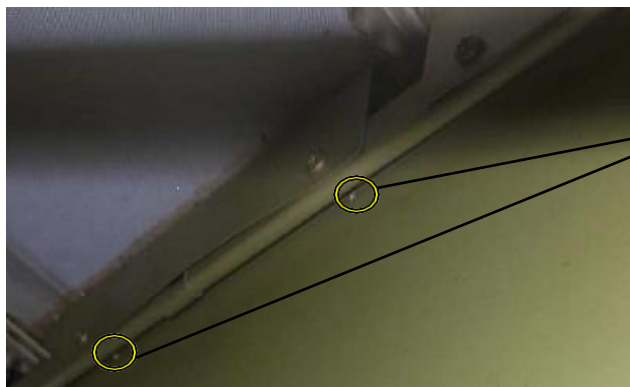
**Photograph # 1**

- 6 If there are drill bit marks that are highlighted in the INITIAL action, as exemplified in the next photograph, do as specified in the NOTE.

**NOTE:** If you notice wick marks from drill.

*Check the drawings in the maintenance logbooks and comply with the requirement to monitor their condition*
