# SERVICE NO. 540B BULLETIN

Date: February 9, 2021

**INSPECTION AND REINFORCEMENT OF  
STABILATOR TIP TUBE AND WEIGHT ASSEMBLY**

PA-23-250 (Six-Place) Aztec "F"

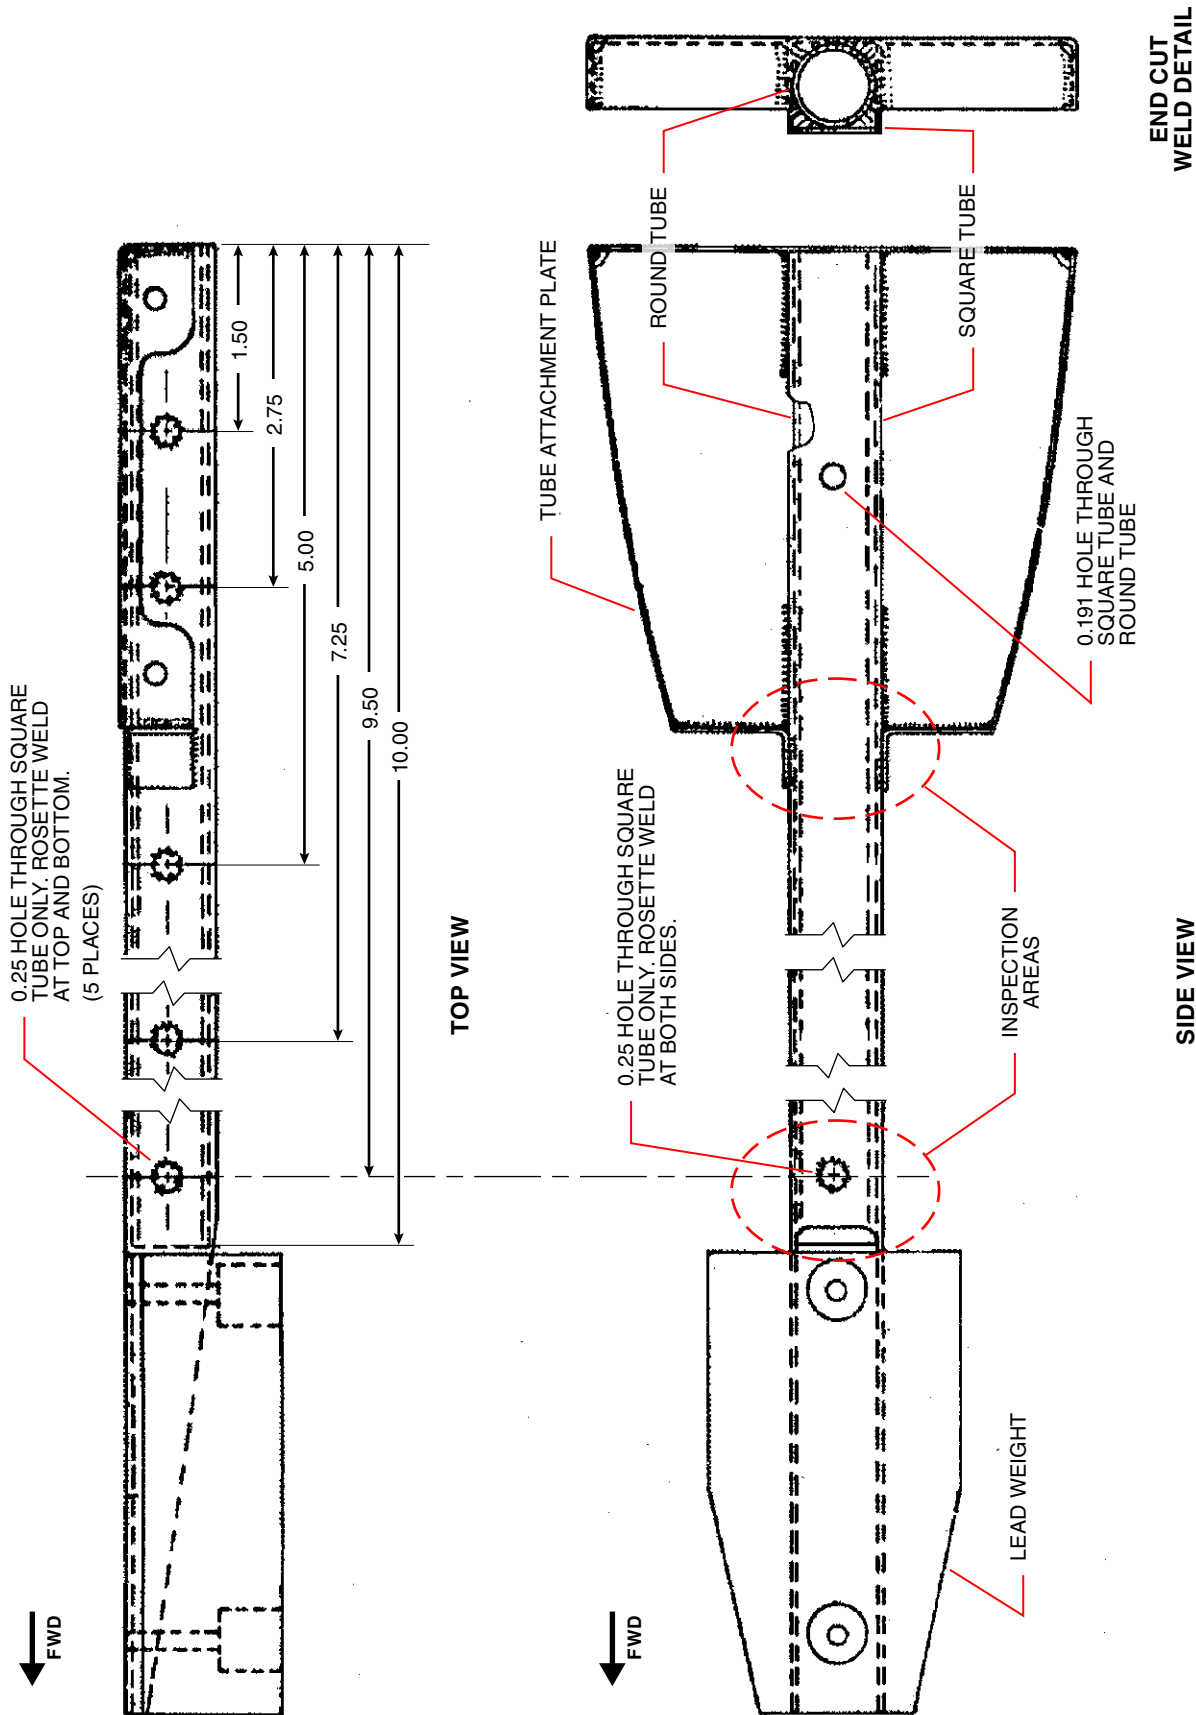
**Figure 1**  
Top View and Side View of Tube and Weight Assembly

Field reports indicate that cracks have been found in the stabilator tip tube and weight assembly installed on the affected aircraft, regardless of prior maintenance and repair history. If not identified and addressed, this condition could result in separation of the weight from the tube.

3. RC – For serial numbers (S/Ns) 27-7654001 through 27-7954035 if Stabilator Balance Weight Replacement Kit, Piper P/N 763-987, **is not installed**: examine the inspection areas identified in Figure 1. Perform the inspection using a 10X magnifier, a mirror, and a suitable light source or other equipment capable of providing equal or better resolution.

- **If cracks are found**, repair the tube and weight assembly as described in Part II, prior to next flight.
  - **If no cracks are found**, then proceed to Part III.

**NOTE:** Figure 1 shows a stabilator tip tube and weight assembly after repair.

RC – These repair instructions are applicable only to S/Ns 27-7654001 through 27-7954035 without Kit P/N 763-987 installed. Refer to Figure 1.

- b. Cut or drill a hole in the end of the tube attachment plate to allow a 5/8 inch diameter tube to be inserted into the square tube.
  - c. Locate and drill twelve (12) 0.250 holes in the square tube as shown in Figure 1.

- d. Insert a 10-inch length of round steel tube (5/8 x 0.058 Type 4130 Cond. N) into the square tube and rosette weld the tubes together at the twelve (12) 0.250 holes.

- e. Weld shut the area around the hole in the attachment plate and the tubes.
  - f. Weld shut any cracks that were discovered when inspecting the square tube.

- g. Drill a 0.191 hole through the round tube using existing hole in square tube as a guide.
- h. Clean, prime and paint tube and weight assembly.
- i. Reinstall the tube and weight assembly to the stabilator using existing attachment hardware.

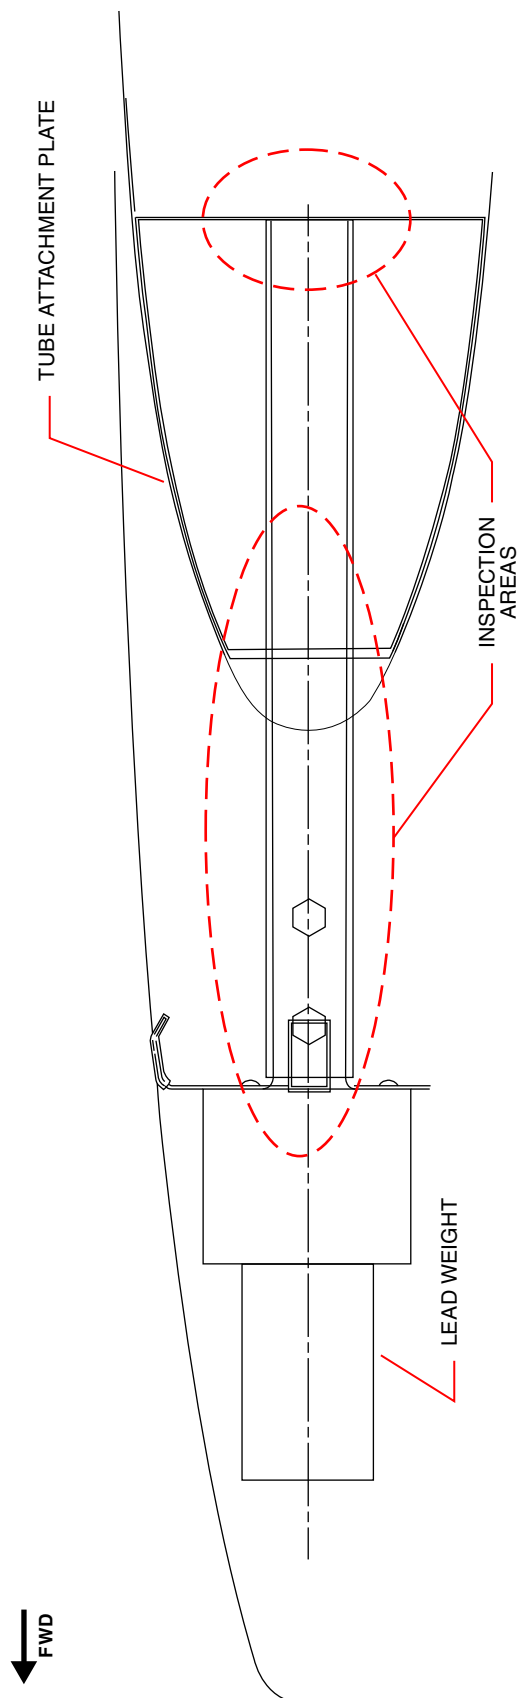
**Figure 2**  
 Side View of Tube and Weight Assembly

4. RC – For S/Ns 27-7954036 through 27-7954121; and for S/Ns 27-7654001 through 27-7954035 if Stabilator Balance Weight Replacement Kit, P/N 763-987, is installed: examine the inspection areas identified in Figure 2. Perform the inspection using a 10X magnifier, a mirror, and a suitable light source or other equipment capable of providing equal or better resolution.
  - **If cracks are found**, then repair is necessary prior to next flight. Contact Piper Customer Service for assistance at (+1) 772-299-2141 or CustomerService@piper.com. Piper’s normal business hours are Monday through Friday, 7:30 a.m. to 4:30 p.m. (Eastern).
  - **If no cracks are found**, then proceed to Part III.

**SIDE VIEW**  
 APPLICABLE TO S/N 27-7654001 THROUGH 27-7954035 WITH PIPER KIT  
 P/N 763-987 INSTALLED, AND S/N 27-7954036 THROUGH 27-7954121
