# SERVICE NO. 1375A BULLETIN

Date: November 29, 2022

**PERIODIC REPLACEMENT OF MAIN LANDING GEAR  
ATTACHMENT HARDWARE**

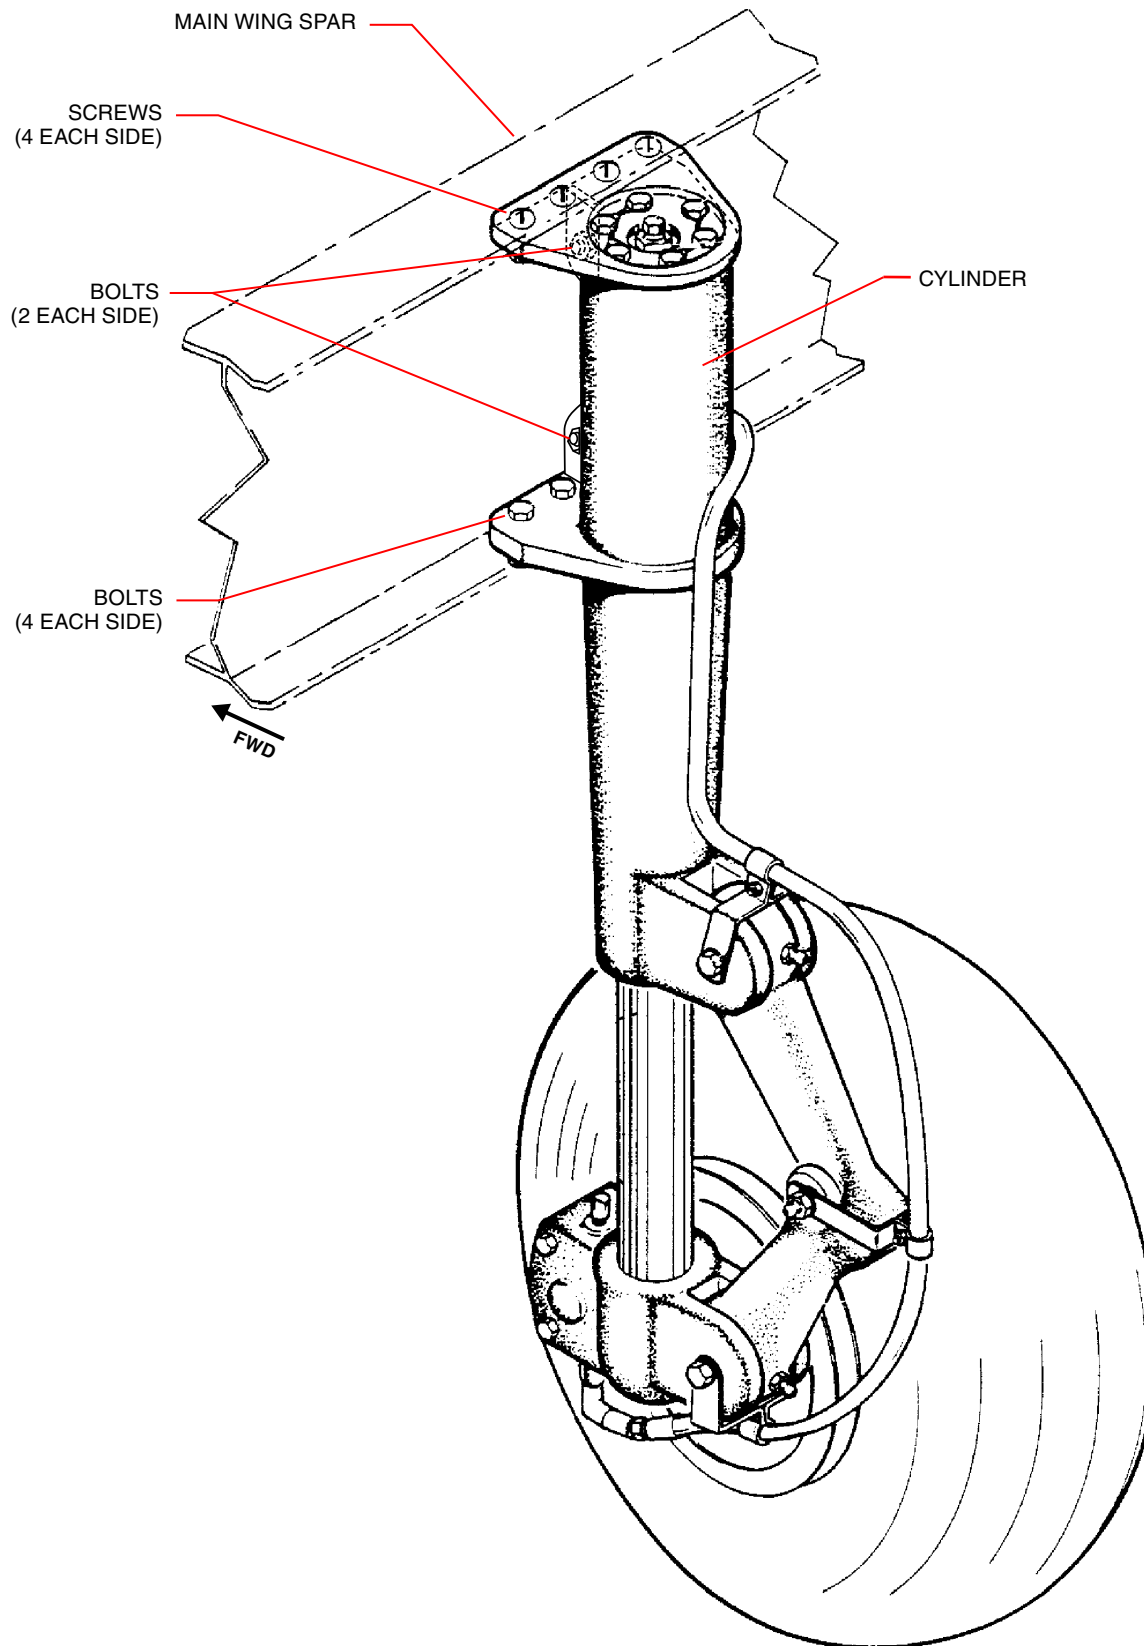
**Figure 1**  
Main Landing Gear – Mounting Hardware

A review of service history reveals that for the affected aircraft, the landing gear mounting hardware is subject to metal fatigue and corrosion. Failure of this hardware could result in a landing gear collapse.

The main landing gear (MLG) are attached to the aircraft with threaded fasteners that pass through mounting flanges on the strut cylinder and the upper and lower flanges of the main wing spar, as depicted in the illustration below. On some of the affected aircraft, additional threaded fasteners pass through the web of the main wing spar.

1. Place the aircraft on jacks.
2. Remove the fairing from around the strut cylinder housing and the access plate located on the bottom of the wing and to the rear of the housing by removing attaching screws.
3. Remove and discard all of the threaded fastener stack ups (which includes screws and bolts, as well as nuts and washers) that attach the MLG to the main wing spar. (See "Figure 1" on page 5.)

- a. Measure the bolt holes common to the main wing spar and the landing gear cylinder (four holes through the lower spar flange and two through the spar web). Compare measured holes sizes against the acceptable maximum hole sizes shown in Table 1.
- If all bolt holes do not exceed the values shown in Table 1, then no modification is required. Proceed to Step 5.
  - If one or more bolt holes exceed the values shown in Table 1, it may be possible to replace the factory original hardware with a 1/64 or 1/32 oversize repair bolt. provided the minimum dimensional requirements as out-lined in 4 b. 1) and / or 4 b. 2) are complied with Proceed to Step 4. b.

5. Order and install new mounting hardware, as specified in the applicable Piper Airplane Parts Catalog (IPC).
6. Apply primer/corrosion protection to reworked areas.
7. Reinstall the access plate onto the bottom of the wing and the fairing that surrounds the strut cylinder housing.
8. Remove the airplane from jacks.
9. Make a logbook entry documenting compliance with this service bulletin.
