**MANDATORY****MEL-57-01****TITLE**

WINGS - FORWARD LOWER SPAR CAP INSPECTION

Cracks have been found in the forward lower carry through spar cap. An undetected crack can cause the spar cap to break which could result in flight instability and potential loss of control.

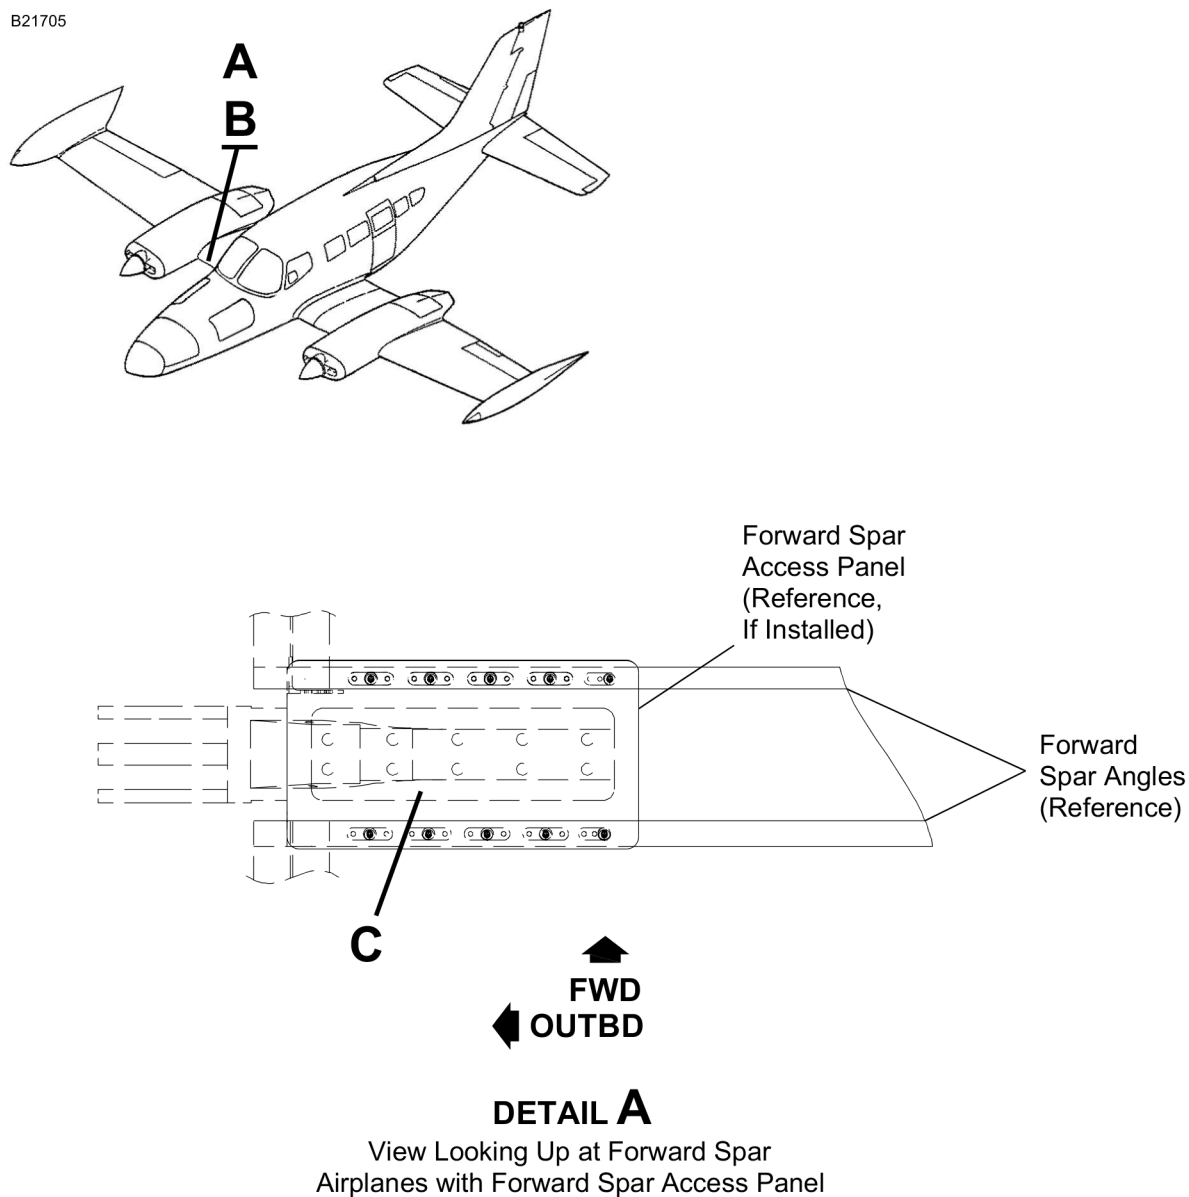
Figure 1. Carry Through Spar Cap Inspection (Sheet 1)

- Model 421C airplanes remove panels 511AB, 511AT, 512AT, 611AB, 611AT and 612AT. (Refer to the Model 421C (1976-1985) Service Manual.)
- A. (Airplanes with the forward spar access panels. Refer to Figure 1, Detail A.) Remove the 5292032-4 or 5292031-10 Forward Spar Access Panel if installed with MEB-57-01, MEB-57-02 or SK425-49.

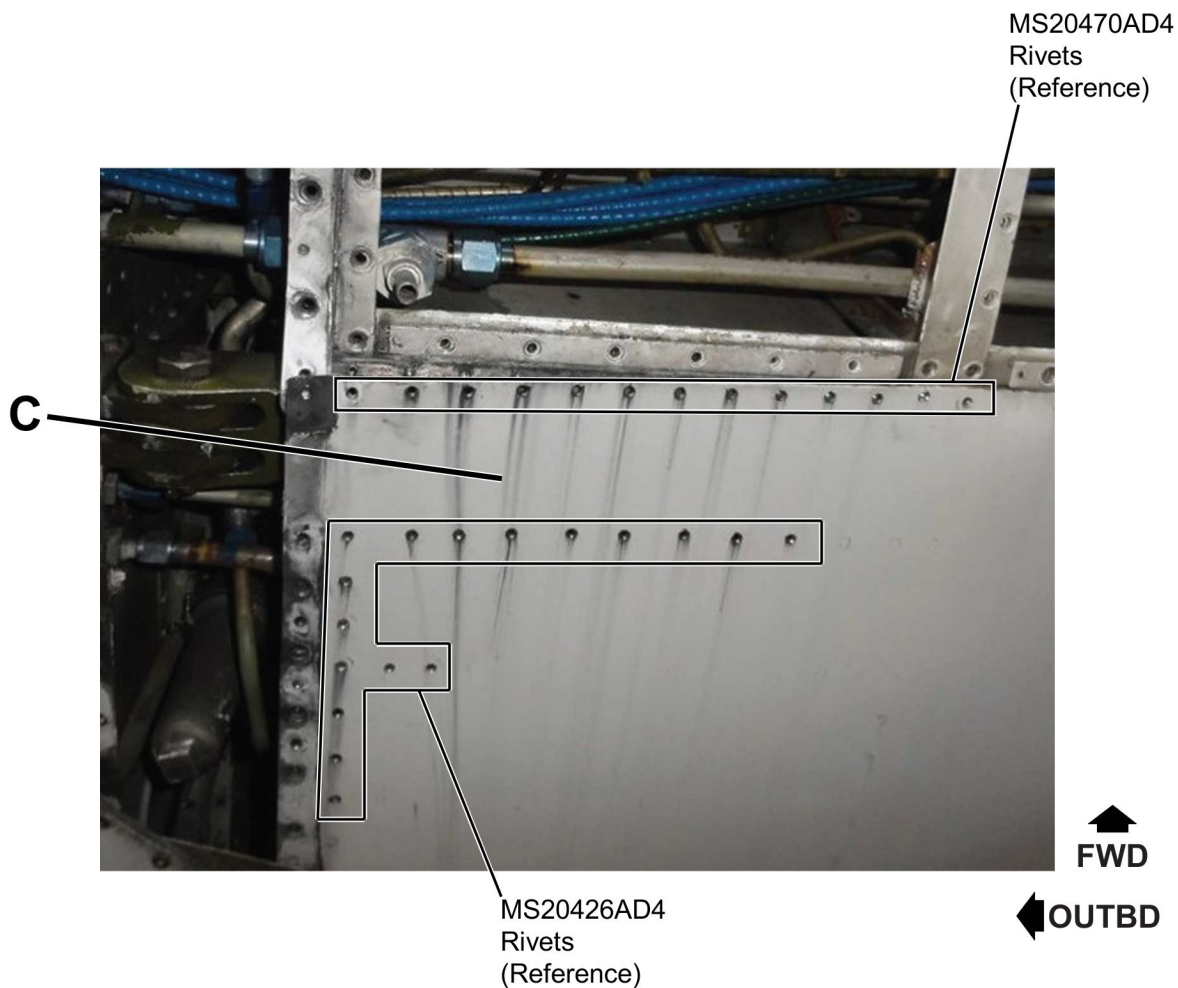
Figure 1. Carry Through Spar Cap Inspection (Sheet 2)

- B. (Airplanes without the forward spar access panels. Refer to Figure 1, Detail B.) Remove rivets as necessary from the left and right lower stub wing skin sufficient to get access to the bottom surface of the lower carry through spar cap for the visual inspection.

**NOTE:** For airplanes that do not have access panel installed.  
The rivet length determined at time of installation.

7. (Airplanes without forward spar access panels.) Install MS20426AD4-X and MS20470AD4-X Rivets to secure the stub wing skin.

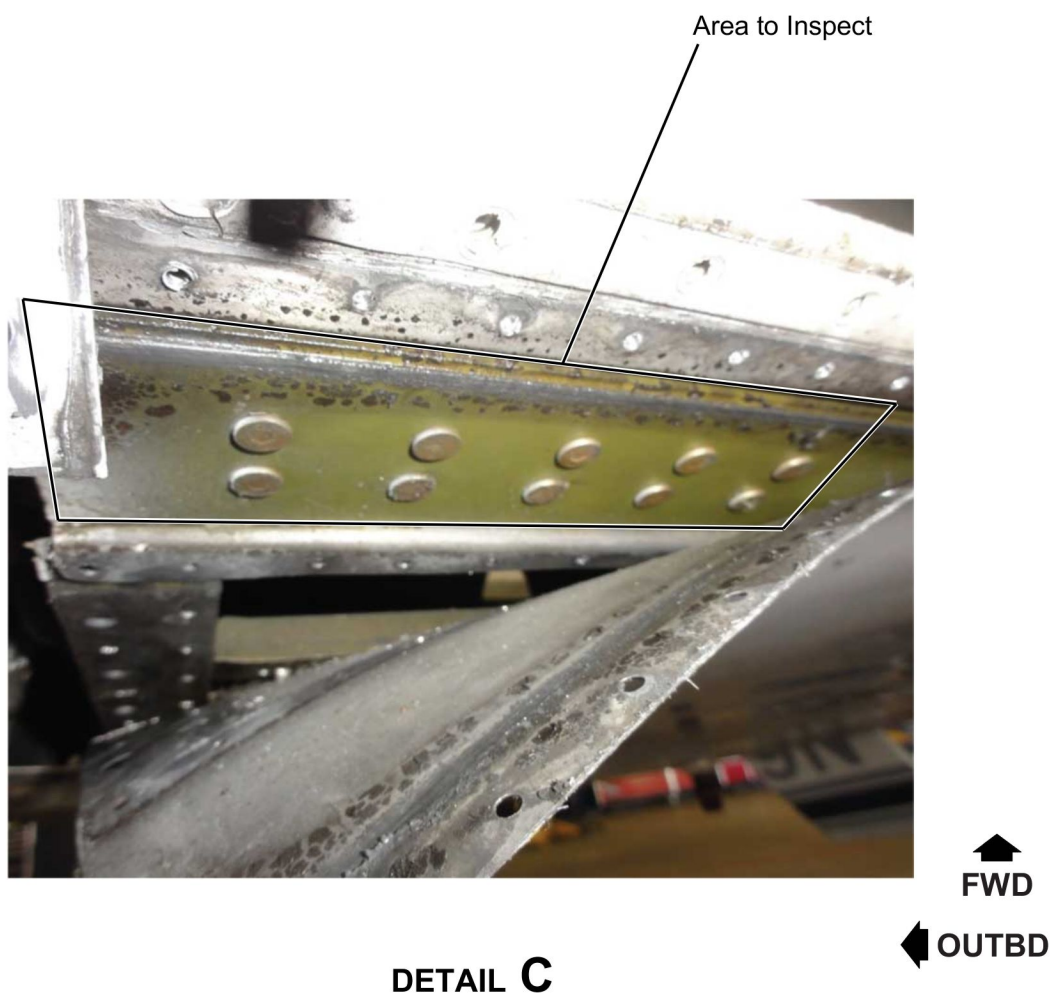
Figure 1. Carry Through Spar Cap Inspection (Sheet 3)

- 3. Clean the lower surface of the left and right side of the carry through spar cap as follows:
  - A. Use a suitable solvent to remove all grease and dirt from the lower spar cap area.
  - B. Wash the remaining solvent off with soap and water and let air dry.
- 4. (Refer to Figure 1, Detail C.) Do a detailed visual inspection of the left and right side of the carry through spar cap as follows:

- A. Use a suitable light source and a 10X Magnifying Lens to inspect the bottom surface of the left and right side of the carry through spar cap inboard of the lower fittings in the area extending 1-inch inboard to 1-inch outboard of the two rows of fasteners and around all 10 fasteners.

- B. If a crack is found, no further flight is permitted. Contact Cessna Structures at: csstructures@txtav.com, or phone: 316-517-6061.
- C. If an area is questionable, do a surface eddy current examination, go to Step 5.
