SERVICE BULLETIN M20-282

DATE: October 30, 2003

**SUBJECT:** INSPECTION OF AVIONICS PRODUCTS, EATON, MOONEY OR VICKERS LANDING GEAR ACTUATORS [MAC P/N'S – 560254-501, -503, -505, AND –507; AVIONICS PRODUCTS AND EATON (OR VICKERS) P/N'S 102000-1, -2, -3, -4, -5, -7]

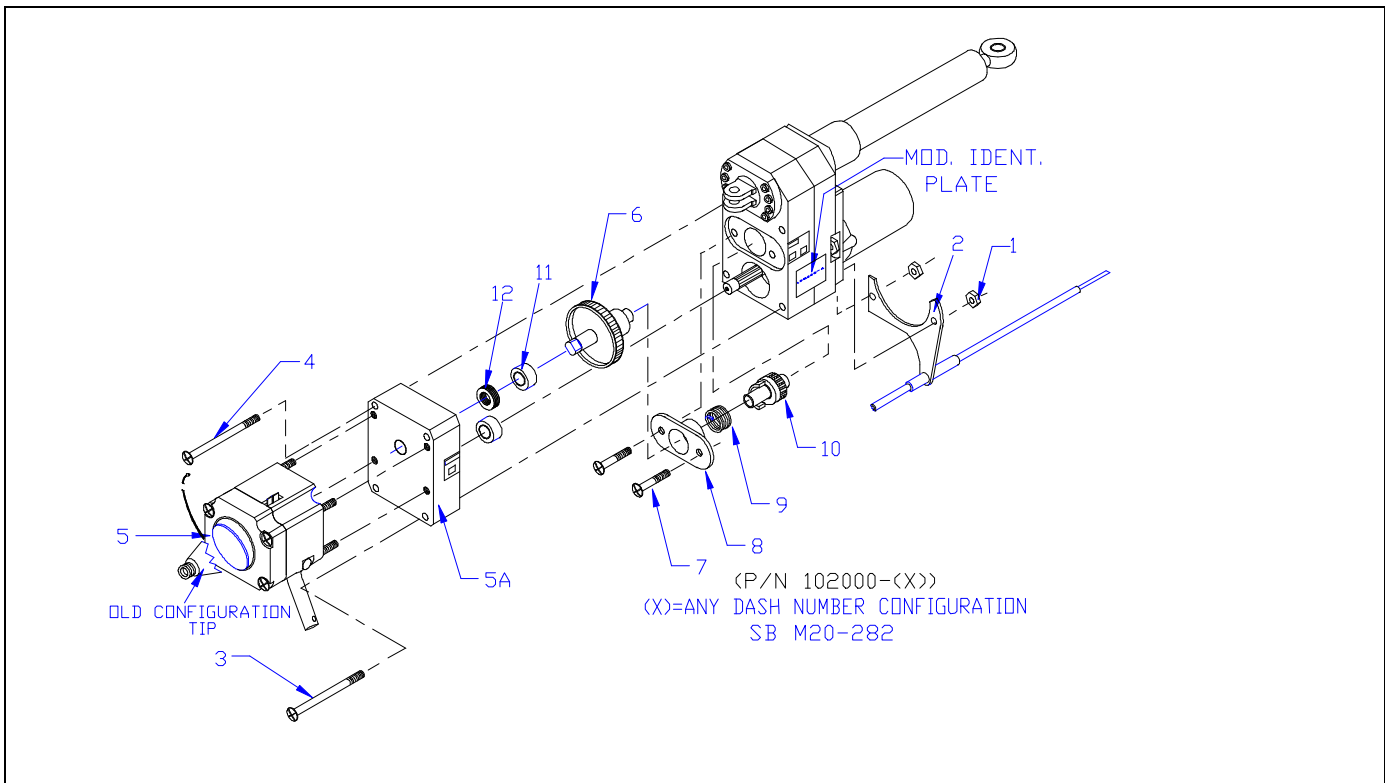
FIGURE SB M20-282-1

**DISASSEMBLY OF ACTUATOR:** [Reference **Figure SB M20-282-1**]

1. To avoid stripping screw heads, use impact screwdriver to break Loctite thread seals and remove two (2) long screws (Item 3) and two (2) short screws (4).
2. With razor or similar tool, slice through identification plate and remove recoiler assembly (5) and Clutch Housing Mount Assembly (5A).

3. Remove input gear assembly (6) from clutch housing (8) by pulling with slight force.
10. Remove two (2) screws (7) and remove clutch housing (8), "No-Back" Clutch Spring (9), and output gear assembly (10) from actuator body.
4. Remove "No-Back" Clutch Spring (9) from clutch housing using input gear assembly (6) as removal tool. Insert input gear assembly (6) into "No-Back" Clutch Spring from flanged end of housing (8). Remove "No-Back" Clutch Spring by rotating gear CCW and pulling slightly.

1. Lubricate clutch housing and new spring with lubricant supplied [MIL-G-81322].
2. Use gear assembly (6) as insertion tool; place new "No-Back" Clutch Spring on cam end of assembly and while rotating CCW, install "No-Back" Clutch Spring into clutch housing to about mid-point. **DO NOT FORCE SPRING**. While rotating CCW, gently push "No-Back" Clutch Spring into housing bore until fully seated.
3. Withdraw gear assembly (6).
4. Insert clutch gear assembly (10) into "No-Back" Clutch Spring and housing from cylindrical end of housing, insuring that "No-Back" Clutch Spring tangs fit into recesses in cam.

5. Lubricate output gear teeth (10) (lubricant supplied in kit) and install clutch housing, gear and spring assembly into actuator body by mating gear (10) to the output gear train assembly. To engage gear teeth and fully seat hub into bearing, rotation of gear assembly may be required.
6. Re-install screws (7) to secure clutch housing into actuator body. Use Loctite, Grade A, on threads.
7. Re-insert input gear assembly (6) into clutch housing and "No-Back" Clutch Spring assembly until fully seated. Lubricate gear teeth (6) with lubricant supplied in kit.

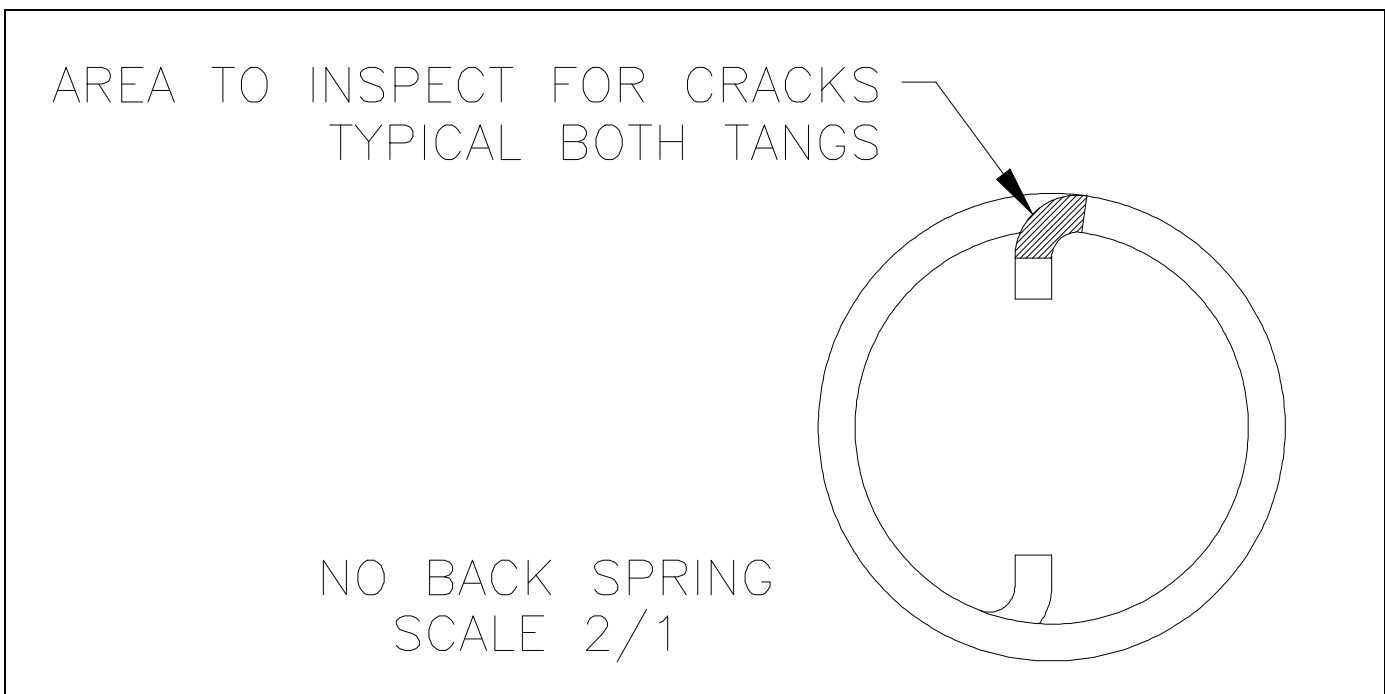
FIGURE SB M20-282-2

1. The inspection will require the use of a magnifying glass in the 16X to 40X power range. This inspection should be conducted in a clean room environment with good lighting.
2. If a maintenance shop has any "No Back" Clutch Springs in inventory, it is recommended that these also be visually inspected by qualified shop QA personnel in accordance with the criteria of Step 3 below and tagged as approved with a NOTE or Date Stamp documented by the maintenance shop QA personnel.
3. All clutch springs, either from the actuator or from shop inventory, must be visually inspected at the bend radius of both "tang ends" for evidence of any type of crack or stress fracture in the outboard, bend radius [reference **Figure SB M20-282-2** for additional inspection criteria]

4. If any evidence of a crack or stress is found, the clutch spring must be discarded.
5. An approved, new clutch spring that has been inspected and documented as inspected and approved either by a maintenance shop's QA personnel per Step 2 above or a clutch spring received from Mooney Airplane Company, Inc., which has been inspected by MAC Quality Inspection Department personnel are eligible for installation into the actuator removed from the aircraft.
