## **ALERT SERVICE BULLETIN**

**222-26-115**

**MODEL AFFECTED:** 222

**SUBJECT:** TAIL ROTOR PITCH HORN ASSEMBLY P/N 222-012-774-109, REMOVAL FROM SERVICE.

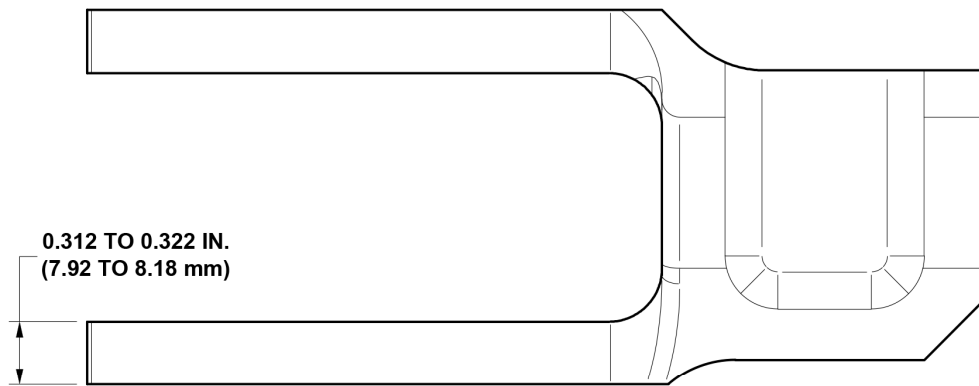
222-012-705

The part number of the pitch horn assembly is vibro-etched on the component. The physical differences between the 222-012-705-XXX pitch horn assembly and the 222-012-774-XXX pitch horn assembly are shown in Figure 1.
