## **ALERT SERVICE BULLETIN**

**505-20-17**

**MODEL AFFECTED:** 505

**SUBJECT:** FLAP RESTRAINT SUPPORT P/N 206-010-181-101,  
ONE-TIME INSPECTION OF

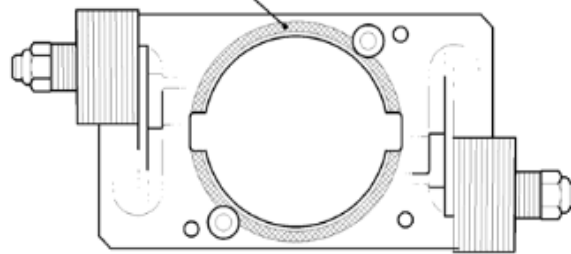
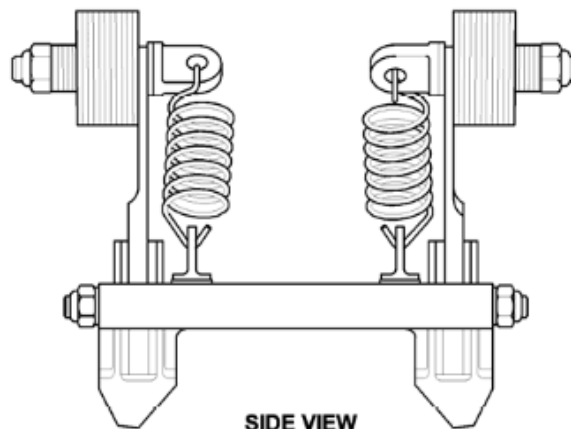
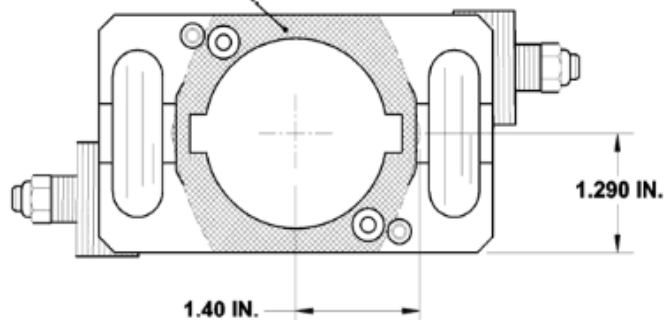
**FIGURE 1 – Flap Restraint Support Surface Contact Area**

2. Remove the flap restraint assembly [DMC-505-A-62-20-02-00A-520A-A](#).
3. Inspect the flap restraint support surfaces in contact with the mast nut and the main rotor trunnion for presence of clear coat (Figure 1). Clear coat is not acceptable at the areas shown.

PRIMER ONLY ON SURFACE IN CONTACT  
WITH MAST NUT FOOT PRINT

PRIMER ONLY ON SURFACE  
IN CONTACT WITH TRUNNION

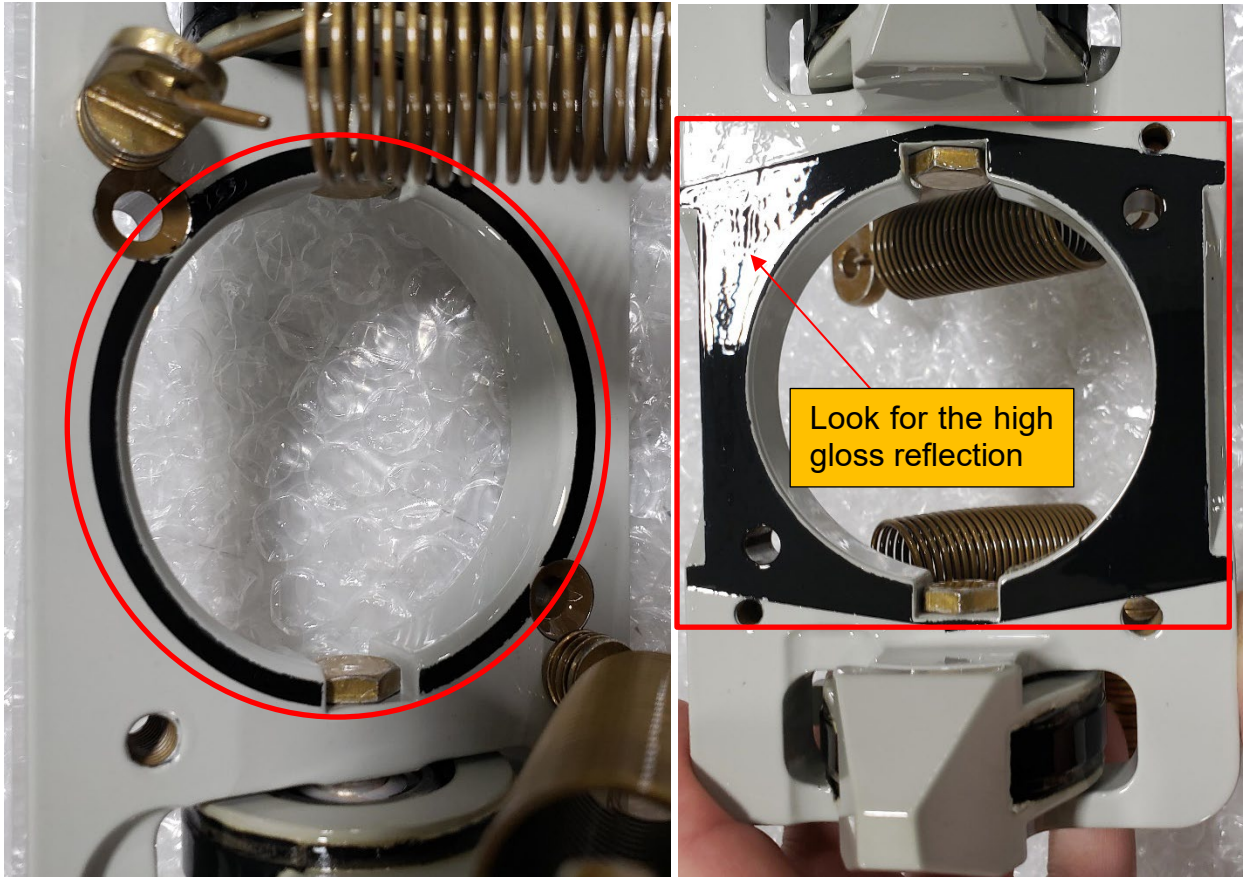
**FIGURE 2 – Example Flap Restraint Support WITH Clear Coat**

The investigation revealed that the loss of torque was due to application of clear coat on the flap restraint support P/N 206-010-181-101 at the areas in contact with the mast nut and the main rotor trunnion.

- a. If **no** clear coat is found overlaying the primer (Figure 2), go to step 4.
  - b. If clear coat **is found** overlaying the primer (Figure 2), remove the clear coat as follows;
    - (1) Remove clear coat by sanding using 180 grit abrasive paper (C-423) and wiped clean with solvent. Some amount of clear coat may be removed with cheese cloth (C-486) soaked with MEK (C-309) or equivalent solvent.
4. Install the flap restraint assembly [DMC-505-A-62-20-02-00A-720A-A](#).
  5. Make an entry in the helicopter logbook and historical service records indicating findings and compliance with this Alert Service Bulletin.
