# ALERT SERVICE BULLETIN

NO. 407-10-93

**MODEL AFFECTED:** 407

**SUBJECT:** TAILBOOM ATTACHMENT HARDWARE,  
REPLACEMENT OF.

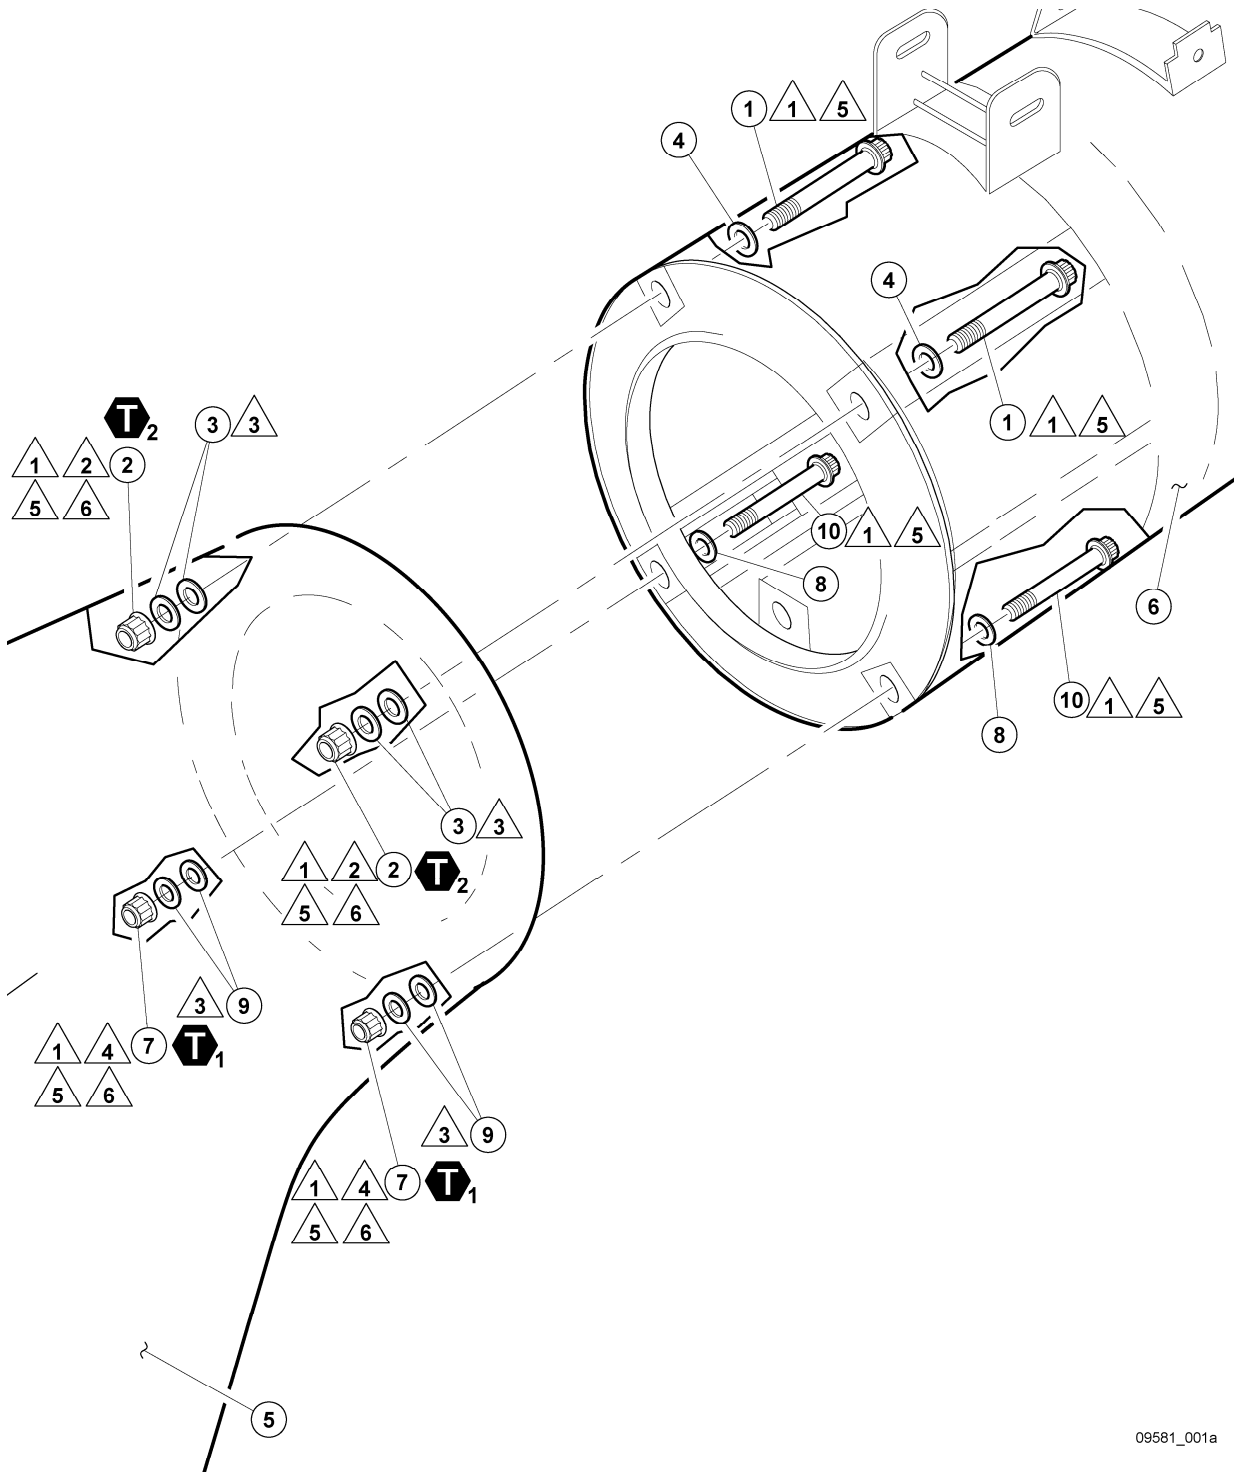
FIGURE 2: Replacement of tailboom upper attachment bolts (Sheet 1 of 2)

Bell Helicopter has reviewed the tailboom attachment installation of the Model 407. It has been determined that the torque values specified in the maintenance manual and used during assembly of the 407 for the tailboom attachment bolts exceed the specified torque range recommended for subject bolts.

1 360 TO 370 INCH/LBS  
(40.6 TO 41.8 Nm)

2 570 TO 580 INCH/LBS  
(64.4 TO 65.5 Nm)

1. (Ref. Figure 2) Remove left upper attachment bolt (1) and nut (2) but retain the chamfered washer (4) and the regular washers (3). Discard the nut (2) and the bolt (1) you have removed.

2. Install a new bolt (1) procured from a BHT-Approved supply source as follows:
  - a) Coat the shank of the new bolt (1) and the faying surfaces of the chamfered washer (4) with anti-corrosion compound (C-586). Do not apply compound on any threads of the bolt (1).
  - b) Fit the new bolt (1) (with the chamfered washer (4) against head of bolt (1)) through the tailboom and the fuselage upper mating fittings.
  - c) Select a sufficient number of washers (3) for opposite end of bolt (1) to obtain a minimum of 1 to a maximum of 3 threads showing beyond the nut (2) after proper torque is obtained. Coat the faying surfaces of these washers (3) with anti-corrosion compound (C-586) and fit over shank of the new bolt (1).

3. Install a new nut (2) on the forward end of the bolt (1) as follows;
  - a) Coat the nut (2) faying surface prior to assembly. Do not apply compound on any threads of the nut (2).
  - b) Run the nut (2) on the threads of the mating bolt (1) with a dial indicator type torque wrench and measure existing tare.
  - c) Torque the nut (2) between 570 to 580 inch/lbs (64.4 to 65.5 Nm) of torque plus the tare of the nut (2), using socket P/N 407-230-001-101 or equivalent tool.
  - d) Back off nut (2) at least a minimum of  $\frac{3}{4}$  of a turn before re-applying the same torque between 570 to 580 inch/lbs (64.4 to 65.5 Nm) plus the existing tare of the nut (2).
  - e) Coat bolt (1) head, nut (2) and washers (3, 4) with anti-corrosion compound (C-586).
4. Repeat Steps 1 through Step 3 for the opposite right upper bolt (1) and mating nut (2).

5. (Ref. Figure 2) Remove left lower attachment bolt (10) and nut (7) but retain the chamfered washers (8) and the regular washers (9). Discard the nut (7) and the bolt (10) you have removed.

- a) Coat the shank of the new bolt (10) and the faying surfaces of the chamfered washer (8) with anti-corrosion compound (C-586). Do not apply compound on any threads of the bolt (10).
- b) Fit the new bolt (10) (with the chamfered washer (8) against head of bolt (10)) through the tailboom and the fuselage lower mating fittings.
- c) Select a sufficient number of washers (9) for opposite end of bolt (10) to obtain a minimum of 1 to a maximum of 3 threads showing beyond the nut (7) after proper torque is obtained. Coat the faying surfaces of these washers (9) with anti-corrosion compound (C-586) and fit over shank of the new bolt (10).

- a) Coat the nut (7) faying surface prior to assembly. Do not apply compound on any threads of the nut (7).
- b) Run the nut (7) on the threads of the mating bolt (10) with a dial indicator type torque wrench and measure existing tare.
- c) Torque the nut (7) between 360 to 370 inch/lbs (40.6 to 41.8 Nm) of torque plus the tare of the nut, (7) using proper tool.
- d) Back off nut (7) at least a minimum of  $\frac{3}{4}$  of a turn before re-applying the same torque between 360 to 370 inch/lbs (40.6 to 41.8 Nm) plus the existing tare of the nut (7).
- e) Coat bolt (10) head, nut (7) and washers (8, 9) with anti-corrosion compound (C-586)

1 Replace existing bolts and nuts by new ones.
-

2 Upper nut must have tare above minimum value of 14 inch-pounds (1.58 Nm).
-

4 Lower nut must have tare above minimum value of 9.5 inch-pounds (1.07 Nm).
-

6 Torque nut to indicated value then back off nut a minimum of 3/4 of a turn before retorquing again.
7. Perform torque check 1 to 5 hours after initial installation. Repeat this torque check at repetitive periods between 1 to 5 hours until torques stabilize at all 4 locations.
8. Perform torque check of all hardware every 300 hours of component operation.
