## **ALERT SERVICE BULLETIN**

**UH-1H-II-26-38**

**MODEL AFFECTED:** UH-1H-II

**SUBJECT:** COUPLING 204-040-603-007, -009 and -011,  
INSPECTION OF

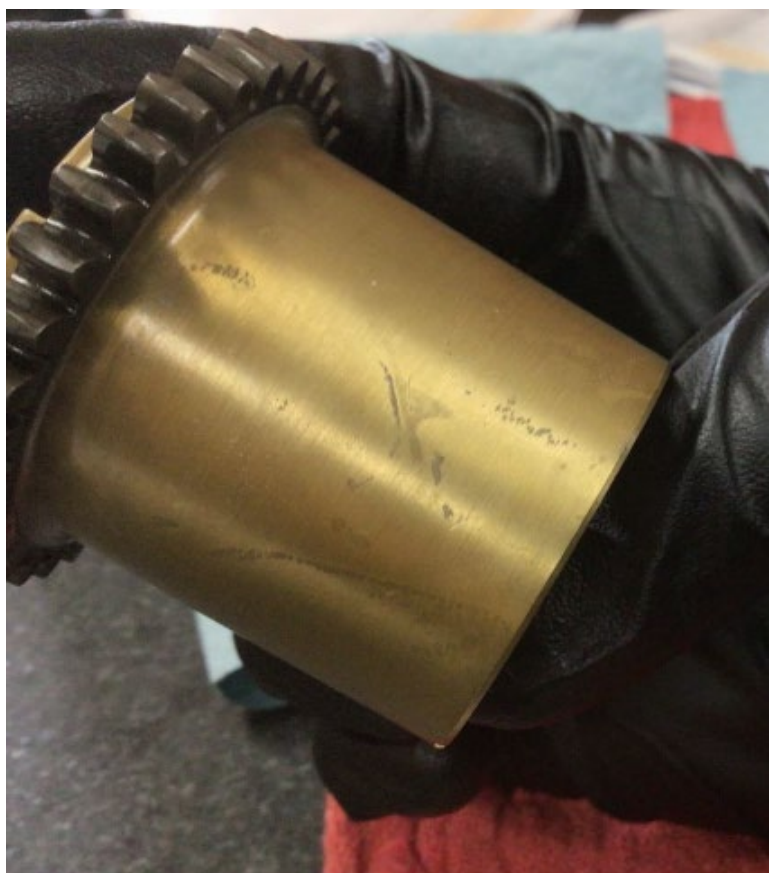
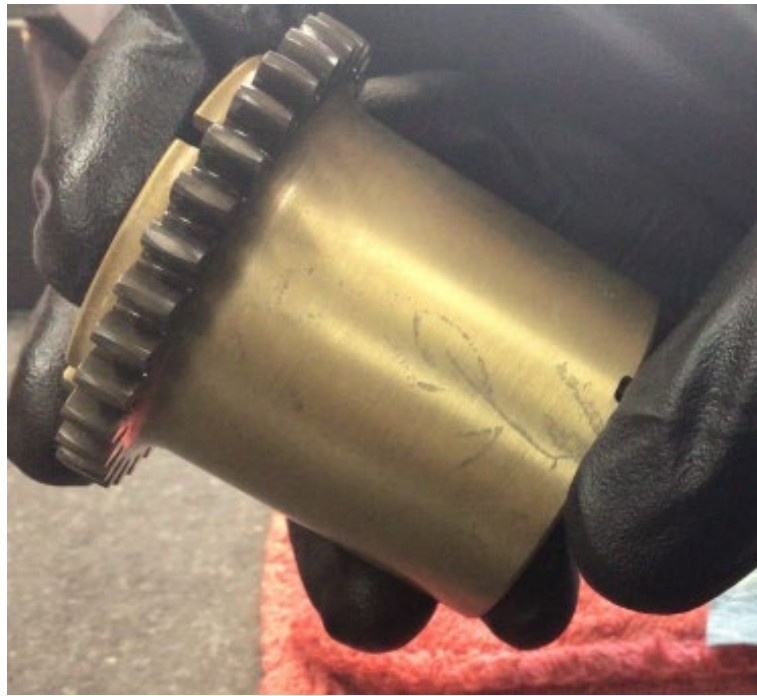
Some 204-040-603-007, -009 and -011 tail rotor drive inner couplings may have been delivered with corrosion damage on the cadmium-plated surfaces as illustrated in Figure 1 of the Accomplishment Instructions. The suspected -007 couplings, listed in the Parts Affected block were manufactured in June 2021. The suspected -009 couplings were manufactured between September 2020 and September 2022 while the suspected -011 couplings were manufactured between November 2020 and August 2021.

3. Disassemble the coupling assembly and thoroughly clean the 204-040-603 inner couplings, for inspection (BHT-212-CR&O).
4. With reference to Figure 1, inspect the coupling outside diameter (OD) for presence of corrosion.

**Figure 1 (sheet 1 of 2) - Examples of corrosion on the coupling OD.**

5. For couplings with corrosion on more than 10% of the total cadmium plated OD surface:
  - a. If the corrosion depth does not exceed 0.005 inch (0.127 mm) or cannot be felt with a 0.020 inch (0.508 mm) radius probe, remove the coupling from service within the timeframe specified for **PART II**.

- b. If the corrosion depth exceeds 0.005 inch (0.127 mm) or can be felt with a 0.020 inch (0.508 mm) radius probe, replace the coupling before the next flight.

6. For couplings with corrosion on less than 10% of the total cadmium-plated OD surface that cannot be removed manually with a white Scotch Brite (or equivalent) pad:

- a. If the corrosion depth does not exceed 0.005 inch (0.127 mm) or cannot be felt with a 0.020 inch (0.508 mm) radius probe, remove the coupling from service within the timeframe allowed for accomplishment for **PART II**.

7. For couplings with corrosion on less than 10% of the total cadmium-plated OD surface that can be removed manually with a white Scotch Brite pad (or equivalent), remove all corrosion and apply brush cadmium plating to the repaired surface (BHT-ALL-SPM).

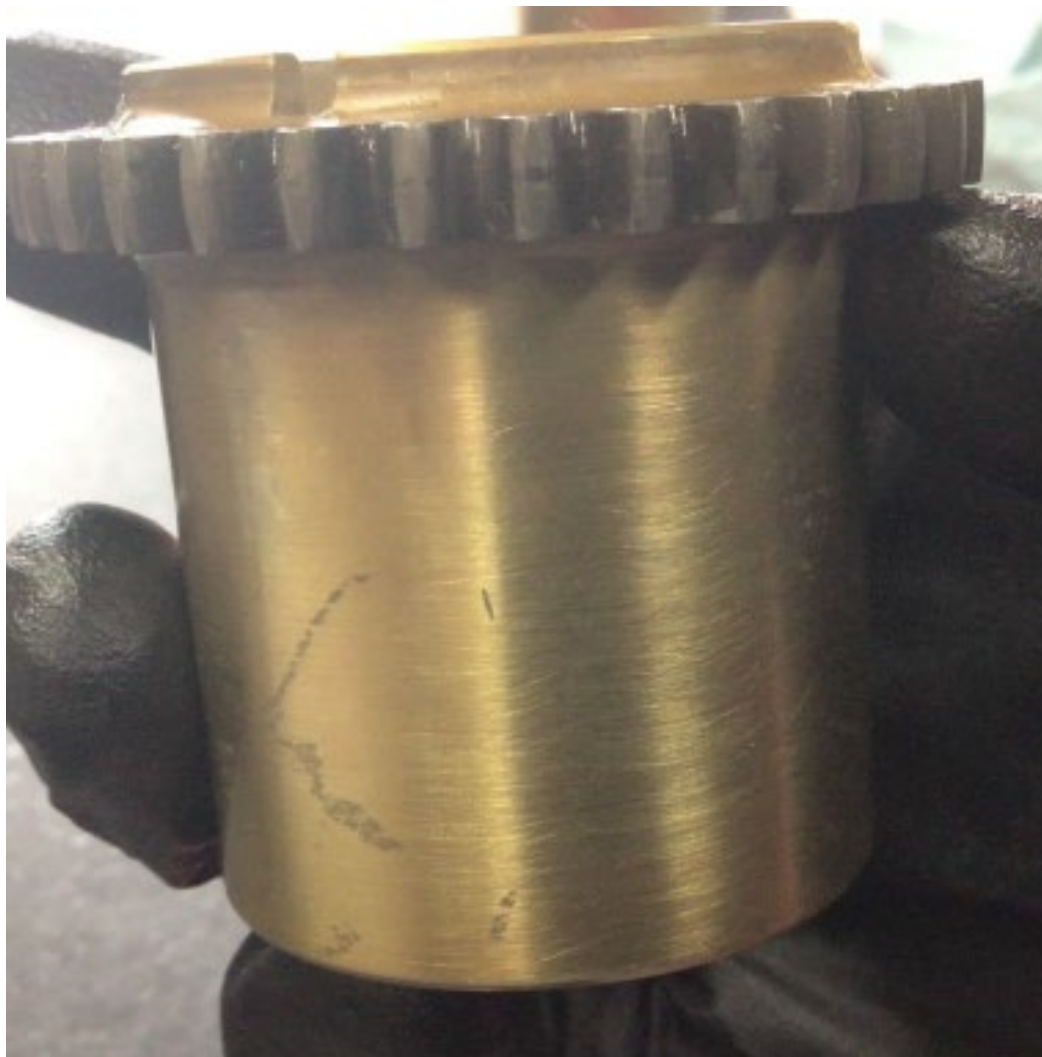
**Figure 1 (sheet 2 of 2) - Examples of corrosion on the coupling OD.**
