## SB Issuer/TC holder

**Company name:** Pipistrel Vertical Solutions d.o.o.  
**Address:** Vipavska cesta 2, 5270 Ajdovščina, Slovenia  
**Website:** <http://www.pipistrel-aircraft.com>  
**Contact:** +38653663873  
**Type:** ALPHA Trainer  
**Model** ALPHA Trainer LSA, ALPHA Trainer, ALPHA Club

| <b>SB Name:</b> | <b>Fuel system inspection</b> |
| <b>Subject:</b> | Fuel odor check in the aft cabin area. |

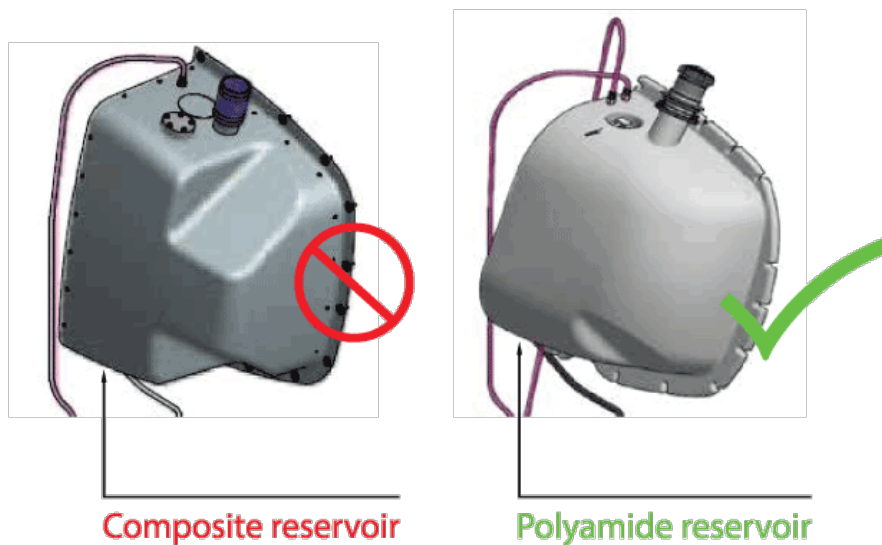
| <b>Affected Aircraft:</b> | All Pipistrel ALPHA Trainer and LSA ALPHA Trainer aircraft <u>with polyamide fuel reservoir installed (p/n; 1292010)</u> . See REMARKS section for details (Figure 1. and Figure 2.). |

Figure 1: Composite and polyamide reservoir. The main notable differences are the material, shape and fittings.

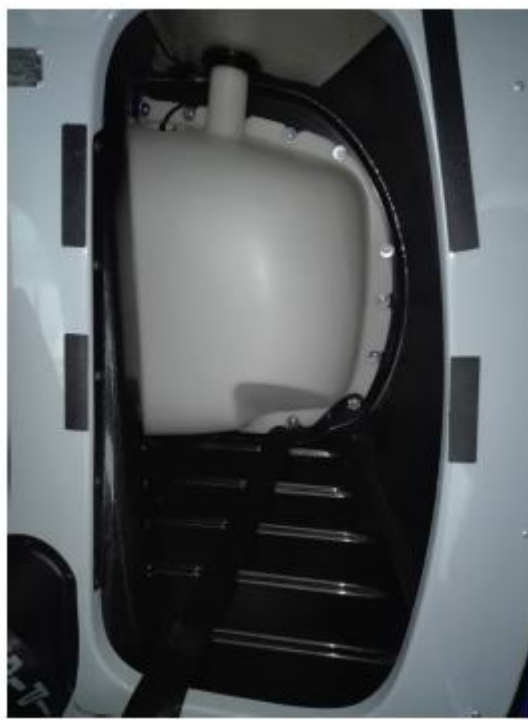
Figure 2: Polyamide reservoir.

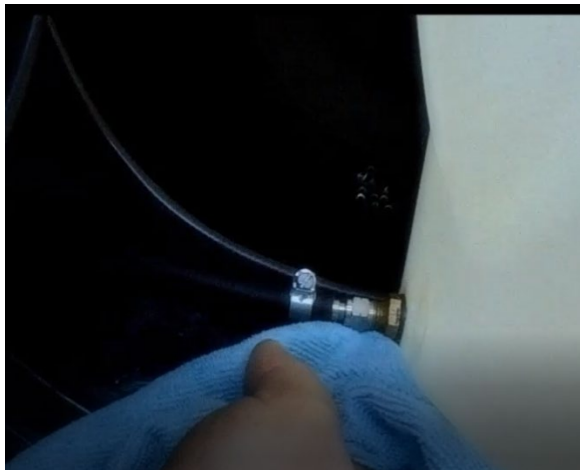
Figure 3: Dry cloth inspection

**NOTE:** The figure above merely illustrates how to inspect for moisture. It is not representative of the fuel outlet configuration found on the affected aircraft.

| <b>Actions:</b> | <p><b>Part 1: Inspection</b></p> <ol style="list-style-type: none"><li>Remove the crew seats.</li><li>Check for any smell/odor of fuel.</li><li>If nothing is detected proceed to step g. If smell/odor of fuel is present proceed to step d.</li><li>Remove baggage compartment (if applicable).</li><li>Check for moisture along the fuel lines, reservoir outlet and fuel fittings in the area aft of cabin (Figure 3).</li></ol> <p><b>WARNING: If the smell of fuel or any signs of moisture are present, flying the aircraft is not recommended. Please contact Pipistrel (<a href="mailto:support@pipistrel-aircraft.si">support@pipistrel-aircraft.si</a>) for further guidelines.</b></p> <ol style="list-style-type: none"><li>Install baggage compartment (if applicable).</li><li>Install the crew seats.</li></ol> |
