# EMERGENCY **ALERT SERVICE BULLETIN**

| COLIBRI | Number | VERSIONS | |
|---|---|---|---|
| <b>EC120</b> | <b>24A012</b> | Civil: | <b>B</b> |

SUBJECT: **ELECTRICAL POWER**

EMERgency SWitch (EMER SW) wiring

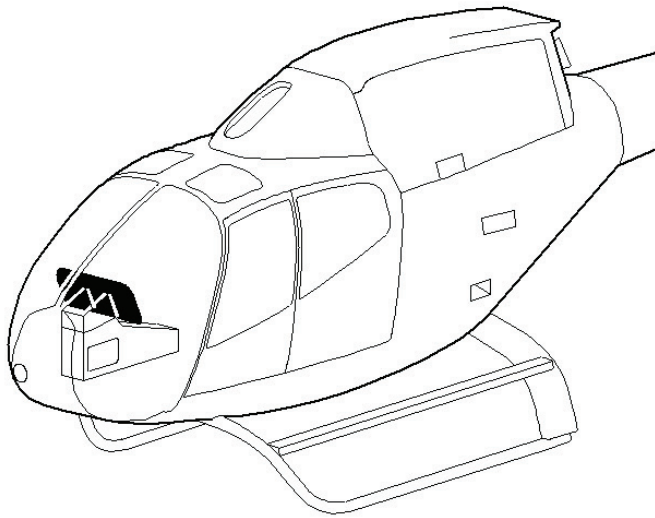
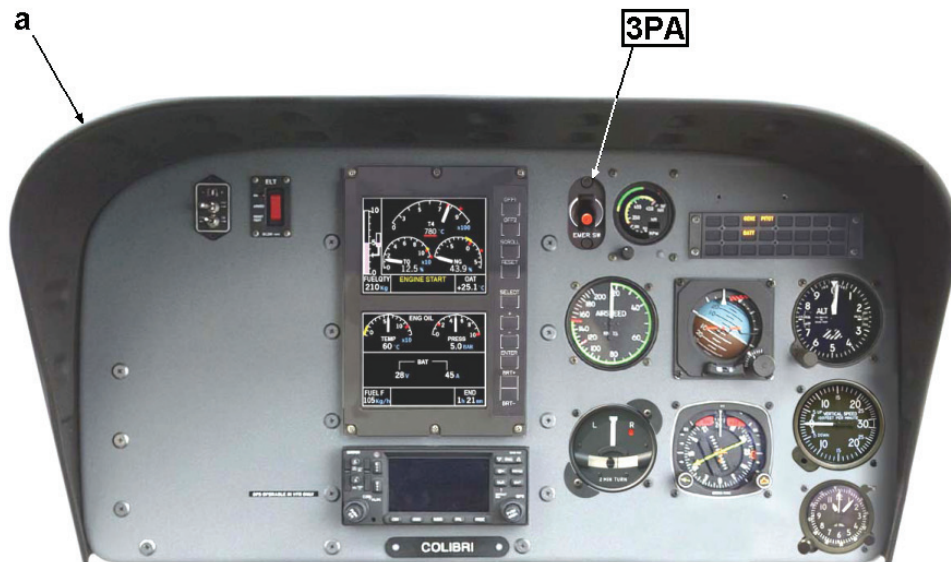
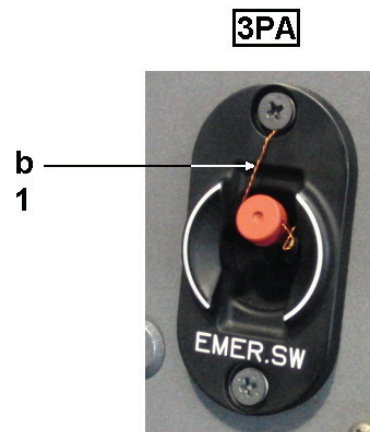
Figure 1 - "EMER SW" Switch

The technical investigations conducted revealed that cross-wiring at the "EMER SW" switch caused the malfunction. In this configuration, the "smoke in the cockpit/cargo" procedure described in the flight manual does not isolate the equipment electrical power supply.

- Using tool (zz), reconnect "EMER SW" (3PA) switch wires in compliance with Figure 2:
  - . Wire marked "2431-0016" to terminal "3PA-1A".
  - . Wire marked "2431-0003" to terminal "3PA-2A".

- . [BAT/EPU]: ON  
Check that all equipment items are energized.
- . [BAT/EPU]: OFF
- . [GENE]: ON  
Check that all equipment items are energized.
- Stop the engine and rotors.
- Replace snapwire (b) (Figure 1) with snapwire (1).
