EUROCOPTER  
DIRECTION TECHNIQUE SUPPORT  
13725 MARGNANE CEDEX FRANCE

# ALERT SERVICE BULLETIN

**No. 55.00.16**

Improvement of attachment strength for upper and lower fin skids

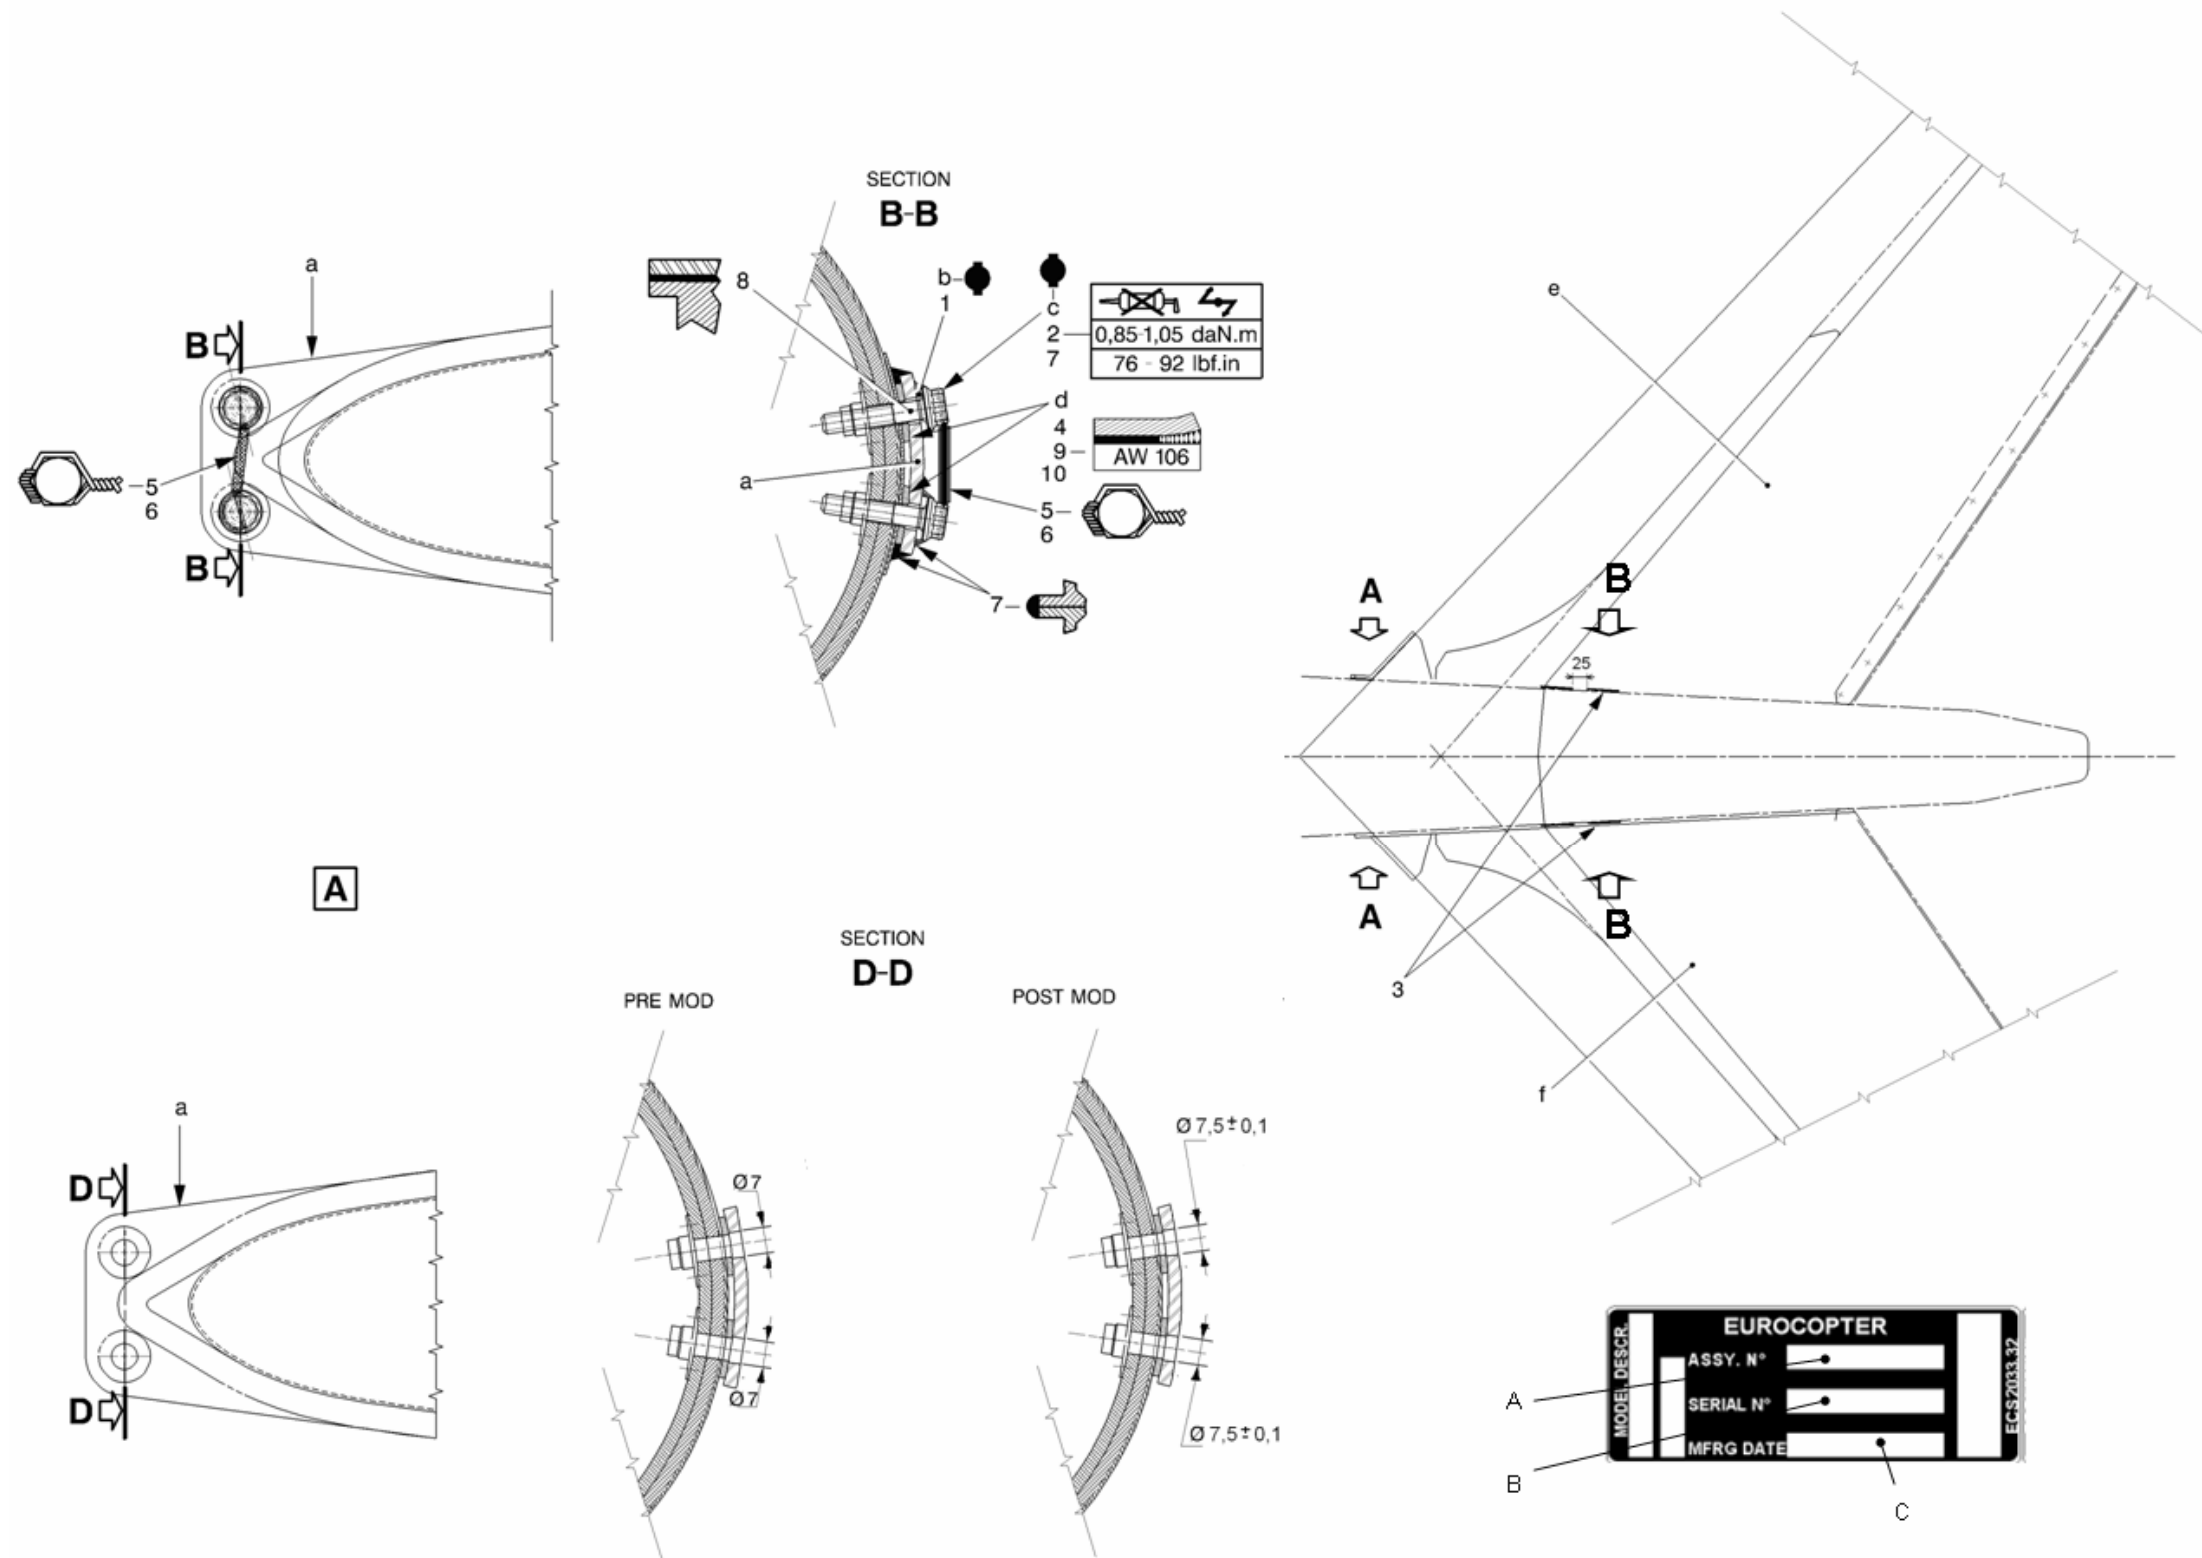
Figure 1

During take-off of an aircraft from Ecureuil family, the upper fin tilted leftwards.

- reducing risks of loaded installation by increasing the diameter of passage holes for bolts on lower and upper fin attachment fittings on tail boom.
- improving fatigue strength of upper and lower fin attachment by replacing bolts P/N: 22126BV060032L with special bolts with higher head P/N: 350A23-4016-20 and replacing washers P/N: 23112AG060LE with special washers P/N: 350A23-4017-22.

- Remove and separate upper fin (e) from lower fin (f) as per Work Card 55.00.00.402 (MET).
- Scrap bolts (c) and washers (b).

- Increase initial diameter of passage holes for bolts in fitting (a) from 7 mm to 7.5 mm + or – 0.1 mm.
- Deburr and carry out protection against corrosion.
- Carry out paint touch up, as required, as per Work Card 20.04.05.101 (MTC).

- Assemble upper fin (e) and lower fin (f) as per Work Card 55.00.00.402 (MET).
- Offer up fin assembly on tail boom.
- Check presence of peel washers (d) installed underneath fitting (a):
  - If peel washers are present (d), check that fitting (a) is properly resting on existing washers (d). Otherwise, remove peel washers (d) and carry out procedure below,

- if no peel washers are present (d) check clearance between fin and skin of tail boom as per Work Card 55.00.00.402 (MET) and should setting be required:

- define thickness of peel washers (4) to be installed as per clearance read,
  - install and bond peel washers (4) on skin of tail boom by means of adhesive (9) and hardener (10) as per Work Card 20.06.02.303 (MTC).

- Loosen TGB attachment bolts TGB in order to facilitate installation of new bolts (2).
- Coat shank of bolts (2) with sealant (8).
- Fit bolts (2) fitted with washer (1).

- Tighten bolts (2) to torque.
- Safety bolts (2) by means of lockwire (5).
- Protect twist of lockwire (5) with a piece of sheath (6).
- apply bead of sealant (7) on periphery of fitting (a) of fin (e or f) and around heads of bolts (2).

- Tighten TGB attachment bolts as per Work Card 65.20.00.401(MET).
- Identifying as per paragraph 2.D.
- Carry out final steps defined in Work Card 55.00.00.402 (MET).
