# EMERGENCY ALERT SERVICE BULLETIN

## **SUBJECT: ENGINE CONTROLS - Twist grip**

**Functional check and installation of a protection for micro-contacts 53Ka and 53Kb and 65K (IDLE / FLIGHT mode)**

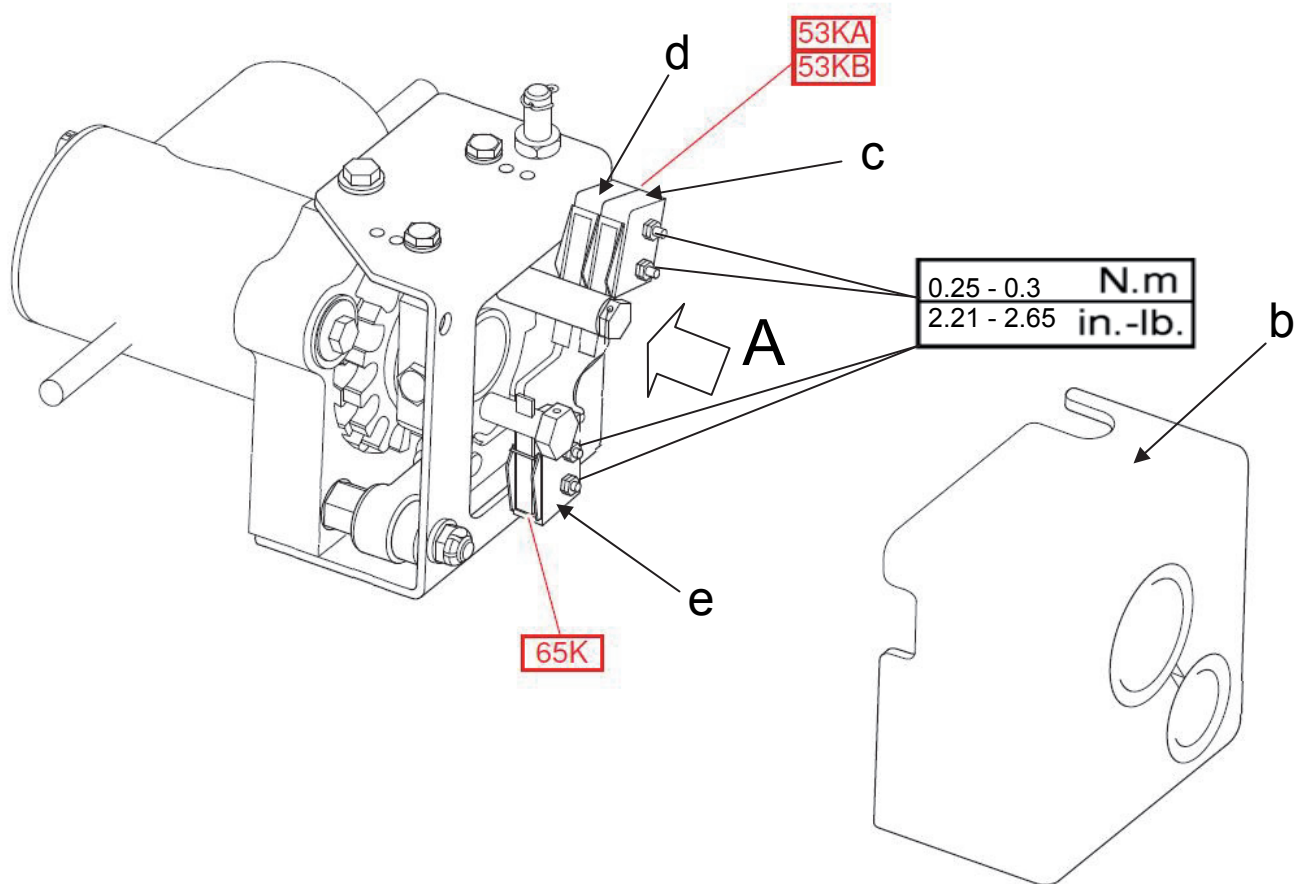
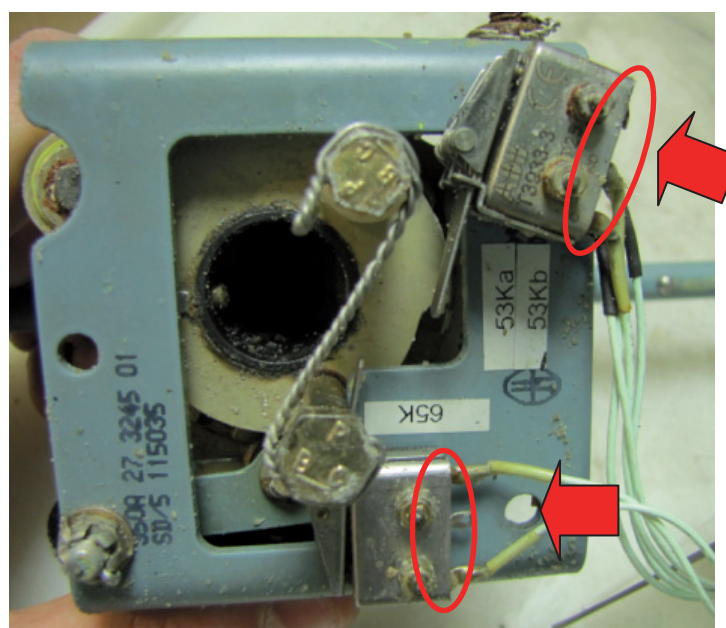
Figure 1

- Remove the lower front cowl as per AMM Task 53-51-00, 4-2.
- Remove the protective cowl (b).
- Inspect the wiring side of micro-contacts (c), (d) and (e) in order to ensure that there are no marks, residues or corrosion (DETAIL A - Figure 1).
- If there are marks, residues or corrosion, comply with paragraph 3.B.2.
- If there are no marks, residues or corrosion, comply with paragraph 3.B.3.

- Disconnect electrical connector 87DELTAP1 (a).
- Loosen and remove micro-contacts (c, d) and (e) as per AMM Task 76-12-03, 4-1 (AS350 and AS550) or 76-12-03, 4-1b (EC130).
- For each micro-contact, note the position of the wires on the terminals.
- Remove and discard the sheath.
- Remove any varnish present.
- Unsolder the wires.
- Clean the wire side as per MTC Work Card 20.04.03.401 or 20.04.03.103.

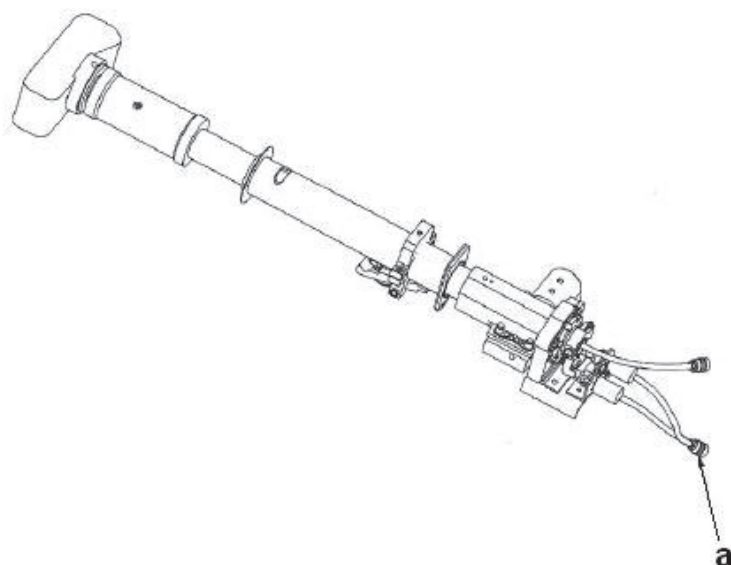
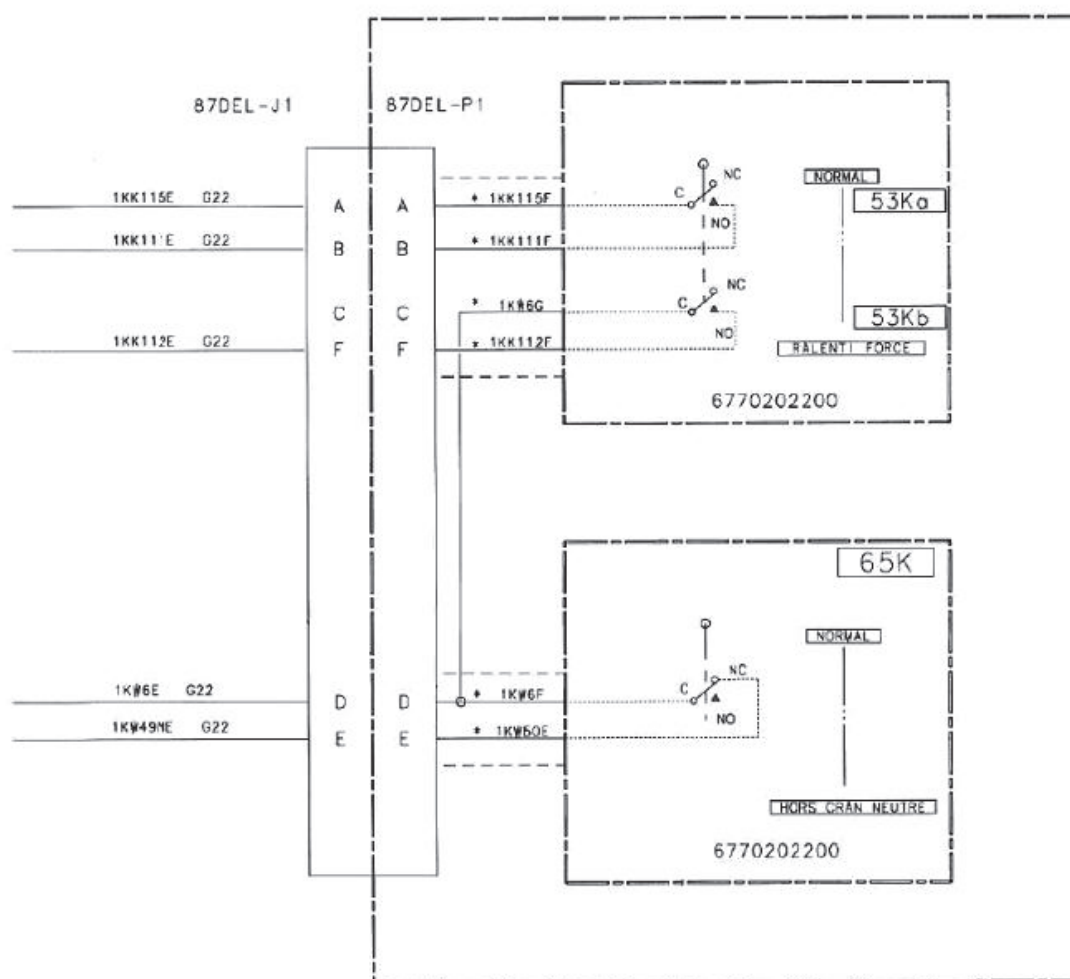
Figure 2: Electrical continuity test of micro-contacts 53Ka, 53Kb and 65K

- If not previously disconnected, disconnect electrical connector 87DELTAP1 (a).
- Carry out an electrical insulation test at 50 volts using a megohmmeter (zz) connected between:
  - . the housing of micro-contact 53Ka and terminals A and B of connector 87DELTAP1.
  - . the housing of micro-contact 53Kb and terminals D and F of connector 87DELTAP1.
  - . the housing of micro-contact 65K and terminals D and E of connector 87DELTAP1.Values higher or equal to 10 MΩ are acceptable.
- If the values displayed are lower than 10 MΩ, replace the concerned micro-contact as per AMM Task 76-12-03, 4-1 (AS350 and AS550) or 76-12-03, 4-1b (EC130).
- Comply with paragraph 3.B.4.

- Connect an ohmmeter (yy) to terminals A and B of micro-contact 53Ka.
- Turn the twist grip from "IDLE" to "FLIGHT" and from "FLIGHT" to "IDLE":
  - . Check on the ohmmeter (yy) that the micro-contact closes in the "IDLE" position and opens as soon as the twist grip is turned from the "IDLE" position to the "FLIGHT" position.

- . Check on the ohmmeter (yy) that the micro-contact closes in the "IDLE" position and opens as soon as the twist grip is turned from the "IDLE" position to the "FLIGHT" position.

- . If the check result is not correct, replace the concerned micro-contact as per AMM Task 76-12-03, 4-1 (AS350 and AS550) or 76-12-03, 4-1b (EC130).
