FUEL - FUEL LOW LEVEL FLOAT SWITCH (SL001, LEFT; SR001, RIGHT) MOUNTING NUT TORQUE INSPECTION

525 (M2)

SL525-28-06  
Page 1 of 3

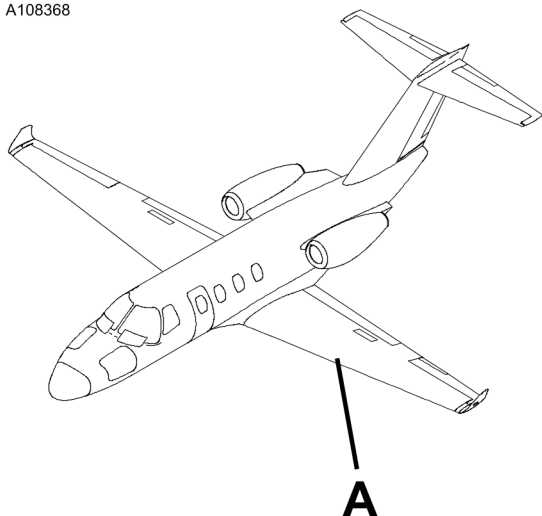
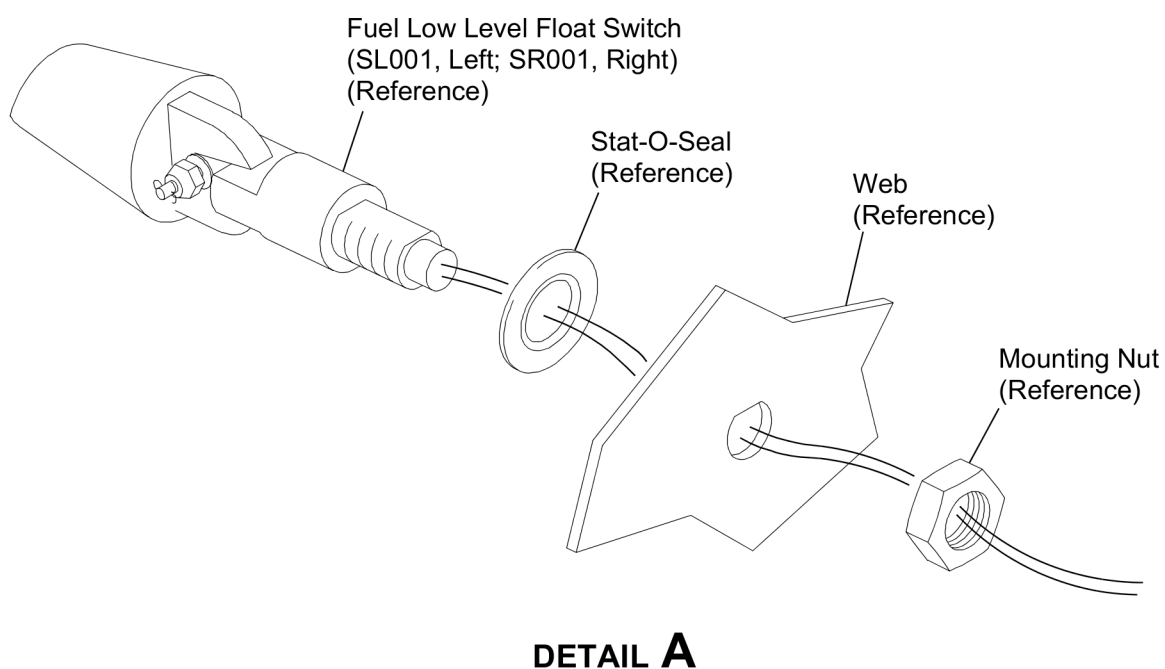
Figure 1. Fuel Low Level Float Switch (SL001, Left; SR001, Right) (Sheet 1)

To make sure that the mounting nut on the fuel low level float switch (SL001, Left; SR001, Right) is properly torqued. Fuel may leak into the main landing gear wheel well if the mounting nut is not torqued properly.

2. (Refer to Figure 1, Detail A.) Remove sealant from around the fuel low level float switch (SL001, Left; SR001, Right) mounting nut.
3. Torque the fuel low level float switch (SL001, Left; SR001, Right) mounting nut from 145 to 150 inch pounds. (Refer to Citation Standard Practices Manual, Chapter 20, Tubing, Hose and Fittings - Maintenance Practices.)

4. Fillet seal around the fuel low level float switch (SL001, Left; SR001, Right) mounting nut with Type 1 Class B-2 sealant. (Refer to Citation Standard Practices Manual, Chapter 20, Fuel, Weather, Pressure, and High-Temperature Sealing - Maintenance Practices.)
