**N° SB 937 – CS – Ed. 2 Rev. 1****Date: 26/02/2026**

**MANDATORY** by the AD No. 2026-0023 ☒ **May become MANDATORY** after EASA evaluation ☐**RECOMMENDED** ..... ☐ **INFORMATION** ..... ☐**SUBJECT:** P2010 Lycoming IO-390 – Exhaust Muffler Flame Tube Inspection

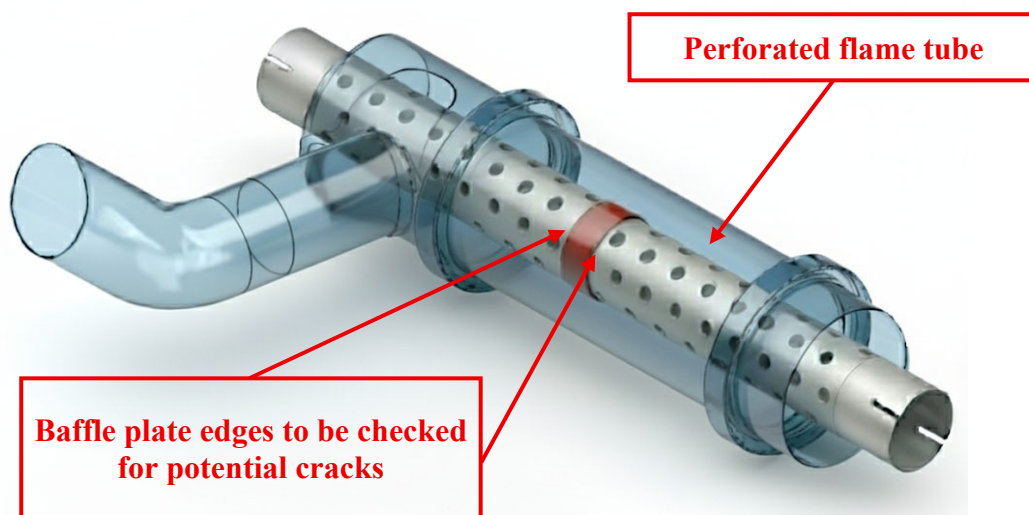
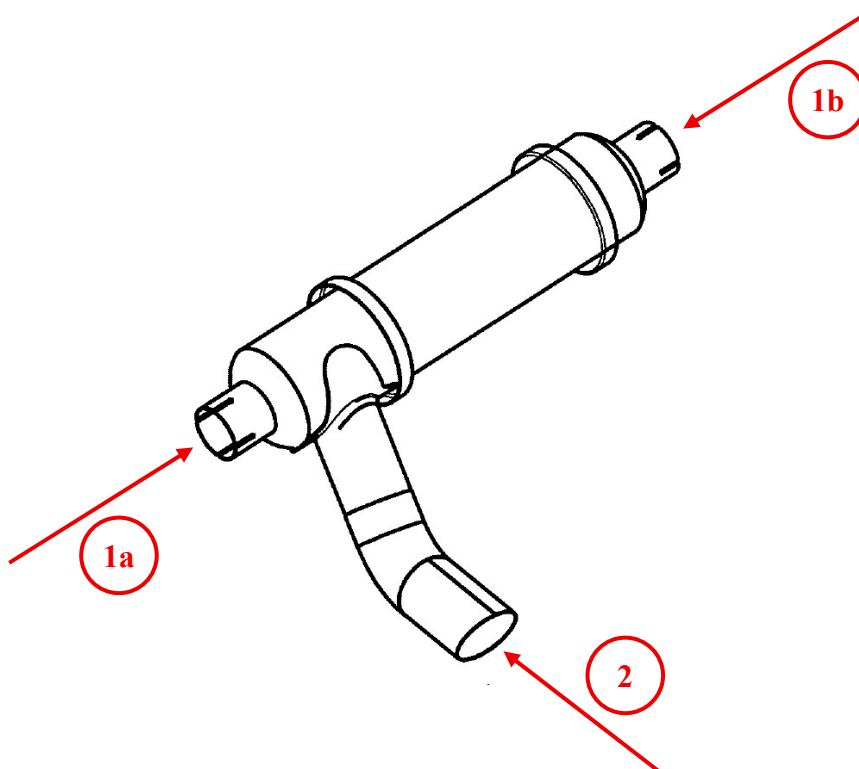
***Figure 1 - Exhaust Muffler Flame Tube Inspection (3D model for reference only)***

**SCOPE:** Following an occurrence report involving a Tecnam P2010 aircraft equipped with a Lycoming IO-390 engine, Tecnam has identified a potential risk concerning the structural integrity of the flame tube located within the exhaust muffler. If not addressed, this condition could result in a partial or complete obstruction of the exhaust system, potentially leading to engine malfunction or stoppage.

| <i>N</i> | <i>Accomplishment Instructions</i> |
|---|---|
| <b>3</b> | <p><b><i>Carry out the inspection of the exhaust flame tube</i></b><br/> <b><i>Refer to Figure 1</i></b></p> <p><i>Perform a detailed borescope inspection of the internal surfaces of the perforated flame tube within the exhaust muffler, accessing the interior through both the left and right entry points (points 1a and 1b). Focus the inspection on the region adjacent to the steel baffle plate located at the mid-length of the flame tube itself (the plate is highlighted in red in the 3D model shown as reference). <b><u>It is mandatory to perform the inspection from both sides to ensure full coverage.</u></b> Check for any of the following conditions: cracks, fractures or any signs of potential initiation of such defects. Subsequently, conduct a borescope inspection of the external surfaces of the perforated flame tube by inserting the borescope through the single outlet port normally leading to the exhaust terminal (point 2), <u>checking for the same conditions as above.</u> The external surface of the flame tube shall be inspected along its entire length, with particular attention to the area around the two edges of the steel baffle plate that are welded to the flame tube.</i></p> |

| <i>N</i> | <i>Accomplishment Instructions</i> |
|---|---|
| <b>4</b> | <p><b><i>If any abnormal condition is found, contact Tecnam for further instructions (an Occurrence Report will be required)</i></b></p> <p><i>If no damage is found during the inspection, proceed with reinstalling the exhaust muffler. Refer to the applicable procedure in AMM Supplement S6, ATA 78-10</i></p> |
