**N° SB 170 – CS – Ed 1 Rev 1****Date:** 25 09 2014

**Approval No: DO-170-140925**

**MANDATORY** by the AD No.yyyy-xxxx ☐ **May become MANDATORY** after EASA evaluation ☒**RECOMMENDED** ..... ☐ **INFORMATION** ..... ☐**SUBJECT:** P2006T Exhaust pipes inspection

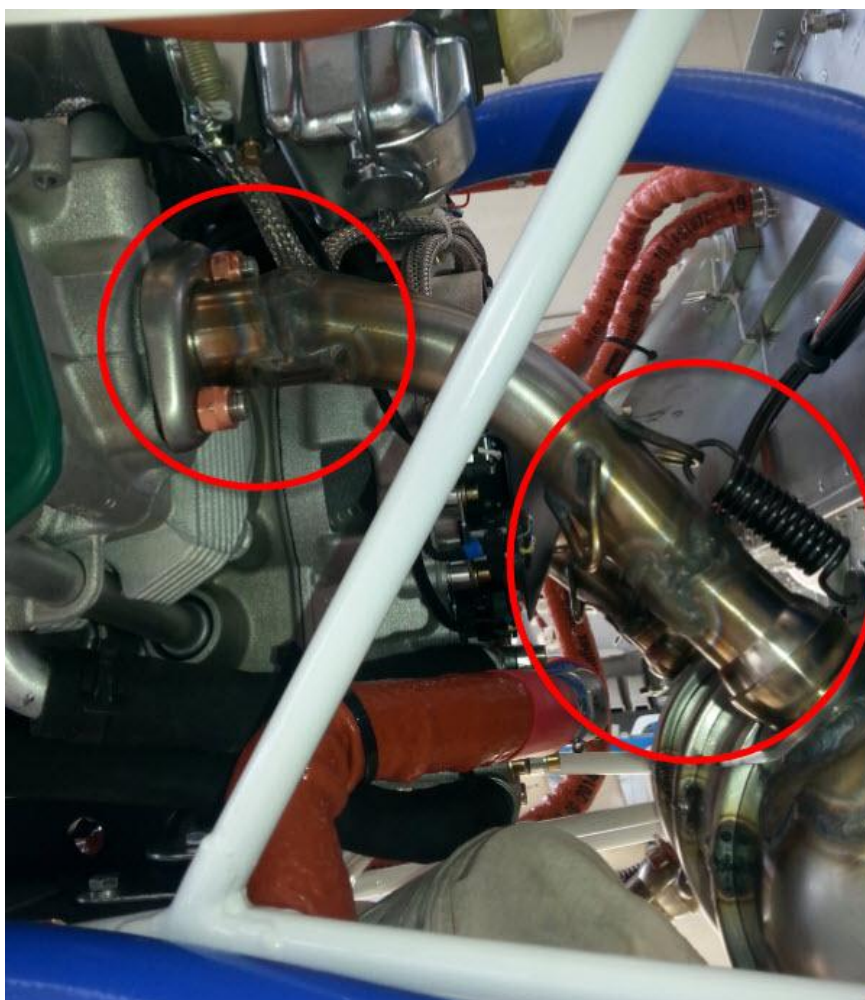
**Fig.1 Rear left exhaust pipe**

- 1) Remove the engine cowlings upper and lower (LH and RH), according P2006T AMM;
- 2) Perform the visual inspection on all 4 exhaust pipes for each engine (with particular attention of the welded points highlighted in the following pictures) for cracks and deformation, use a torch light and/or mirrors if needed;

**If a crack is found, fill the occurrence report herein attached and send it to Tecnam.**
