**N° SB 738 – CS – Ed. 1 Rev. 2**

**SUBJECT:**    P-Mentor Seat Rails inspection

**SCOPE:**    Following the receipt of an occurrence report, Tecnam mandates an inspection of P-Mentor seat rails.  
 This inspection must be conducted within the compliance timeframe specified below to assess the rails condition, wear and locking system interference, which could potentially result in seat unlocking.  
 The required inspection instructions are reported in Appendix A of this document.

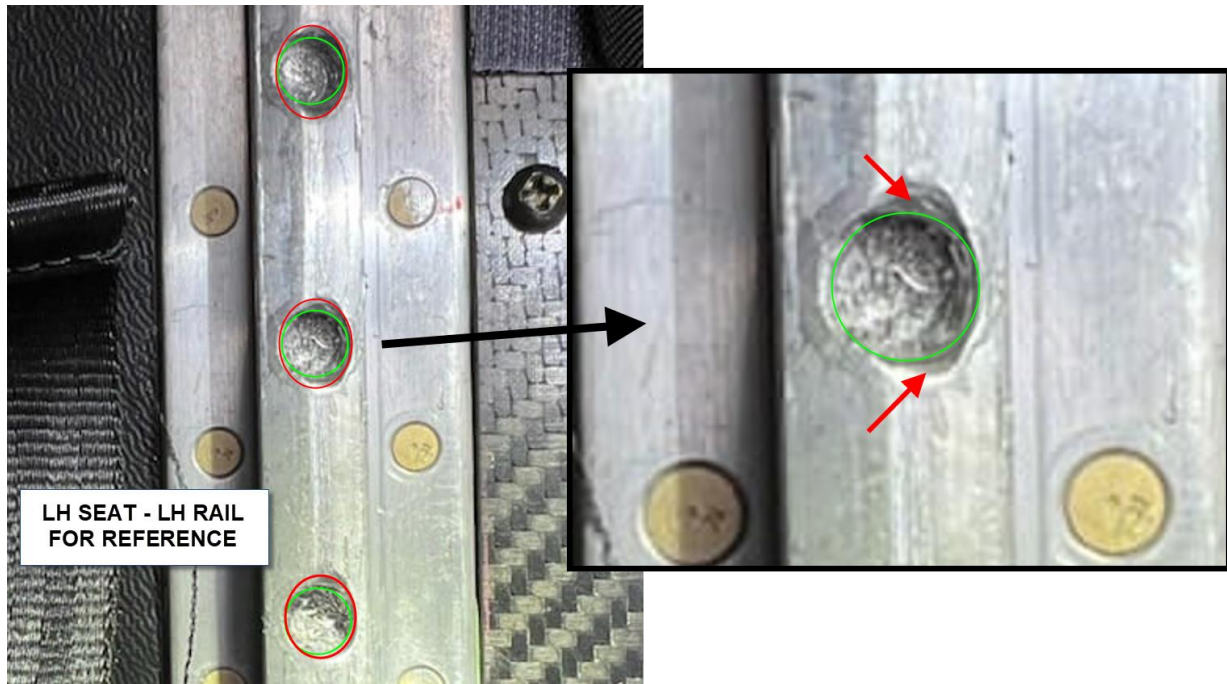
**Figure 1 Damaged seat rails.**

| N | Accomplishment Instructions |
|---|---|
| 5 | Using a magnifying glass and a concentrated light, visually inspect the seat rails holes (particularly LH rail on Left seat and RH rail on RH seat) for deformation and excessive wear (see figure 1).<br>If deformation or abnormalities are detected, please report the inspection result to Tecnam through the Form below; |

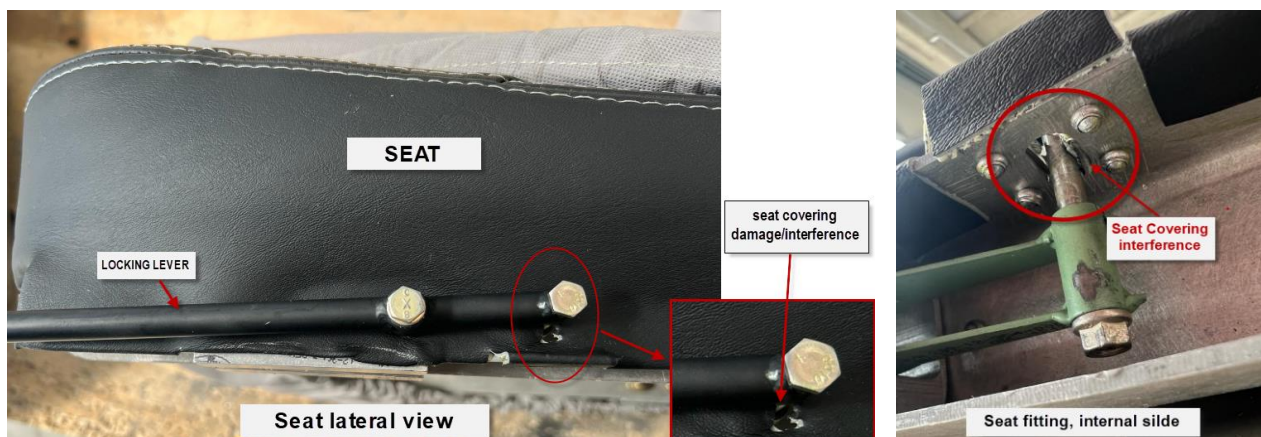
**Figure 2 locking system interference.**

| N | Accomplishment Instructions |
|---|---|
| 4 | Moreover, verify and eliminate potential locking system interference caused by contact with the seat covering (see figure 2). Trim as needed to ensure the retaining pin and spring move freely within their path.<br><i>Note: Such interference could trigger partial Locking of the Pin, potentially leading to seat un-locking issues, as well as wear on the seat guides' surface.</i> |

**WRONG INSTALLATION**

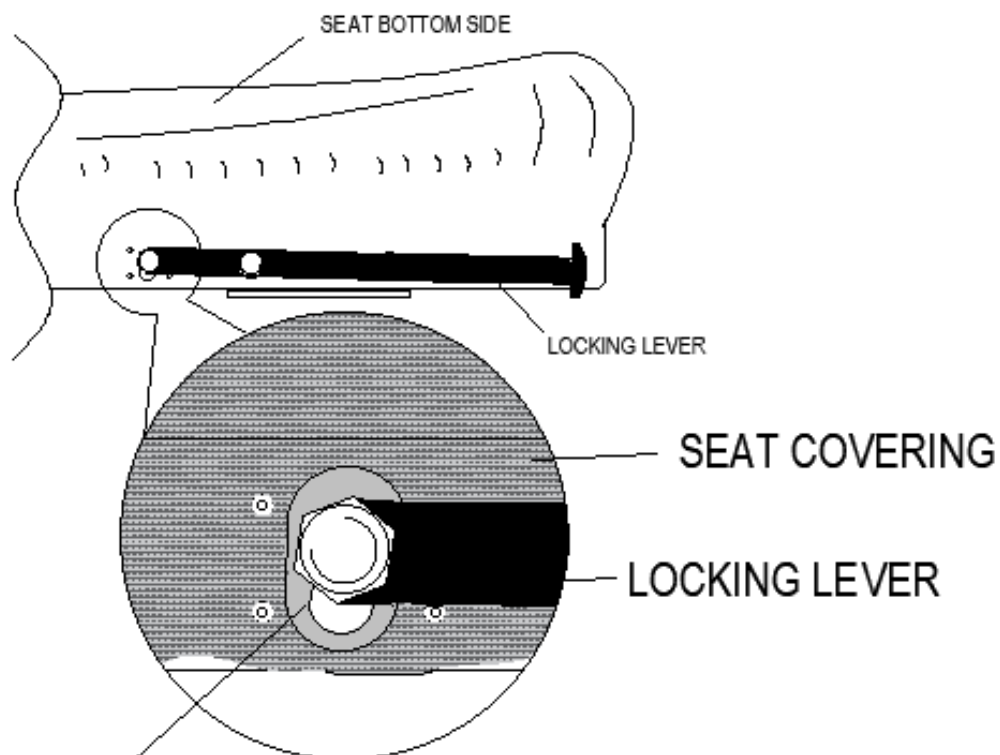
**Figure 3 Seat locking system.**

**CORRECT INSTALLATION**

Verify for a clearance between seat covering and the hole edge.  
Minimum 3mm clearance has to be present.
